Appendix I1

Accessibility Audit Report

Jacobs Engineering Ireland Limited

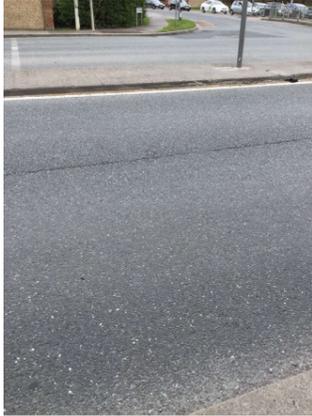
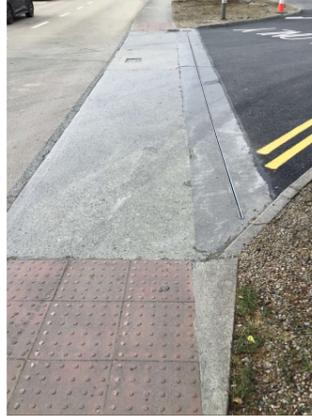
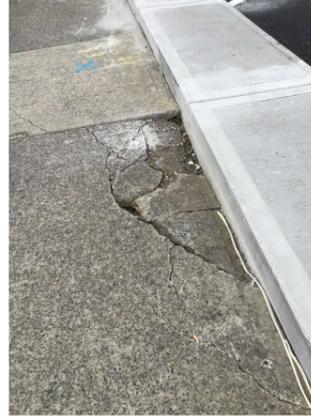
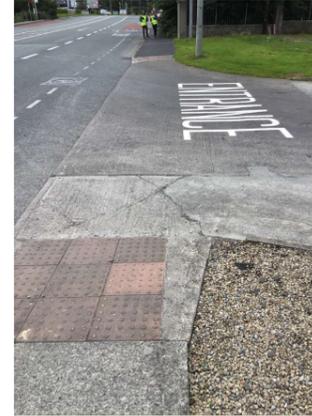
997 - No crossing facilities provided	1003 - Inappropriately constructed vehicle crossover point	1004 - Broken paving / footway	1005 - Inappropriately constructed vehicle crossover point
<p>This is located at the junction of the R132 and L2300. It is high severity as there are no alternative crossings at this point, making it inaccessible.</p>	<p>This is located along the R132, near the L2300 junction. This is high severity due to the risk of visually impaired pedestrians not being aware of the presence of a kerb and veering into the carriageway.</p>	<p>This is located along the R132 outside the Texaco garage shop. This is considered high severity due to the presence of a trip hazard which could result in a fall into traffic.</p>	<p>This is located along the R132 at the entrance to the Texaco garage shop. It is considered high severity due to the risk of visually impaired pedestrians not being aware of the presence of a kerb and veering into the carriageway.</p>

<p>717697, 745305</p>	<p>717677, 745280</p>	<p>717680, 745248</p>	<p>717686, 745204</p>
<p>Solution: Provide crossing facilities.</p>	<p>Solution: Raise the driveway to meet the required standard height.</p>	<p>Solution: Implement more suitable paving which is even.</p>	<p>Solution: Raise the entryway to meet the required standard height.</p>
1012 - No crossing facilities provided	1013 - No crossing facilities provided	1020 - No crossing facilities provided	1021 - Footpath not provided
<p>This is located along the R132 located at the entrance to a number of retail units. This is high severity as it is not clear where the end of the footpath is, which may cause visually impaired pedestrians to veer into the carriageway.</p>	<p>This is located along the R132, at the entrance to Glenmore House B&B. This is considered high severity as there is no distinction between the entrance and the carriageway, causing visually impaired pedestrians to veer into the carriageway.</p>	<p>This is located along the R132, at a private entrance. This is high severity as there is no distinctions between the entryway and the road, which could cause visually impaired pedestrians to veer into the carriageway. There is no alternative to crossing at this point, making it inaccessible.</p>	<p>This is located along the R132, at a private entrance, at the same crossing as 1020. This is high severity as there is no footpath provided on this side of the entryway, making it inaccessible for those with reduced mobility, or visually impaired pedestrians with no indication of direction.</p>

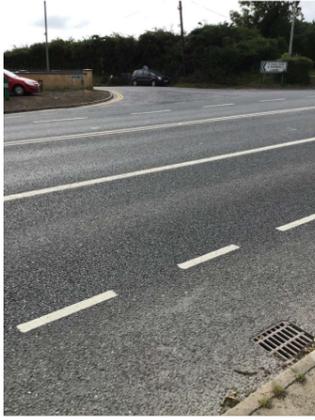
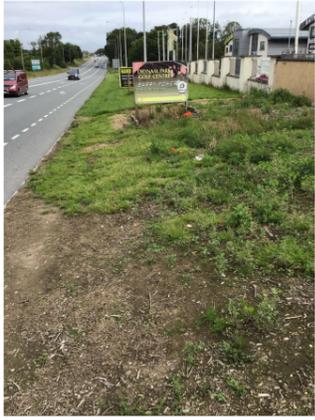
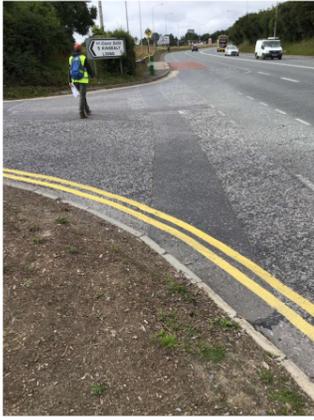
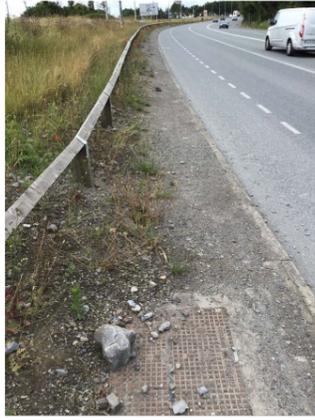
1027 - No crossing facilities provided	1028 - Footpath not provided	1029 - No crossing facilities provided	1030 - Footpath not provided
<p>This is located along the R132, at Kettles Lane. It is considered high severity as it makes for unsafe crossing, as there is no alternative crossing at this point, making it inaccessible.</p>	<p>This located along the R132, north of Kettles Lane. This is considered high severity as it makes the area inaccessible for those with reduced mobility, or visually impaired pedestrians who would have no indication of direction.</p>	<p>This is located along the R132, at Kettles Lane. This is considered high severity as there is no alternative to crossing at this point making it inaccessible.</p>	<p>This is located along the R132, at the bus stop south of Kettles Lane. This is high severity as it makes the bus stop inaccessible for those with reduced mobility.</p>

717756, 744482	717778, 744482	717777, 744474	717777, 744430
Solution: Provide crossing facilities.	Solution: Provide footpath.	Solution: Provide crossing facilities	Solution: Provide footpath.
1035 - No crossing facilities provided	1037 - No crossing facilities provided	1040 - No crossing facilities provided	1041 - No crossing facilities provided
<p>This is located along the R132, on approach to the Cloghran Roundabout. It is considered high severity as there is no alternative to crossing at this point, making it inaccessible.</p>	<p>This is located on Stockhole Lane, at the approach to Cloghran Roundabout. This is considered high severity as there are no alternative crossings at this point, making it inaccessible.</p>	<p>This is located along the R132, south of Cloghran Roundabout. This is considered high severity as there is no alternative to crossing at this point, making it inaccessible.</p>	<p>This is located on the Naul Road, on approach to Cloghran Roundabout. This is high severity as there is no alternative to crossing at this point, making it inaccessible.</p>

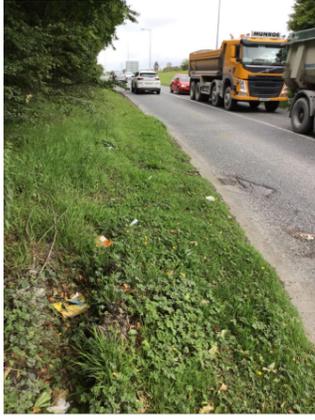
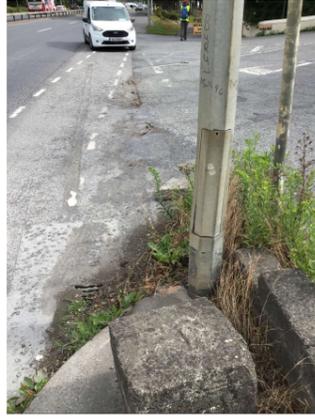
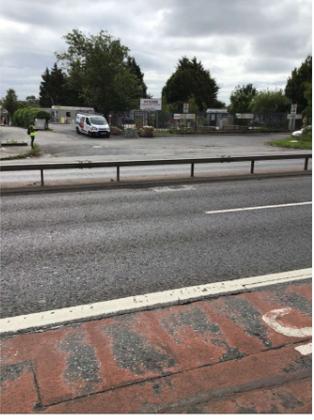
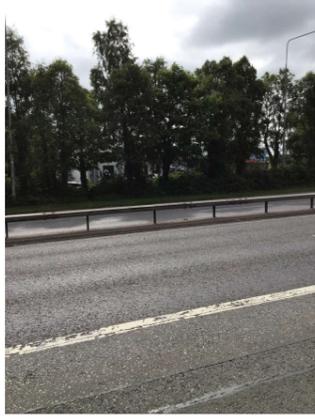
<p>1042 - Footpath not provided</p>	<p>1044 - No crossing facilities provided</p>	<p>1049 - No crossing facilities provided</p>	<p>1050 - Footpath not provided</p>
<p>This is located on Naul Road, on approach to Cloghran Road. This is considered high severity as it is inaccessible to those with reduced mobility.</p>	<p>This is located along the R132, at Old Stockhole Lane. This is considered high severity as there is no alternative to crossing at this point. There is no distinction between the crossing and the carriageway, which could cause visually impaired pedestrians to veer into the carriageway.</p>	<p>This is located along the R132, opposite Old Stockhole Lane. This is high severity as a lack of crossing requires unreasonable diversion and makes crossing inaccessible.</p>	<p>This is located along the R132, on approach to Airport Roundabout. This is high severity as a lack of footpath makes the area inaccessible to those with reduced mobility, as they are forced to travel along the carriageway.</p>

<p>717661, 744148</p>	<p>717652, 743987</p>	<p>717608, 743904</p>	<p>717602, 743859</p>
<p>Solution: Provide footpath.</p>	<p>Solution: Provide crossing facilities.</p>	<p>Solution: Provide crossing facilities.</p>	<p>Solution: Provide footpath.</p>
<p>1053 - No crossing facilities provided</p>	<p>1054 - Unsuitable access for disabled users</p>	<p>1055 - Unsuitable access for disabled users</p>	<p>1056 - Unsuitable access for disabled users</p>
<p>This is located on the R132, on approach to Airport Roundabout. This is considered high severity as crossing requires unreasonable diversion, making it inaccessible.</p>	<p>This is located at the R132 exit of Airport Roundabout. It is considered high severity as the push button is not working, with no sound or pulse for disabled users, making it inaccessible.</p>	<p>This is located at the R132 exit of Airport Roundabout. It is considered high severity as the push button is not working, with no sound or pulse for disabled users, making it inaccessible.</p>	<p>This is located at the exit lanes from Dublin Airport towards Airport Roundabout. It is considered high severity as the push button is not working, with no sound or pulse for disabled users, making it inaccessible.</p>

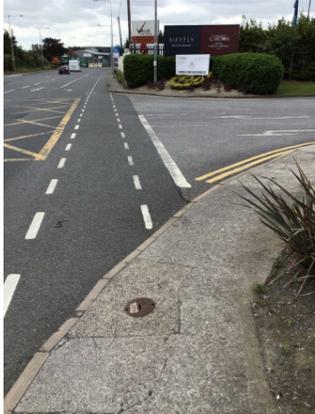
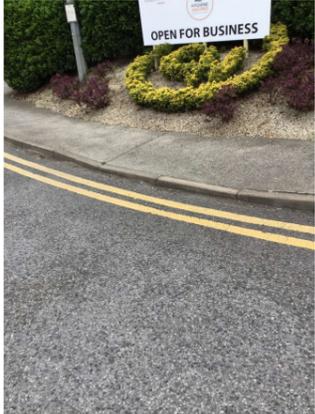
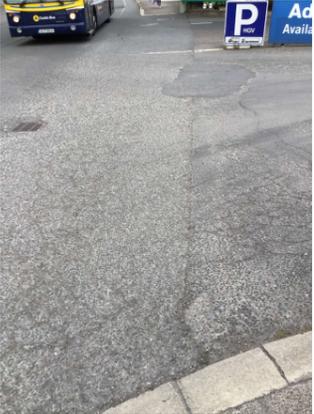
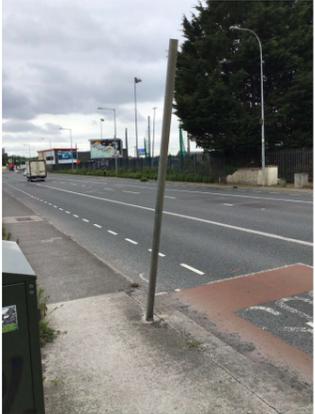
1077 - Crossings not aligned	1078 - Dropped kerbs not flush with crossing	1084 - No crossing facilities provided	1087 - Signpost in footway
<p>This is located along Swords Road, at the entrance to Quick Park Dublin Airport. This is high severity as the lack of distinction between the crossing and road could cause visually impaired pedestrians to veer into the carriageway.</p>	<p>This is located along Swords Road, at the entrance to Carlton Hotel Dublin Airport. This is high severity as it is inaccessible to those with reduced mobility, and wheelchair users.</p>	<p>This is located on Swords Road, at the entrance to Collinstown Business Park. This is high severity as the lack of distinction between the crossing and road could cause visually impaired pedestrians to veer into the carriageway.</p>	<p>This is located on the R132, at the bus stop south of Collinstown Business Park. This is high severity as it presents danger to visually impaired pedestrians. It also reduces the width of the footpath, making it inaccessible to wheelchair users.</p>

<p>717037, 742008</p>	<p>717038, 741992</p>	<p>717081, 741855</p>	<p>717082, 741814</p>
<p>Solution: Reposition dropped kerb to align crossings.</p>	<p>Solution: Lower kerb to be flush with crossing.</p>	<p>Solution: Provide crossing facilities.</p>	<p>Solution: Relocate signpost to more appropriate location, or completely remove as no sign present.</p>
1092 - No crossing facilities provided	1102 - No crossing facilities provided		
<p>This is located along the R132, at the entrance to Glen Dimplex. This is high severity as there is no alternative to crossing at this point, making it inaccessible.</p>	<p>This is located along the R132, at the entrance of North Ring Business Park. This is high severity as there is no alternative to crossing at this point, making it inaccessible.</p>

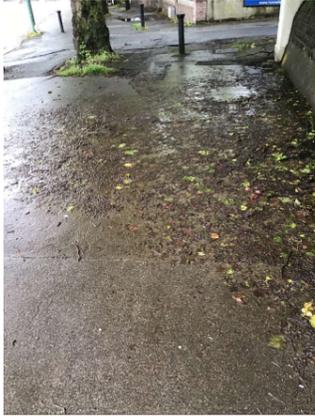
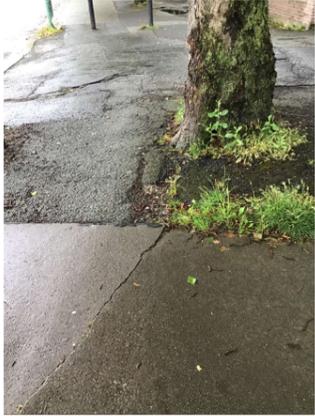
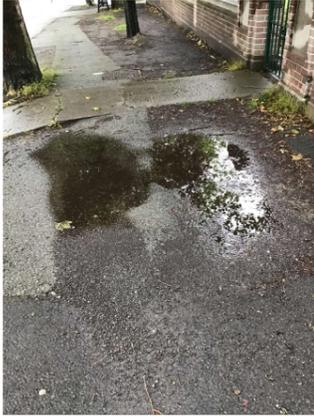
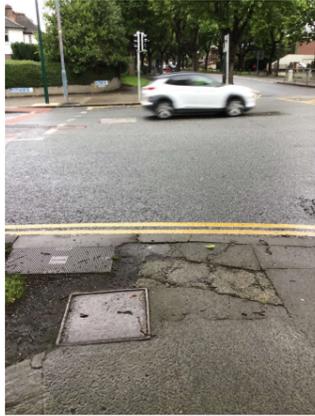
<p>1237 - Ponding</p>	<p>1238 - Uneven paving / footway</p>	<p>1239 - Ponding</p>	<p>1251 - No crossing facilities provided</p>
<p>This is located on the R132 (Drumcondra Road Upper), at the entrance to Home Farm Football Club. This is considered high severity as it presents a slip hazard for visually impaired pedestrians</p>	<p>This is located on the R132 (Drumcondra Road Upper) at the entrance to Home Farm Football Club. This is considered high severity as it presents a trips hazard for visually impaired pedestrians, or those with reduced mobility.</p>	<p>This is located on the R132 (Drumcondra Road Upper), south of the entrance to Home Farm Football Club. This is considered high severity as it presents a slip hazard for visually impaired pedestrians.</p>	<p>This is located at the junction of Drumcondra Road Upper and Griffith Avenue. It is considered high severity as there is no alternative to crossing at this point, making it inaccessible.</p>

<p>716441, 737666</p>	<p>716436, 737661</p>	<p>716429, 737652</p>	<p>716418, 737585</p>
<p>Solution: Improve drainage or resurface to prevent ponding.</p>	<p>Solution: Fix uneven paving to mitigate trip hazard.</p>	<p>Solution: Improve drainage or resurface to prevent ponding.</p>	<p>Solution: Provide crossing facilities.</p>
<p>1268 - Uneven paving / footway</p>	<p>1277 - Uneven paving / footway</p>	<p>1279 - No crossing facilities provided</p>	<p>1280 - No crossing facilities provided</p>
<p>This is located along Drumcondra Road Upper, south of Home Farm Road. This is high severity as it presents a trip hazard for visually impaired pedestrians.</p>	<p>This is located along Drumcondra Road Upper, north of Home Farm Road. This is considered high severity as it presents a trip hazard for visually impaired pedestrians and presents difficulty for those with reduced mobility.</p>	<p>This is located on Home Farm Road, at the junction with Drumcondra Road Upper. This is high severity as there is no alternative to crossing at this point, making it inaccessible.</p>	<p>This is located along Drumcondra Road Upper, at the junction with Home Farm Road. This is considered high severity as there is no alternative to crossing at this point, making it inaccessible.</p>

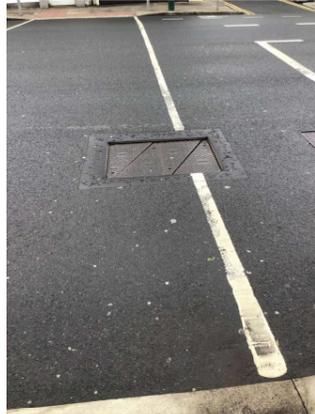
716231, 737155

This is located on Drumcondra Road Upper, outside Dublin City University. This is considered high severity as it presents a trip hazard for visually impaired pedestrians.

Solution: Fix paving to mitigate trip hazard.

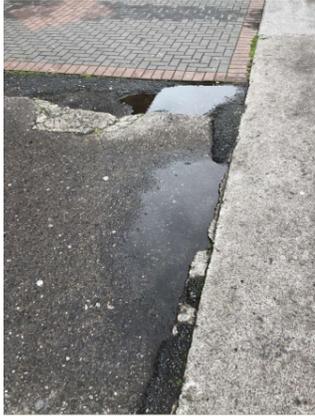
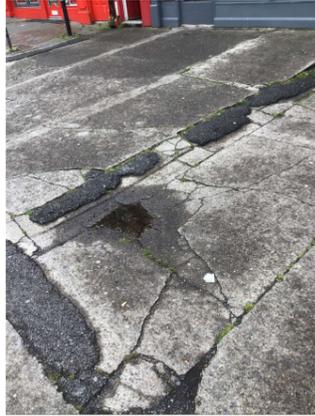
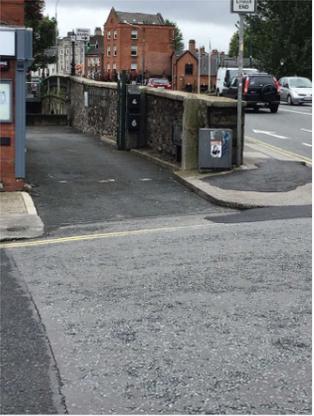
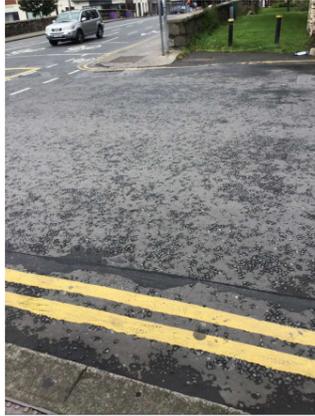
1305 - Uneven paving / footway	1307 - Uneven paving / footway	1310 - No crossing facilities provided	1316 - No crossing facilities provided
<p>This is located along Drumcondra Road Upper. It is considered high severity as it presents a trip hazard to visually impaired pedestrians. It also presents difficulty for those with reduced mobility.</p>	<p>This is located along the retail units on Drumcondra Road Upper, north of Richmond Road. This is considered high severity as it presents a trip hazard for visually impaired pedestrians and presents difficulty for those with reduced mobility.</p>	<p>This is located along Drumcondra Road Upper, next to Hanlon & Co Solicitors. This is considered high severity as there is no alternative to crossing at this point, making it inaccessible. It also allows visually impaired pedestrians to dangerously veer onto the carriageway.</p>	<p>This is located on Millmount Avenue, off Drumcondra Road Upper. This is high severity as there is no alternative to crossing at this point, making it inaccessible. It also allows visually impaired pedestrians to dangerously veer onto the carriageway.</p>

<p>716167, 736876</p>	<p>716154, 736839</p>	<p>716134, 736810</p>	<p>716115, 736821</p>
<p>Solution: Fix paving to mitigate trip hazard.</p>	<p>Solution: Fix paving to mitigate trip hazard.</p>	<p>Solution: Provide crossing facilities.</p>	<p>Solution: Provide crossing facilities.</p>
1319 - No crossing facilities provided	1320 - No crossing facilities provided	1331 - Inappropriately constructed vehicle crossover point	1331 - No dropped kerbs at crossing
<p>This is located along Drumcondra Road Lower, at Cian Park. This is high severity as there is no alternative to crossing at this point, making it inaccessible.</p>	<p>This is located along Drumcondra Road Lower, at Botanic Avenue. This is considered high severity as there is no alternative to crossing at this point, making it inaccessible.</p>	<p>This is located along Drumcondra Road Lower, north of Hollybank Road. This is high severity as there is uneven paving presenting a trip hazard to visually impaired pedestrians.</p>	<p>This is located along Drumcondra Road Lower, north of Hollybank Road. This is high severity as it presents a trip hazard for visually impaired pedestrians, and difficulty for those with reduced mobility.</p>

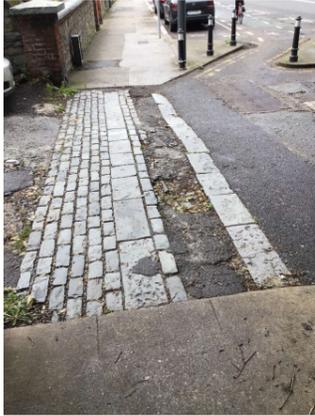
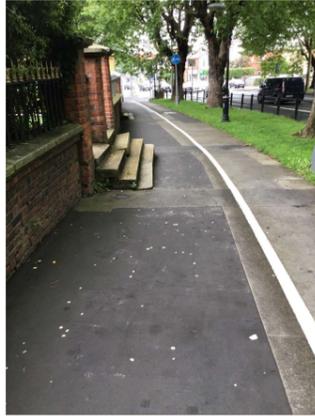
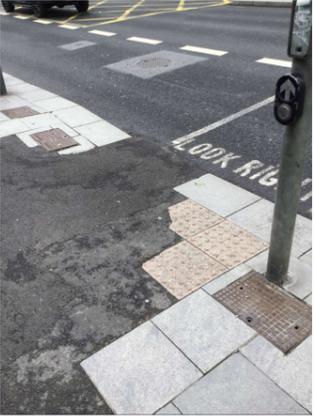
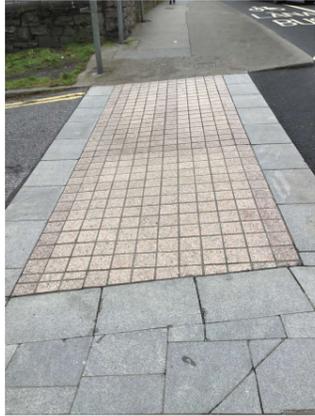
<p>1344 - Road Surfacing at Crossing Poor</p>	<p>1356 - Inappropriate street furniture</p>	<p>1361 - Incorrect tactile paving at crossing</p>	<p>1362 - No tactile paving at crossing</p>
<p>This is located along Drumcondra Road Lower, opposite St Alphonsus' Road Lower. This is high severity as it presents a trip hazard for visually impaired pedestrians, and difficulty for those with reduced mobility.</p>	<p>This is located along Drumcondra Road Lower, north of Carlingford Road. This is high severity as it presents a trip hazard for visually impaired pedestrians.</p>	<p>This is located along Drumcondra Road Lower, at Whitworth Road junction. This is high severity as visually impaired pedestrians are unaware of crossing and may veer onto carriageway.</p>	<p>This is located along Drumcondra Road Lower, at Whitworth Place. This is high severity as visually impaired pedestrians are unaware of crossing and may cross when not safe to do so.</p>

<p>716019, 736311</p>	<p>716077, 736545</p>	<p>715868, 736034</p>	<p>715864, 736026</p>
<p>Solution: Fix road surface and provide crossing facilities.</p>	<p>Solution: Relocate street furniture.</p>	<p>Solution: Provide correct tactile paving.</p>	<p>Solution: Provide correct tactile paving at crossing.</p>
<p>1363 - Vehicles parked in footway</p>	<p>1368 - Unsuitable access for disabled users</p>		
<p>This is located along Drumcondra Road Lower, north of Whitworth Place. This is high severity as it makes the path inaccessible for people using wheelchairs or walking aids.</p>	<p>This is located along Drumcondra Road Lower, at the junction with R131. This is high severity as the push button does not pulse for visually impaired or deaf pedestrians, making it inaccessible.</p>

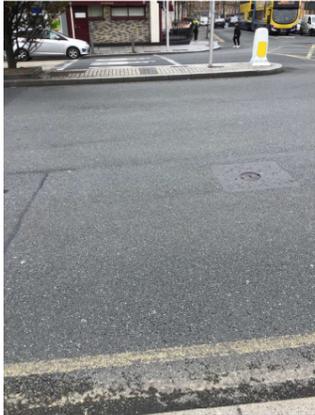
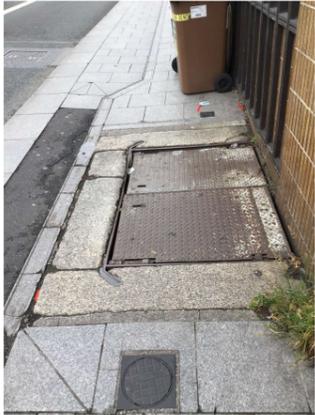
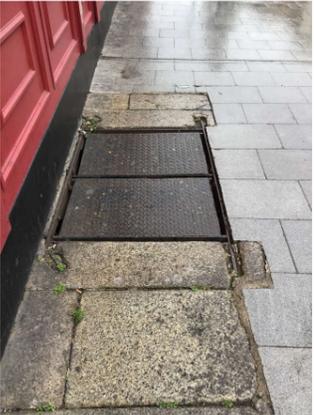
1376 - No crossing facilities provided	1394 - Uneven paving / footway	1453 - Uneven paving / footway
<p>This is located along Dorset Street Lower, at the junction with Synnott Place. This is considered high severity as crossing requires unreasonable diversion, making it inaccessible.</p>	<p>This is located along Dorset Street Lower, north of Ruco café. This is high severity as it presents a trip hazard for visually impaired pedestrians, and difficulty for those with reduced mobility.</p>	<p>This is located along Dorset Street Upper, outside Maye's pub. This is considered high severity as it presents a trip hazard for visually impaired pedestrians, and difficulty for those with reduced mobility.</p>

<p>715688, 735743</p>	<p>715590, 735581</p>	<p>715477, 735376</p>
<p>Solution: Provide crossing facilities.</p>	<p>Solution: Fix paving to mitigate trip hazard.</p>	<p>Solution: Fix paving to mitigate trip hazard.</p>

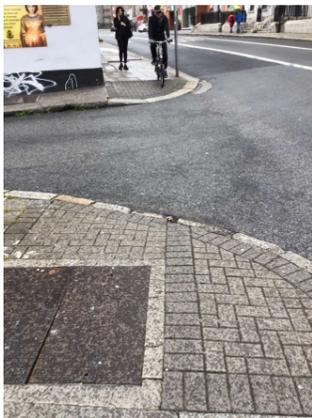
<p>Solution: Provide crossing facilities. Tighten Junction</p>			
<p>Solution: Provide crossing facilities.</p>		<p>Solution: Provide crossing facilities.</p>	
1446 - No crossing facilities provided			
<p>This is located on Granby Row, at Granby Lane. This is high severity as there is no alternative to crossing at this point, making it inaccessible.</p>

<p>715425, 735143</p>			
1446 - No crossing facilities provided			
<p>Solution: Provide crossing facilities.</p>
