Appendix M2
Road Safety Audit
Stage 1

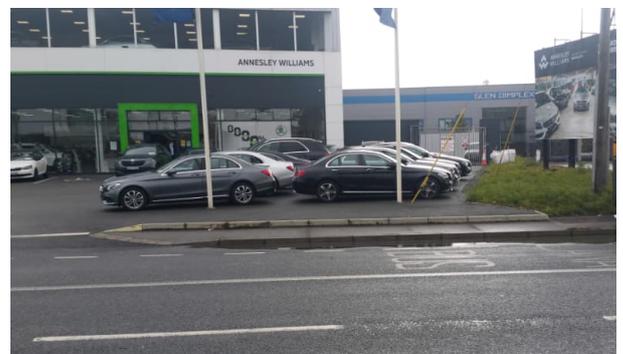
Figure 2.1 Ponding of water in the carriageway (Ch A4650)

The Audit Team noted on site the ponding of water in the carriageway at various locations. The widening of the carriageway to facilitate additional lanes may increase the risk of ponding of water and increase the risk of loss of control type collisions due to ice during cold conditions

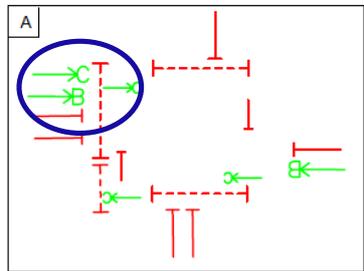
Figure 2.3 Swords Road/
Northwood Avenue

The Audit Team note that at some junctions, the signal phasing indicates that the cyclist 'green' movement proceeds at the same time as the bus lane 'green'. The Audit Team note that the cycle stop line is placed ahead bus stop line but is concerned that where the bus lane is used by taxi or private coaches to undertake a left turn movement and are unaware of the need to yield to cyclists crossing, increasing the risk of cyclist and vehicular conflicts.

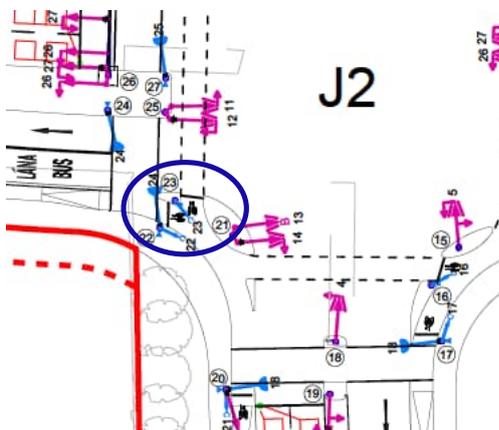
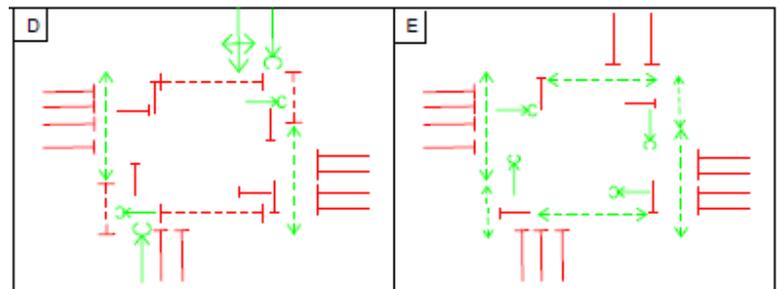
Figure 2.5 Swords Road/ Boroimhe Road

The drawings indicate the provision of cycle lights in close proximity within the junction in various locations. There is concern that the alternative green phase of these lights will cause cyclists confusion putting them into conflict with either vehicular traffic or other vulnerable road users.

The Design Team should ensure cycle signals and associated stop lines are located in such a way not to cause confusion.

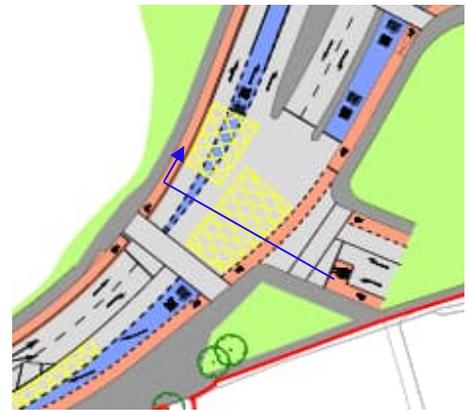
Figure 3.1 Access to Cycle Track for right turns

The Audit Team note that on the northern arm of the proposed junction (Dublin Road), there is a proposed signalised junction access on the western side to service future development. It is unclear as to how right turners on the minor arm will construe the road layout ahead with general traffic lanes located either side of the bus lane. There is a risk of unsafe manoeuvres due to unfamiliarity with the road layout and the proximity of the two signalised junctions to one another.

The design team should provide advance directional signage to ensure motorists are aware of the road layout ahead.

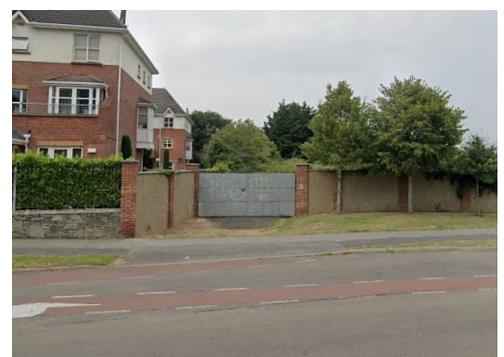
Figure 3.2 Existing Access on Boraimhe Rd

On the Boraimhe Road eastbound, the Audit Team noted the presence of an existing entrance with a dished crossing facilitating vehicular access. The proposed Bus Stop at this location may inhibit the visibility splay at this access, increasing the risk of vehicular collision.

If this access is to be maintained, the Design Team should consider relocating the proposed bus stop.

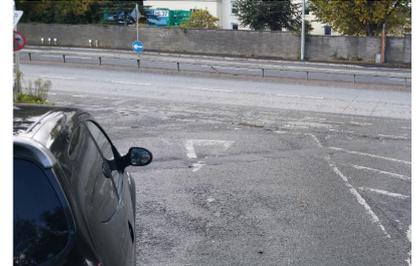
Figure 3.4 Existing road markings

The Audit Team notes the existing road markings indicate 'Yield' road markings at this existing priority junction at chainage A2,150m. Due to the existing vertical gradient, there is the increased risk of vehicular collision with some vehicles rolling forward before there is an acceptable a gap in oncoming traffic.

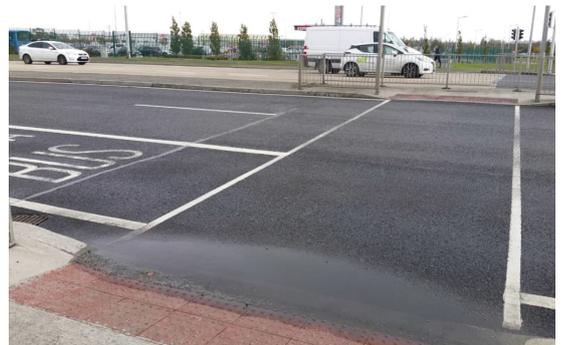
Figure 3.5 Ponding at existing crossing

The Audit Team noted at chainage 3+000, the ponding of water on the carriage way at an existing pedestrian crossing. During cold condition this standing water could lead to an increased risk of trips and falls.

The design team should ensure gullies are located on the upstream side of the dished kerbs to prevent water flowing across the low kerbs and depositing loose debris underfoot of pedestrians.

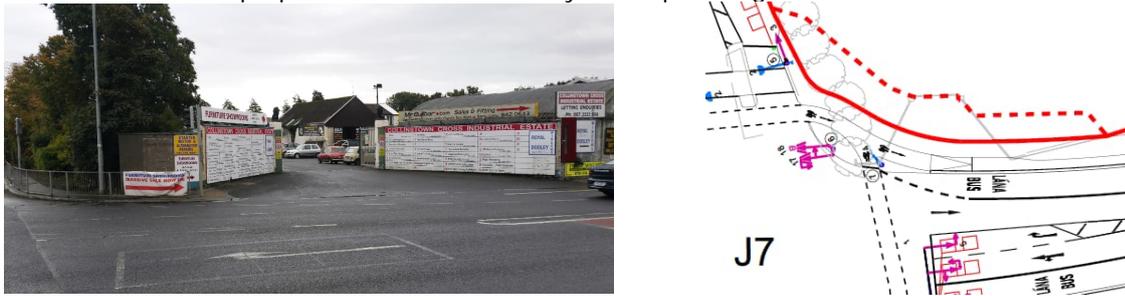
Figure 3.7 Existing access to Industrial Estate

The Audit Team are concerned that the proximity of the Collinstown Cross Industrial Estate to the proposed junction. From the drawings provided it is unclear whether the existing junction is to be retained or where an alternative access is proposed. It is noted that a cycle ramp and signal is located at the mouth of the entrance

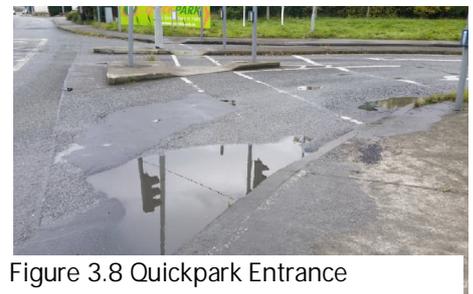
Figure 3.8 Quickpark Entrance

The Audit Team noted deterioration of the pavement at the Quickpark entrance leading to ponding of water. This may lead to slips, trips and falls at the pedestrian crossing or loss of control during cold conditions.

The Design Team should ensure that the pavement design is sufficient to cater for the traffic volumes and loadings.

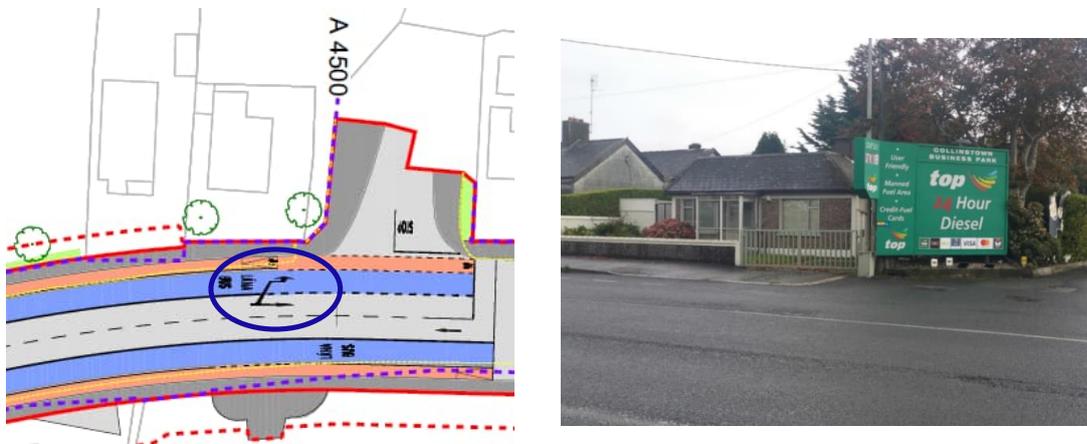
Figure 3.9 Conflict between cycle ramp and existing entrance

The Audit Team are concerned that the proposed cycle ramp kerbing at chainage A4500, will inhibit access to an existing entrance. Motorists may be unaware of the presence of kerbing leading to loss of control type collisions.

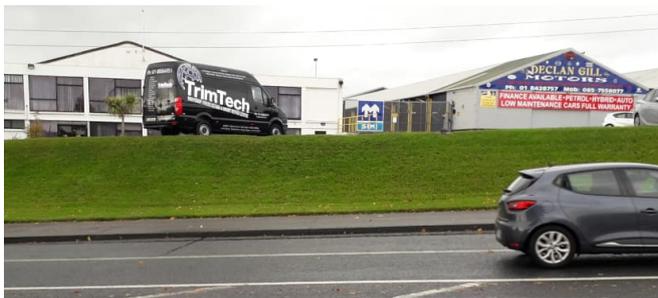
Figure 3.11 Level difference for proposed footpath widening

The Audit Team note that the location of the proposed bus stop northbound, has a steep gradient for the location where the footpath is to be widened. No details are provided with respect to any proposed retaining structure; therefore the audit team could not assess the potential safety impacts at this location. The audit team are concerned that there may be potential of fall from height risk at this location.

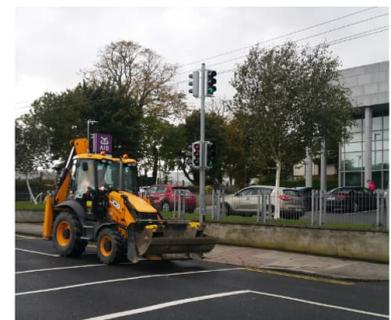
Figure 3.13 Existing OH Electricity Line

The Audit Team note the proximity of existing electricity lines to existing High Mast Pole Mountings on the northern side of the carriageway at Chainage A6700. There is a hazard risk during maintenance of the signal heads.

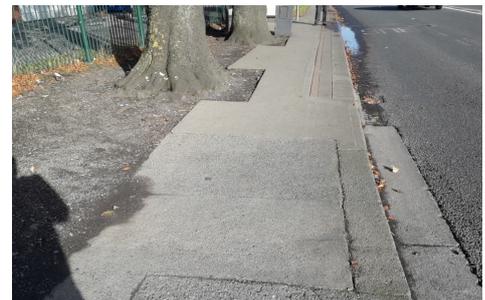
Figure 3.17 Existing footpath

The Audit Team noted that the existing footpath at chainage A8150 narrows due to the proximity of tree stumps. There is an increased risk of pedestrians entering the carriageway in conflict with vehicles due to the insufficient width.

The Design Team should ensure a footpath of minimum width of 2.0m is provided.

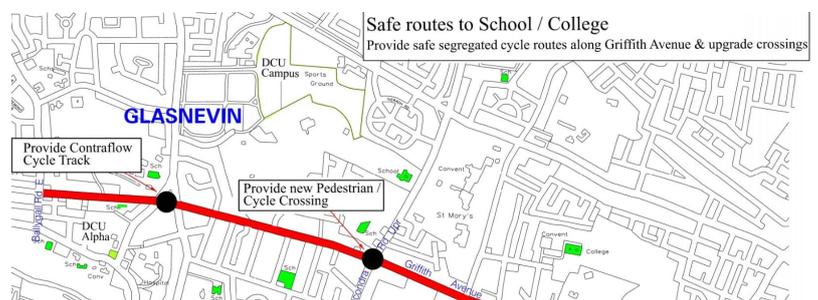
Figure 3.18 Safe routes to School

The Audit Team observed that a on road cycle lane has been developed along Griffith Avenue as part of a safe routes to school initiative by Dublin City Council. It's unclear from the drawings provided how this scheme will tie into the off road cycle lane on the Griffith Avenue/ Swords Road junction.

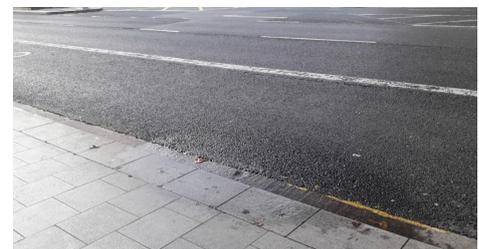
Figure 3.20 Underneath Sligo Dublin Rail Bridge

The Audit Team note that it is proposed to provide a signalised pedestrian crossing under the Dublin Sligo Rail Line. The Audit Team noted water dripping from the above structure. There is an increased risk of trips and falls due to the formation of ice during cold condition.

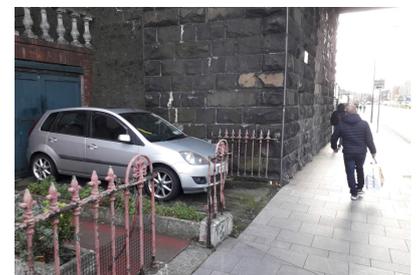
Figure 3.21 Existing driveway

At chainage A10600, the Audit Team is concerned that the proposed bus stop may restrict access to an existing driveway on the eastern side of the Drumcondra Road Lower.

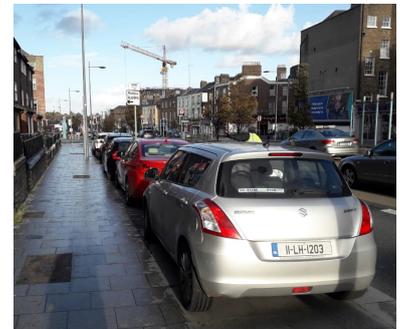
Figure 3.22 Parking on the footpath

At chainage 11150, the Audit Team noted vehicle parking on the footpath. The Audit Team is concerned that parking will continue at this location, increased the risk of the cycle lane being blocked, forcing cyclists on the carriageway in conflicts with vehicles

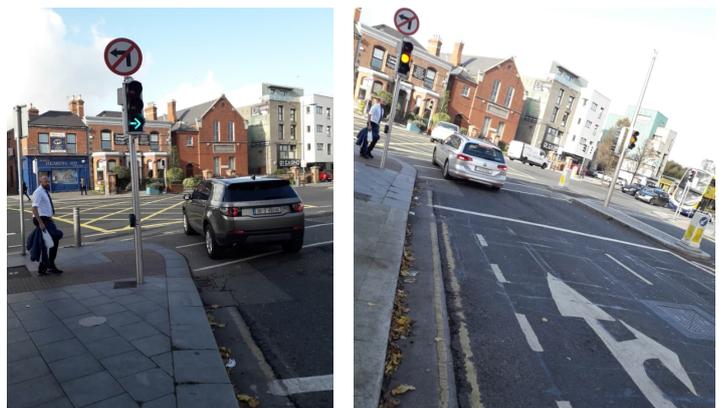
Figure 3.23 Signal/ Road Marking Conflict

The audit Team observed a conflict between existing road markings and signal with respect to a straight-ahead movement from Belvedere Road to Innisfallen Parade. The current arrangement may lead to an increased risk of driver confusion.

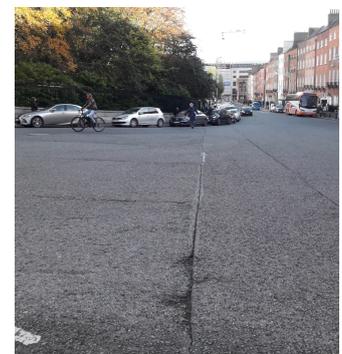
Figure 3.24 Parnell Sq Bellmouth

The Audit Team are concerned that the tie in cross section of Parnell Sq. North adjacent to North Frederik Street does not match existing, and may cause confusion for cyclists and motorists

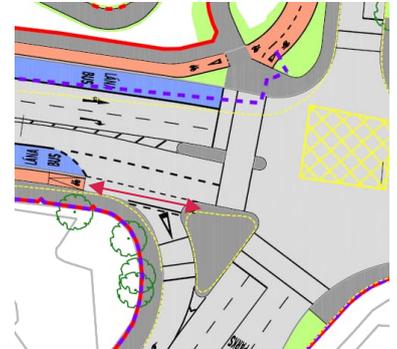
Figure 4.1 Omni Shopping Centre exit

The Audit Team observed vehicles turning right out of the shopping centre and demonstrating poor lane discipline, leading to an increased risk of side swipe type collisions

The Design Team should ensure that cyclists cross this junction arm in a controlled manner.
