Appendix A12.2
Aquatic Baseline
Report

Aquatic baseline report for BusConnects Dublin – Core Bus Corridor Infrastructure Works

Prepared by Triturus Environmental Ltd. for Scott Cawley

August 2022

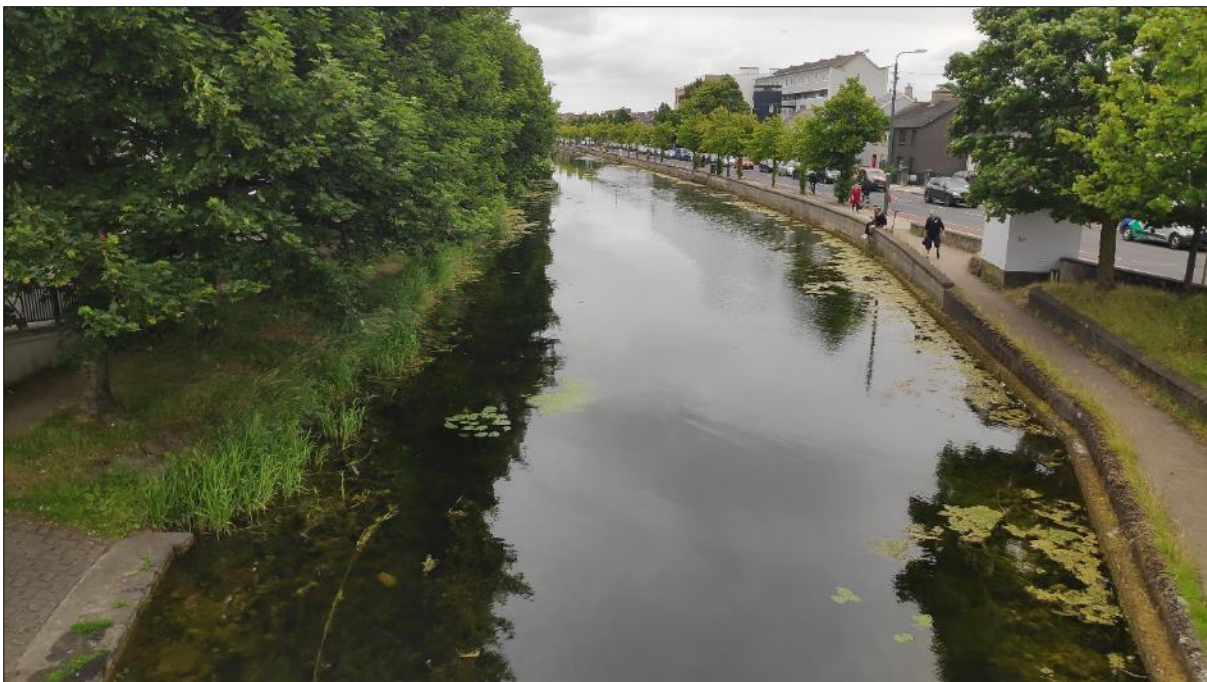
The Grand Canal at Emmett Bridge was a 15m wide channel bound by retaining walls on the south bank with a semi-natural grassy verge along the north. The canal averaged 1.5-2m deep (deeper locally west of the bridge) and featured a bed dominated by organic-rich silt. Some limited gravels and boulders were present in the vicinity of the bridge. The clear-water site was very heavily vegetated with abundant Canadian pondweed (*Elodea canadensis*) and fragile stonewort (*Chara globularis*) with frequent whorled water-milfoil (*Myriophyllum verticillatum*). Yellow water lily (*Nuphar lutea*) and arrowhead (*Sagittaria sagittifolia*) were present but rare. Fennel pondweed (*Stuckenia pectinatus*, syn. *Potamogeton pectinatus*) was present but rare. Submerged and floating mats of filamentous algae were abundant. The moss *Fontinalis antipyretica* grew on retaining walls. The north margin to the east of the bridge supported a narrow riparian fringe dominated by reed sweet grass (*Glyceria maxima*), reed canary grass and great willowherb (*Epilobium hirsutum*), with a strip of amenity grassland (GA2) and scattered planted trees. A mature treeline (WL2) of mostly alder (*Alnus glutinosa*) and sycamore (*Acer psuedoplatanus*) grew along the north bank of the canal heading west.

This section of the Grand Canal was of high value for coarse fish species, particularly as a spawning and nursery habitat given the proliferation of macrophyte vegetation. Species including pike (*Esox lucius*), perch (*Perca fluviatilis*) and roach (*Rutilus rutilus*) are known in the section (pers. obs.). The site was also of high value for European eel. Some good suitability for white-clawed crayfish was

Plate 3.2 Representative image of site 2 on the Grand Canal at Emmett Bridge, facing eastwards from bridge

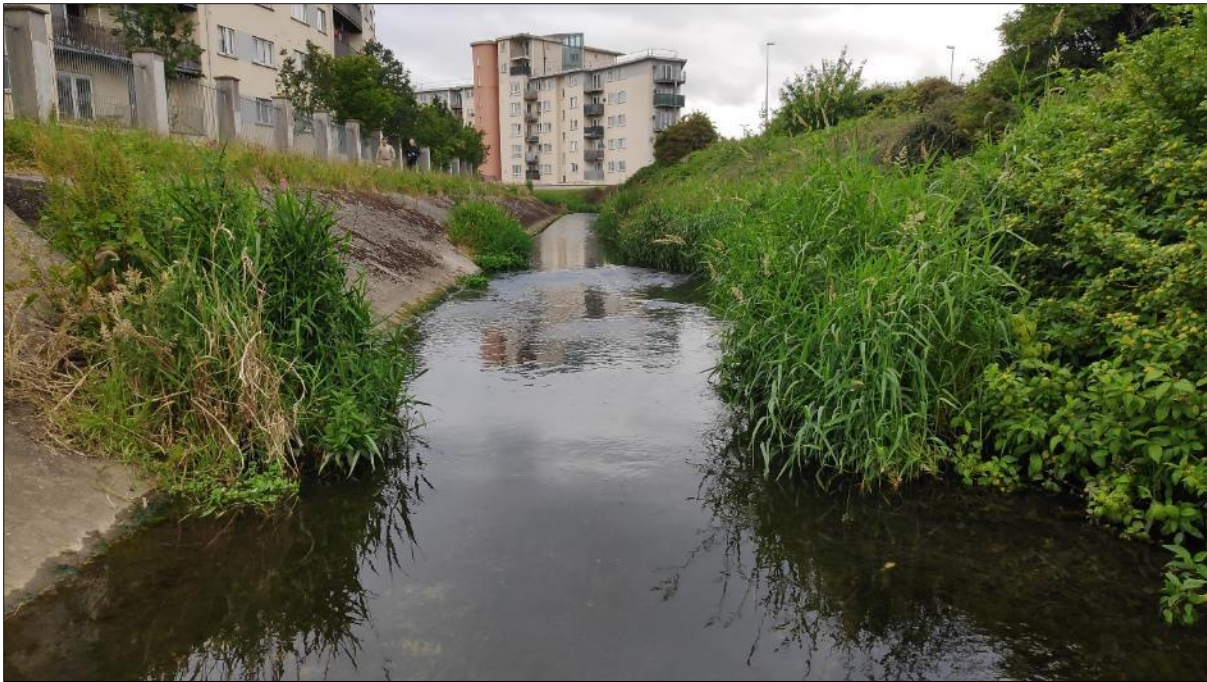
Site 4 was located on the River Camac (09C02) at Yellowmeadows near Clondalkin. The river was a lowland depositing watercourse (FW2) that had been historically straightened and heavily modified, with a retaining wall present along the south bank of the river (adjoining residential areas). The channel averaged 3-4m wide and 0.1-0.25m deep, with bankfull heights of 2-3m. Shallow fast glide predominated with occasional riffles and very limited small pool (to 0.5m). The channel featured an open masonry culvert in the vicinity of the survey site with only localised superficial accumulations of cobble and medium to coarse gravels. Small boulder were also present but localised with occasional sand. Siltation was moderate overall with some shallow accumulations in association with macrophyte beds. Instream macrophytes were rare given the concrete rendered riverbed. Lesser water parsnip (*Berula erecta*), fool's watercress (*Apium nodiflorum*), watercress and localised brooklime (*Veronica beccabunga*) were present in the margins. Cobble zones supported frequent spiked-water milfoil (*Myriophyllum spicatum*). Aquatic bryophytes were limited to occasional *Platyhypnidium riparoides*. Filamentous algal cover was high (30% cover) indicating enrichment. Numerous point sources were present locally, adjoining from the Nangor Road bank. The river margins were dominated by linear belts of reed canary grass with abundant nettle. The north bank was heavily scrubbed with primarily ornamental species like red osier dogwood (*Cornus sericea*) and *Cotoneaster* sp. with frequent invasive buddleja (*Buddleja davidii*), great willowherb and hedge bindweed. Downstream, a mature willow-dominated treeline was present along the river, with ash and sycamore. The site was bordered by parkland (WD5) to the south and artificial surfaces (BL3) to the north (Nangor Road).

Site 4 was of moderate value for salmonids only given its poor hydromorphology and shallow nature, with superior habitat both upstream and (especially) downstream. Spawning and nursery value was limited but nonetheless present (moderate value only). Holding habitat was good despite the lack of pool areas given the undercut banks/overhanging reed canary grass vegetation. White-clawed crayfish were present at a 'low' density >0 to <1 per 10 refugia; Peay, 2003). A total of $n=2$ crayfish were recorded via sweep netting, with one adult and one hatchling recorded. Three-spined stickleback (*Gasterosteus aculeatus*) were visibly abundant. Lamprey ammocoete habitat was present very locally also but spawning habitat was poor (few finer gravels present given high flows rates and rendered bed). No otter signs were recorded during the site visit but the River Camac in the vicinity of the survey site is known to support otter (Macklin et al., 2019).

Plate 3.4 Representative image of site 4 on the River Camac, facing upstream towards Áras Na Cluaine

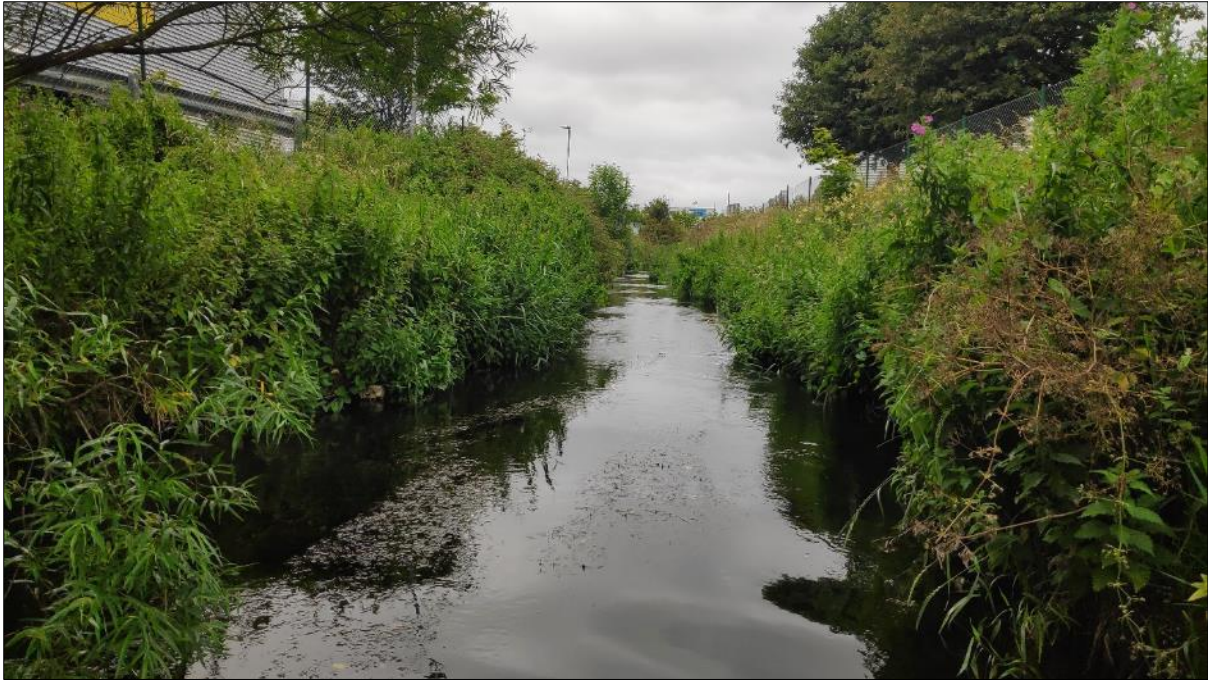
Site 5 was located on the River Camac (09C02) at the Nangor Road crossing (R134). The river was a lowland depositing watercourse (FW2) which had been historically straightened and modified upstream and downstream of the existing R134 road culvert (an extensive twin-bore corrugated pipe, 75m long). These culverts were passable to fish even at low summer flows. However, good recovery was evident instream, despite being surrounded by industrial/urban areas. Upstream of the culvert, the river averaged 3-4m wide and 0.5-1m deep with locally deeper glide and pools to 1m. The profile was dominated by deep glide with localised pool¹. The substrata were dominated by relatively clean, unbedded/mobile fine to coarse gravels with low siltation (only light plumes underfoot). Cobble and small boulder was occasional (more prominent downstream of culvert). Silt beds were present marginally and in association with abundant growth of instream macrophytes. Downstream of the R134 culvert the river was 3m wide on average and 0.4-0.6m deep, with locally deeper pools to 0.8-1m. The flow was greater than upstream and fast glide predominated with occasional riffle areas and localised pools. Given the high flow rates, the substrata were dominated by cobble with occasional boulder. Medium to coarse gravels were frequent and present in small interstitial patches. Sand/silt accumulations were present in pool slacks near the culvert. Overall siltation was moderate. The substrata were relatively compacted (in contrast to upstream slower glide habitat). Macrophyte growth was dominated by abundant spiked water milfoil (50% cover) and frequent curled pondweed (*Potamogeton crispus*) with the margins and riparian slopes dominated by reed canary grass. Downstream, given high shading, instream macrophytes were limited to marginal watercress and

Site 4 offered some very good salmonid habitat (brown trout only given downstream barriers). Upstream of the culvert provided excellent quality spawning and nursery habitat (among the best on the entire river, pers. obs.) with very good holding habitat for abundant adult trout in undercut banks/under overhanging reed canary grass. Downstream, whilst spawning and nursery value was somewhat reduced, adult holding habitat was very good given undercut banks and prominent submerged tree roots (willow and sycamore). These also offered excellent refugia for white-clawed crayfish, which were recorded at 'very high' densities (>5 per 10 refugia; Peay, 2003). A total of $n=25$ crayfish were recorded from 30 refugia via sweep netting, with males, females and juveniles present, ranging from 18-38mm carapace length. The culverts also provided high quality crayfish habitat given an abundance of cobble and boulder. Lamprey ammocoete habitat was present both upstream and downstream of the culvert, usually in association with instream macrophyte beds. European eel habitat was good throughout but better upstream. Two otter spraint sites were recorded under the southern culvert on instream trash/debris (both were old and contained crayfish remains, ITM 708589, 732063 & 708572, 732050).

Plate 3.5 Representative image of site 5 on the River Camac, facing upstream from culverts

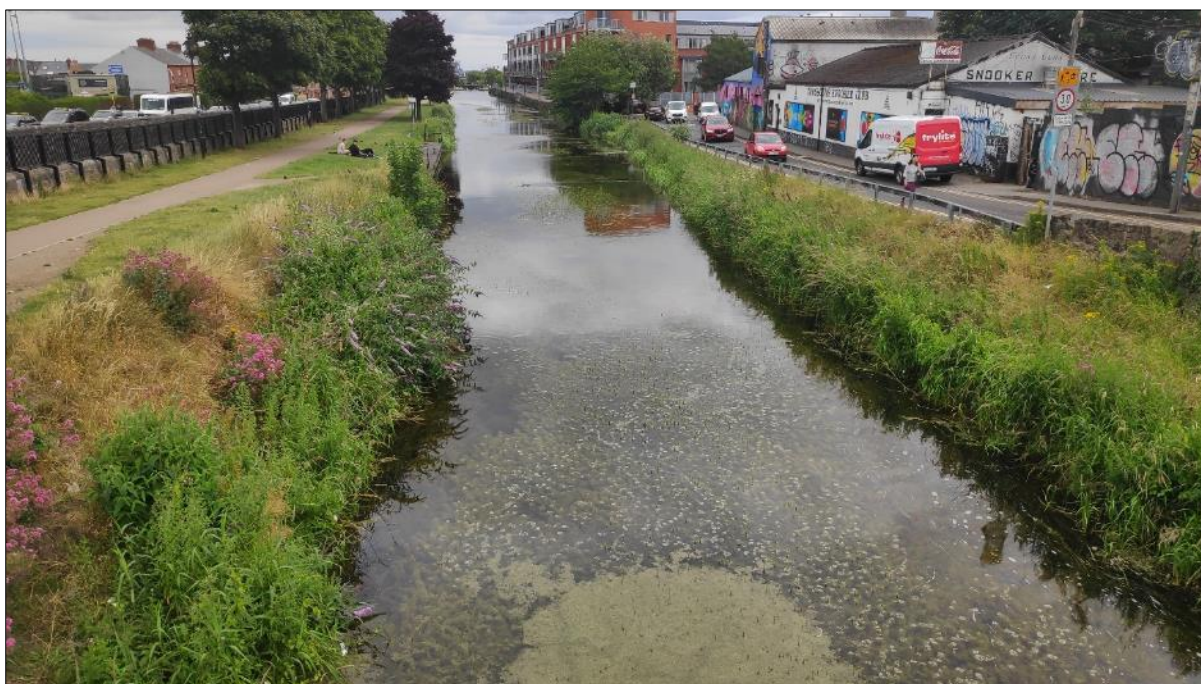
The Royal Canal between the 4th and 5th lock (level 4, Phibsborough) was a uniform 10-12m wide and 1.5-2.5m deep, with a centrally deeper navigation channel in most areas. The substrata were dominated by silt with high clay fractions (often >0.3m in depth), with scattered boulder and localised marginal cobble/gravel areas. Instream, the macrophyte community was dominated by whorled watermilfoil with frequent heterophyllus yellow lily. Ivy-leaved duckweed (*Lemna trisulca*) was abundant. Canadian pondweed (*Elodea canadensis*), Nuttall's pondweed (*Elodea nuttallii*) and stonewort (*Chara* sp.) were all frequent. Amphibious bistort (*Persicaria amphibia*) was occasional along the canal margins. The rare and protected opposite-leaved pondweed (*Groenlandia densa*) is known from this area of the Royal Canal (BEC, 2011; NPWS data) but no stands were observed during the survey (July 2022). The lock structures were covered by the generalist moss species *Fontinalis antipyretica* and *Rhychostegium riparoides* a species common in alkaline waters. The canal margins were lined by narrow linear strips (FS1) dominated by reed sweet grass with frequent stands of iris

Plate 3.9 Representative image of site 8 on the Royal Canal at Phibsborough, facing downstream from Cross Guns Bridge to the 4th lock
