Appendix A16.1-A16.3
Architectural Heritage
Appendices

16. Appendix 16.1 Historical Background

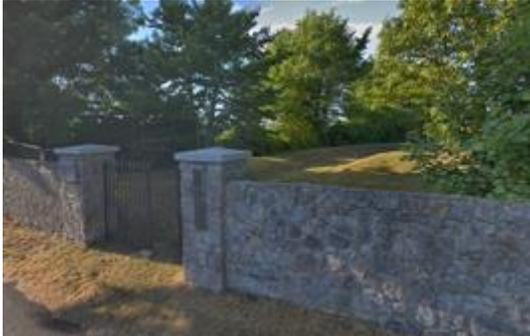
Identification No.	FCC RPS 611
Additional Identifiers	n/a
Legal Status	A Protected Structure
Location	Castlemoate House, Swords Road (R132), Cloughran, Swords
Date of Construction	c.1800

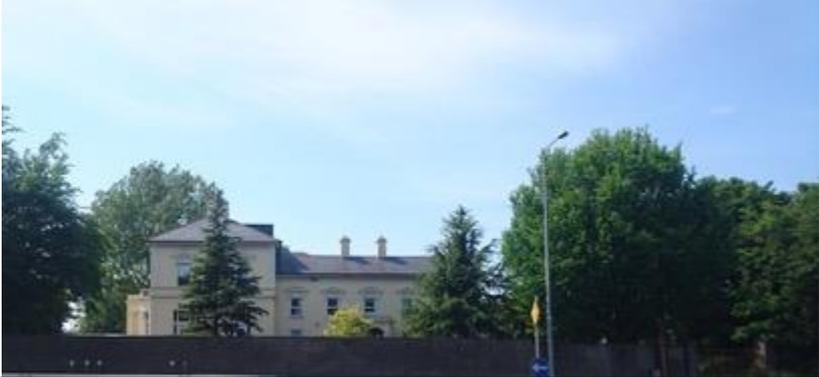
Original Use	House
Description	Five-bay two-storey early 19 th century house, outbuilding, walled garden, and entrance gates, now in use as offices (significantly altered in late 19 th century in Italianate style)
Significance Rating	Regional
Categories of Special Interest	Architectural
Sensitivity	Medium
Photographs

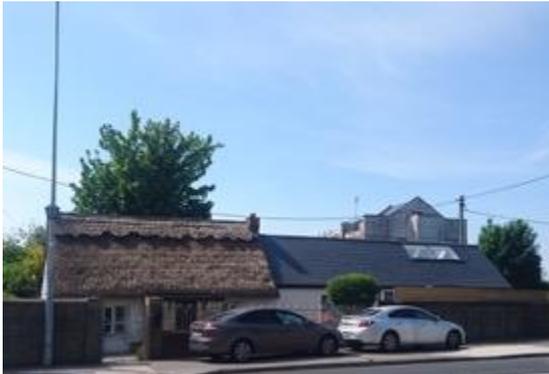
Identification No.	FCC RPS 604
Additional Identifiers	NIAH 11349003
Legal Status	A Protected Structure
Location	Castlemoate House, Swords Road
Date of Construction	c.1800
Original Use	House
Description	Thatched dwelling: Detached three-bay single-storey thatched house, c.1800, with central projecting entrance porch.
Significance Rating	Regional (NIAH)
Categories of Special Interest	Architectural Social Technical
Sensitivity	Medium
Photographs

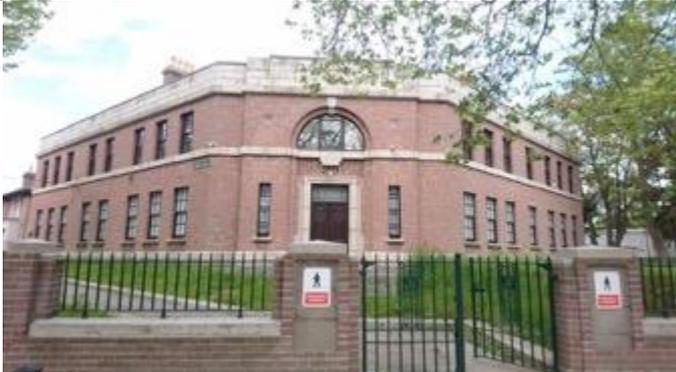
Identification No.	DCC RPS 3329
Additional Identifiers	NIAH 50130143
Legal Status	A Protected Structure
Location	Whitehall Garda Station, Griffith Avenue, Dublin 9
Date of Construction	c.1934
Original Use	Garda station/constabulary barracks
Description	Garda Station, façade: sixteen-bay two-storey detached brick building with stone trims constructed c.1934
Significance Rating	Regional
Categories of Special Interest	Architectural Social
Sensitivity	Medium
Photographs

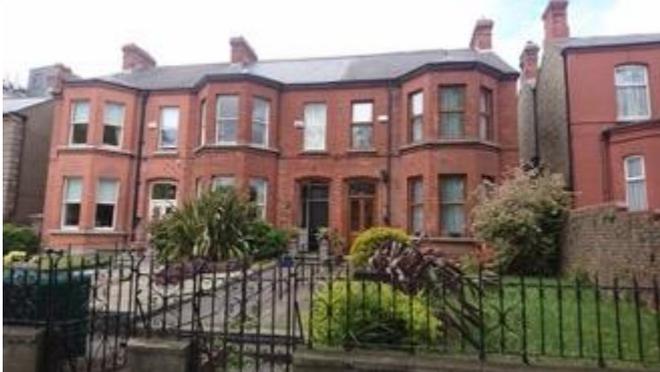
Identification No.	DCC RPS 2370
Additional Identifiers	n/a
Legal Status	A Protected Structure
Location	37 Drumcondra Road Upper, Dublin 9
Date of Construction	c.1820
Original Use	House
Description	House: two bay two storey terraced house with associated walls, gates, and railings
Significance Rating	Regional
Categories of Special Interest	Architectural Artistic
Sensitivity	Medium
Photographs

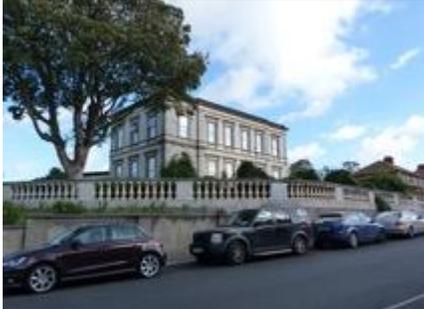
Identification No.	DCC RPS 6084
Additional Identifiers	NIAH 50120013
Legal Status	A Protected Structure
Location	Rosminian House for the Blind, Ormond Road, Dublin 9
Date of Construction	c.1820
Original Use	House
Description	Georgian style detached house, including balustrade boundary wall (which was formerly part of original O'Connell Bridge)
Significance Rating	Regional
Categories of Special Interest	Architectural Artistic
Sensitivity	Medium
Photographs

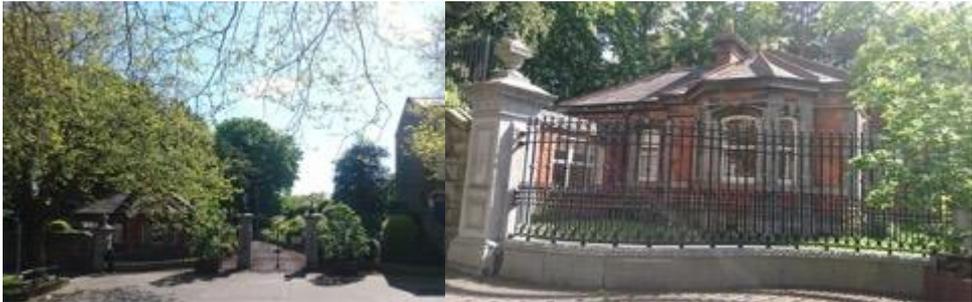
Identification No.	DCC RPS 2368
Additional Identifiers	NIAH 50130175
Legal Status	Protected Structure
Location	94 Drumcondra Road Lower, Dublin 9
Date of Construction	c.1790
Original Use	Houses
Description	Attached seven-bay two-storey former house, built c. 1790, with central pedimented breakfront entrance bay
Significance Rating	Regional (NIAH)
Categories of Special Interest	Architectural
Sensitivity	Medium
Photographs

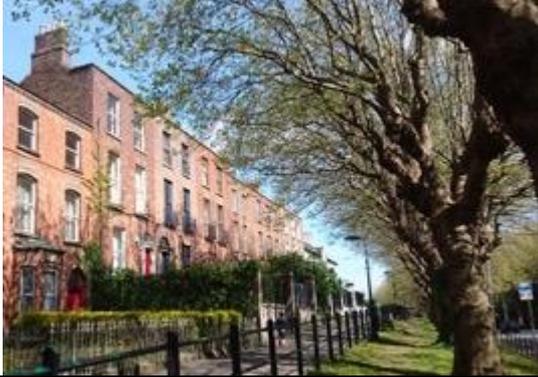
Identification No.	DCC RPS 2362 to 7
Additional Identifiers	NIAH 50130176 to 81
Legal Status	Protected Structures
Location	92, 90, 88, 86, 84 and 82 Drumcondra Road Lower, Dublin 9
Date of Construction	c.1790
Original Use	Houses
Description	Terrace of two bay three storey Georgian houses, including railings, entrance gates and plinth wall
Significance Rating	Regional (NIAH)
Categories of Special Interest	Architectural
Sensitivity	Medium
Photographs

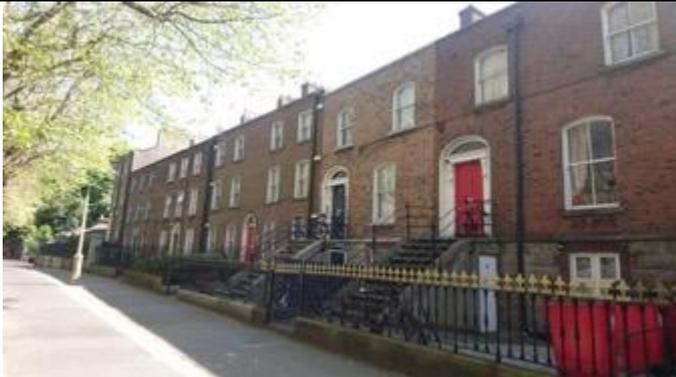
Identification No.	DCC RPS 2344 to 9
Additional Identifiers	n/a
Legal Status	Protected Structures
Location	55, 53, 51, 49, 47 and 45 Drumcondra Road Lower, Dublin 9
Date of Construction	c.1890
Original Use	Houses
Description	Terrace of six houses, three bay two storey with associated front gardens, gates, and railings
Significance Rating	Regional
Categories of Special Interest	Architectural
Sensitivity	Medium
Photographs

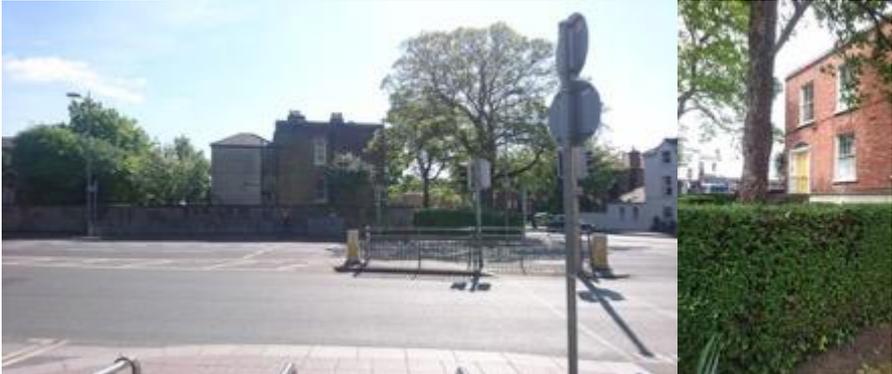
Identification No.	DCC RPS 908
Additional Identifiers	NIAH 50060296, 50060189
Legal Status	A Protected Structure
Location	Binns Bridge, Royal Canal, Dublin 9
Date of Construction	c.1795 and 1864
Original Use	Bridge
Description	Bridge (rail/road and canal): double-arch stone bridge, erected 1864, carrying road over railway line and single-arch bridge, erected c.1795, carrying road over Royal Canal.
Significance Rating	Regional (NIAH)
Categories of Special Interest	Architectural Social Technical
Sensitivity	Medium
Photographs

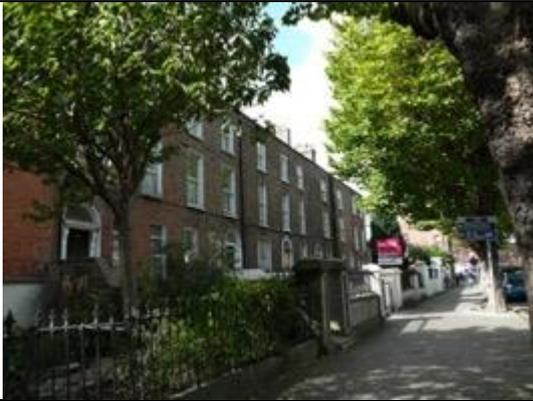
Identification No.	DCC RPS 1741 to 45
Additional Identifiers	NIAH 50010736 to 40
Legal Status	A Protected Structure
Location	450,452,453, 456,458 North Circular Road, Dublin 1
Date of Construction	c.1795
Original Use	House
Description	Houses: terraced three-storey former house over raised basement, built c.1795,
Significance Rating	Regional (NIAH)
Categories of Special Interest	Architectural Artistic
Sensitivity	Medium
Photographs

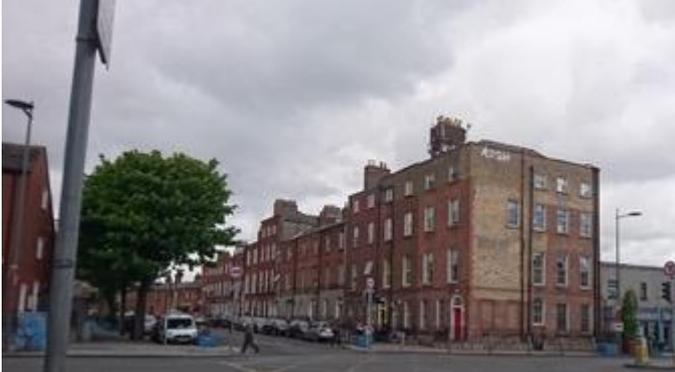
Identification No.	DCC RPS 7970 to 80
Additional Identifiers	NIAH 50060119 to 20, 50060284 to 92
Legal Status	A Protected Structure
Location	1 to 11 Synott Place, Dublin 7
Date of Construction	c.1800
Original Use	Houses
Description	Terrace of five, two-bay four-storey former houses over basement, built c.1800
Significance Rating	Regional (NIAH)
Categories of Special Interest	Architectural Artistic
Sensitivity	Medium
Photographs

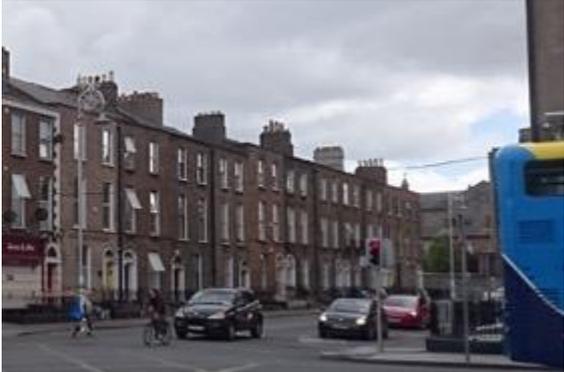
Identification No.	DCC RPS 3129 to 34
Additional Identifiers	NIAH 50010754 to 59
Legal Status	A Protected Structure
Location	45 to 50 Gardiner Street Upper, Dublin 1
Date of Construction	c.1830
Original Use	House
Description	Houses: Terrace of two-bay three-storey houses over exposed basement, built c.1830.
Significance Rating	Regional (NIAH)
Categories of Special Interest	Architectural Artistic
Sensitivity	Medium
Photographs

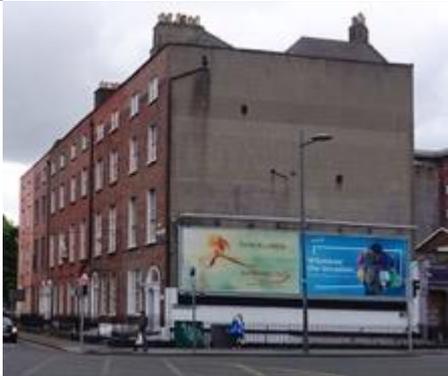
Identification No.	DCC RPS 3124 to 28
Additional Identifiers	NIAH 50010765 to 70
Legal Status	A Protected Structure
Location	37 to 41 Gardiner Street Upper, Dublin 1
Date of Construction	c.1820
Original Use	House
Description	Houses: Terrace of four-storey houses over raised basement, built c.1820, with three-bay ground floor and two-bay upper floors.
Significance Rating	Regional (NIAH)
Categories of Special Interest	Architectural Artistic
Sensitivity	Medium
Photographs

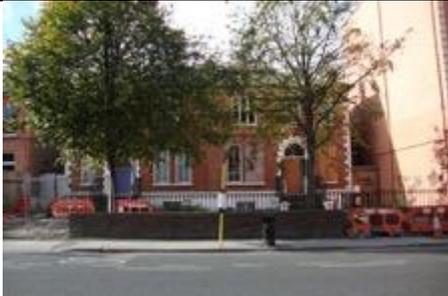
Identification No.	DCC RPS 3122 to 23
Additional Identifiers	NIAH 50010763 to 64
Legal Status	A Protected Structure
Location	34 to 35 Gardiner Street Upper, Dublin 1
Date of Construction	c.1880
Original Use	House
Description	Houses: Semi-detached three-bay two-storey houses over raised basement, built c.1880, with gardens to front.
Significance Rating	Regional (NIAH)
Categories of Special Interest	Architectural Artistic
Sensitivity	Medium
Photographs

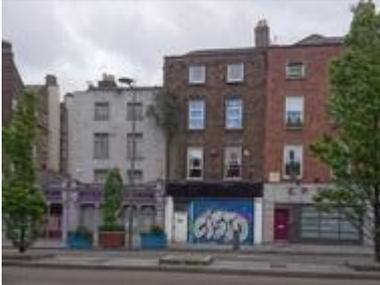
Identification No.	DCC RPS 2329
Additional Identifiers	NIAH 50010709
Legal Status	A Protected Structure
Location	25 Dorset Street Lower, Dublin 1
Date of Construction	c.1800
Original Use	House
Description	House, excluding shopfront: terraced two-bay four-storey brick building, built c.1800
Significance Rating	Regional (NIAH)
Categories of Special Interest	Architectural
Sensitivity	Medium
Photographs

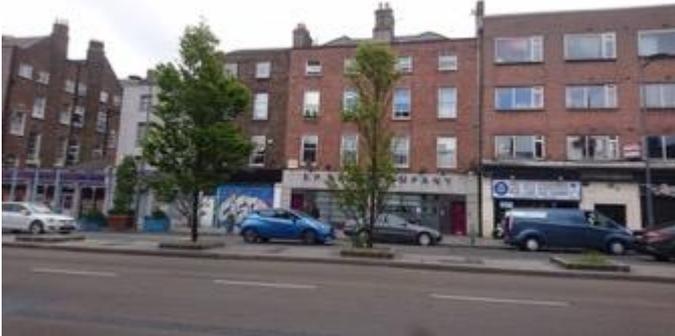
Identification No.	DCC RPS 2328
Additional Identifiers	NIAH 50010708
Legal Status	A Protected Structure
Location	Daly & Company Solicitors, 23 to 24 Dorset Street Lower, Dublin 1
Date of Construction	c.1800
Original Use	House
Description	House, excluding shopfront: terraced two-bay four-storey brick building, built c.1800
Significance Rating	Regional (NIAH)
Categories of Special Interest	Architectural
Sensitivity	Medium
Photographs

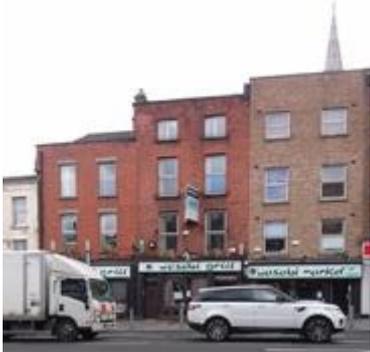
Identification No.	DCC RPS 2327
Additional Identifiers	NIAH 50011184
Legal Status	A Protected Structure
Location	4 Dorset Street Lower, Dublin 1
Date of Construction	c.1800
Original Use	House
Description	Licensed premises: terraced two-bay four-storey house with concealed basement, built c.1800
Significance Rating	Regional (NIAH)
Categories of Special Interest	Architectural Social
Sensitivity	Medium
Photographs

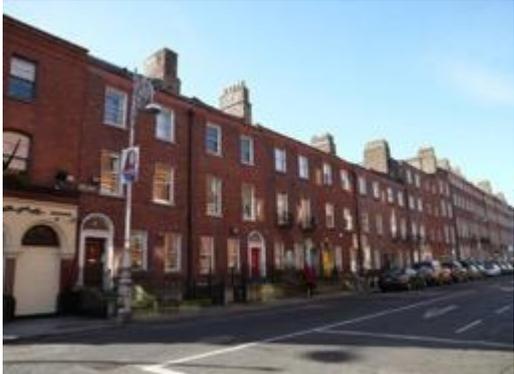
Identification No.	DCC RPS 2469 to 2478
Additional Identifiers	NIAH 50070479 to 88
Legal Status	A Protected Structure
Location	72 to 81 Eccles Street, Dublin 1
Date of Construction	c.1780
Original Use	House
Description	Group of terraced three-bay four-storey over basement houses, built c.1780
Significance Rating	Regional (NIAH)
Categories of Special Interest	Architectural Artistic Social
Sensitivity	Medium
Photographs

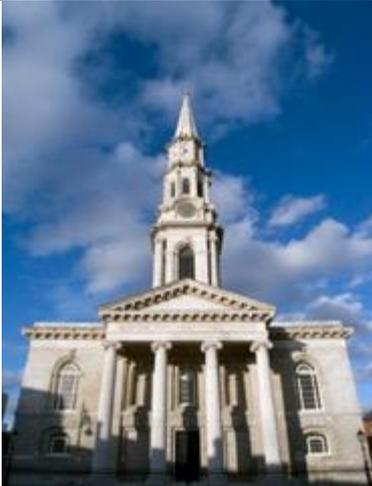
Identification No.	DCC RPS 3573
Additional Identifiers	NIAH 50010878
Legal Status	A Protected Structure
Location	Saint George's Church, Hardwicke Place, George's Place, Dublin 1
Date of Construction	c. 1808
Original Use	Church
Description	Freestanding symmetrical neo-Classical granite Church of Ireland church, begun 1802 and opened 1814, with tetrastyle Ionic portico and three-stage tower and spire to five-bay front facade
Significance Rating	National (NIAH)
Categories of Special Interest	Architectural, Artistic, Cultural, Historical, Technical
Sensitivity	High
Photographs

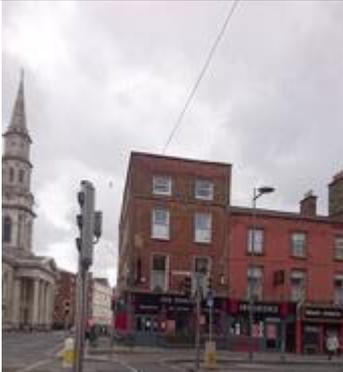
Identification No.	DCC RPS 2333
Additional Identifiers	NIAH 50010707
Legal Status	A Protected Structure
Location	The Temple/ Kavanaghs, 71 Dorset Street Upper, Dublin1
Date of Construction	c.1900
Original Use	Public house
Description	Licensed premises: corner-sited four-storey house, built c.1900 with six-bay north elevation, formerly two Georgian townhouses, and two-bay elevation to Dorset St Upper, with modern pub-front.
Significance Rating	Regional (NIAH)
Categories of Special Interest	Architectural
Sensitivity	Medium
Photographs

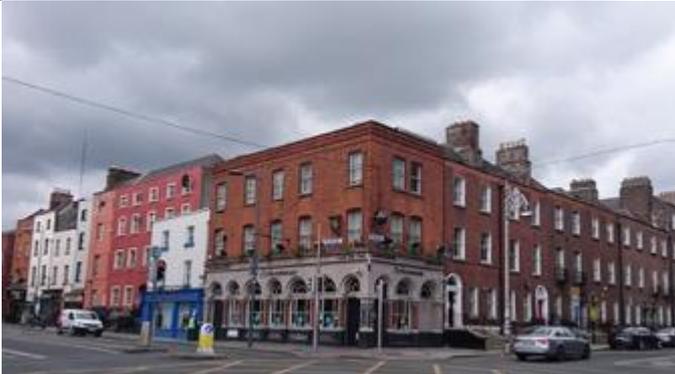
Identification No.	DCC RPS 2334
Additional Identifiers	NIAH 50010705
Legal Status	A Protected Structure
Location	Aurora Bar And Grill 73 Dorset Street Upper, Dublin 1
Date of Construction	c.1880
Original Use	Public house
Description	Licensed premises: corner-sited end-of-terrace five-bay three-storey over basement commercial building, built c.1880.
Significance Rating	Regional (NIAH)
Categories of Special Interest	Architectural Artistic Social
Sensitivity	Medium
Photographs

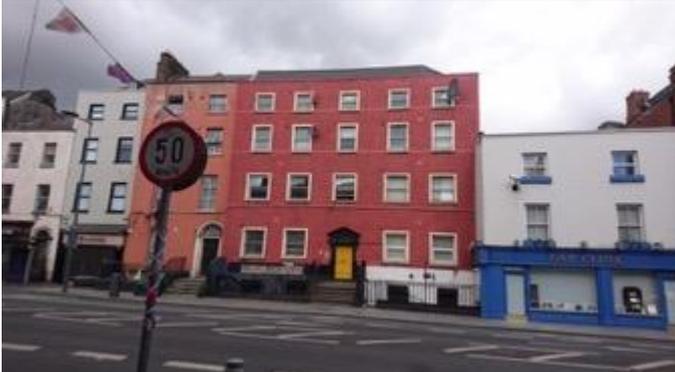
Identification No.	DCC RPS 2335
Additional Identifiers	NIAH 50010704
Legal Status	A Protected Structure
Location	Imagine Ladies Hair Studio/ City Barbers 75 Dorset Street Upper, Dublin 1
Date of Construction	c.1760
Original Use	House
Description	House: terraced two-bay four-storey house over raised basement, built c.1760 with associated steps and railings.
Significance Rating	Regional (NIAH)
Categories of Special Interest	Architectural Artistic
Sensitivity	Medium
Photographs

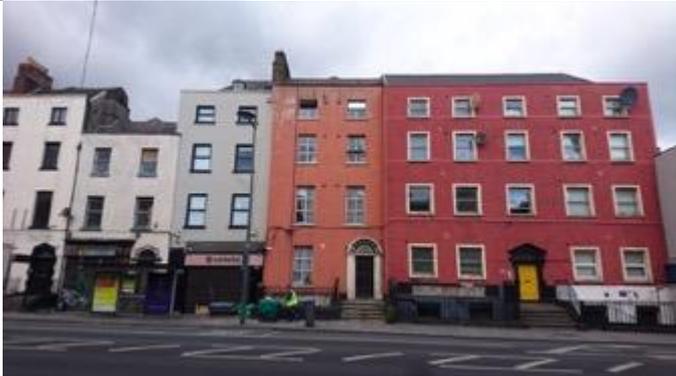
Identification No.	DCC RPS 2337
Additional Identifiers	n/a
Legal Status	A Protected Structure
Location	77 Dorset Street Upper, Dublin 1
Date of Construction	c.1795
Original Use	House
Description	House: two bay four storey, possibly re-built
Significance Rating	Regional
Categories of Special Interest	Architectural
Sensitivity	Medium
Photographs

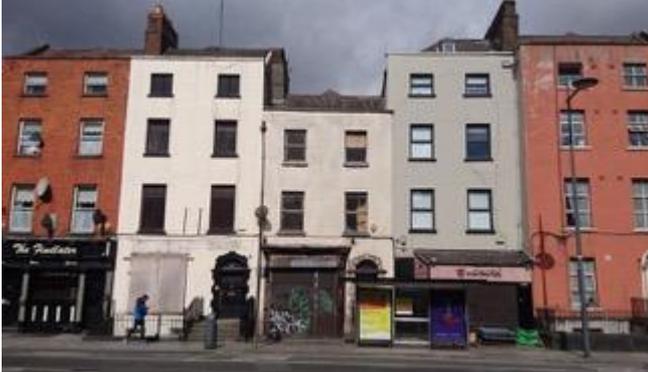
Identification No.	DCC RPS 2338
Additional Identifiers	NIAH 50010701
Legal Status	A Protected Structure
Location	78 Dorset Street Upper, Dublin 1
Date of Construction	c.1760
Original Use	House
Description	House: terraced two-bay three-storey house, built c.1760 with associated steps and railings
Significance Rating	Regional (NIAH)
Categories of Special Interest	Architectural Artistic
Sensitivity	Medium
Photographs

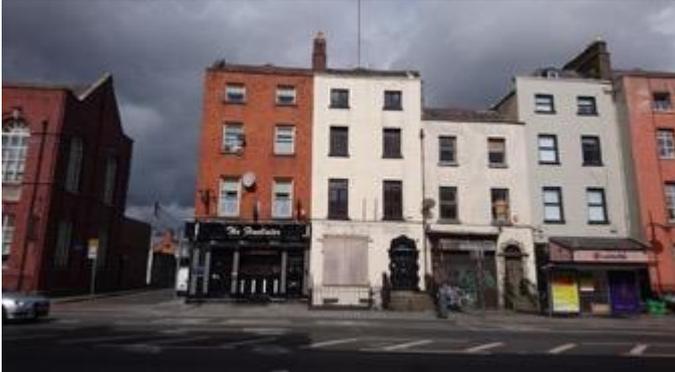
Identification No.	DCC RPS 2339
Additional Identifiers	NIAH 50010700
Legal Status	A Protected Structure
Location	79 Dorset Street Upper, Dublin 1
Date of Construction	c.1760
Original Use	House
Description	House: terraced two-bay four-storey house over raised basement, built c.1760
Significance Rating	Regional (NIAH)
Categories of Special Interest	Architectural Artistic
Sensitivity	Medium
Photographs

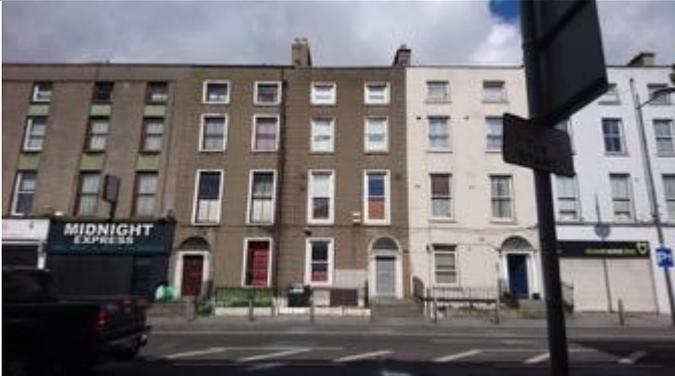
Identification No.	DCC RPS 2340
Additional Identifiers	NIAH 50010696
Legal Status	A Protected Structure
Location	The Dorset Dental Practice, 89 Dorset Street Upper, Dublin 1
Date of Construction	c.1835
Original Use	House
Description	House: terraced two-bay four-storey house over raised basement, built c.1835 with associated steps and railings.
Significance Rating	Regional (NIAH)
Categories of Special Interest	Architectural Artistic
Sensitivity	Medium
Photographs

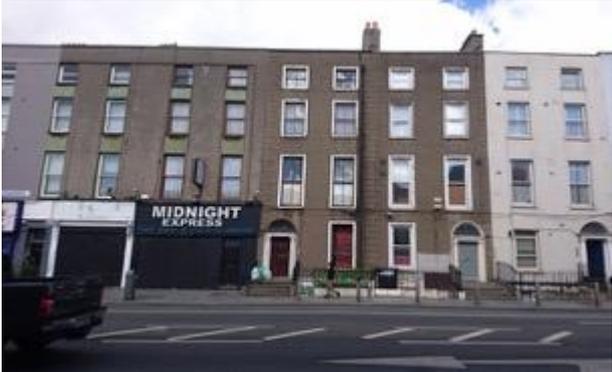
Identification No.	DCC RPS 2341
Additional Identifiers	n/a
Legal Status	A Protected Structure
Location	90 Dorset Street Upper, Dublin 1
Date of Construction	c.1835
Original Use	House
Description	House (surgery): terraced two-bay four-storey house over raised basement, built c.1835 with associated steps and railings.
Significance Rating	Regional (NIAH)
Categories of Special Interest	Architectural Artistic
Sensitivity	Medium
Photographs

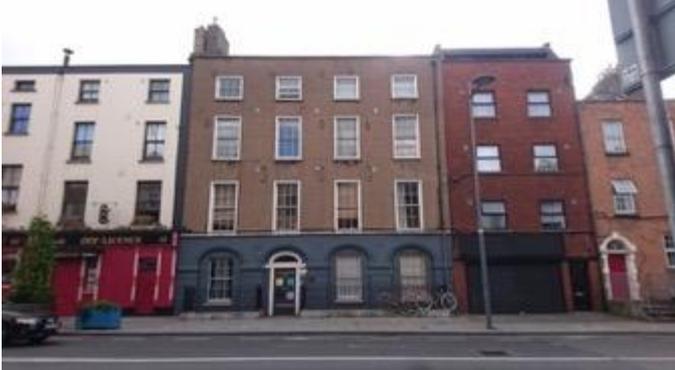
Identification No.	DCC RPS 2332
Additional Identifiers	NIAH 50010694
Legal Status	A Protected Structure
Location	43 Dorset Street Upper, Dublin 1
Date of Construction	c.1790
Original Use	House
Description	House: terraced four-bay four-storey house over raised basement, built c.1790, with arcaded ground floor.
Significance Rating	Regional (NIAH)
Categories of Special Interest	Architectural
Sensitivity	Medium
Photographs

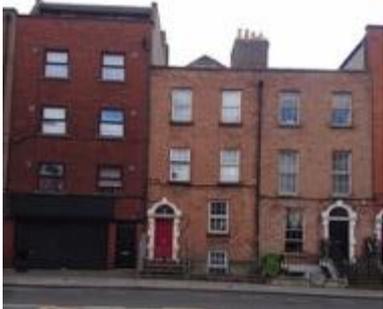
Identification No.	DCC RPS 2331
Additional Identifiers	NIAH 50010693
Legal Status	A Protected Structure
Location	41 Dorset Street Upper, Dublin 1
Date of Construction	c.1750
Original Use	House
Description	House: terraced two-bay three-storey house over raised basement, built c.1750, rebuilt c.1914.
Significance Rating	Regional (NIAH)
Categories of Special Interest	Architectural Artistic
Sensitivity	Medium
Photographs

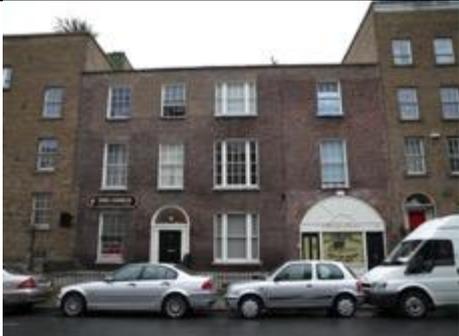
Identification No.	DCC RPS 833
Additional Identifiers	NIAH 50070437
Legal Status	A Protected Structure
Location	Keogh Denture Clinic/ Elegance Massage Parlour, 73 Blessington Street, Dublin 7
Date of Construction	c.1800
Original Use	House
Description	Terraced four-bay three-storey over basement former house, built c.1800, having former integral carriage-arch, now infilled
Significance Rating	Regional (NIAH)
Categories of Special Interest	Architectural
Sensitivity	Medium
Photographs

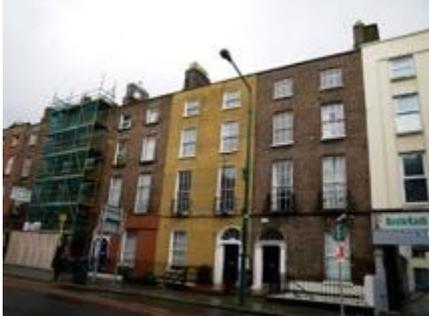
Identification No.	DCC RPS 770 to 3
Additional Identifiers	NIAH 50070436
Legal Status	A Protected Structure
Location	4 to 7 Blessington Street, Blessington Court, Dublin 7
Date of Construction	c.1800
Original Use	House
Description	Group of four terraced two-bay four-storey over basement houses, built c.1800
Significance Rating	Regional (NIAH)
Categories of Special Interest	Architectural
Sensitivity	Medium
Photographs

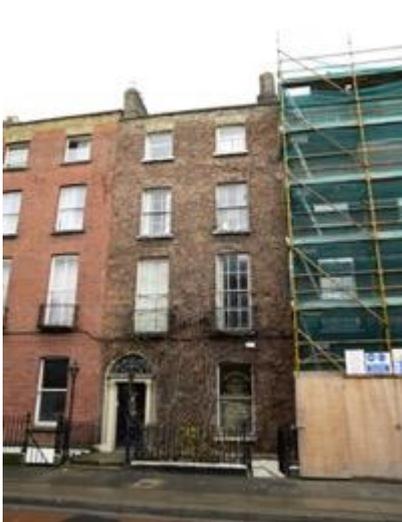
Identification No.	DCC RPS 774
Additional Identifiers	NIAH 50070435
Legal Status	A Protected Structure
Location	8 Blessington Street, Blessington Court, Dublin 7
Date of Construction	c.1800
Original Use	House
Description	Terraced two-bay four-storey over basement former house, built c.1800
Significance Rating	Regional (NIAH)
Categories of Special Interest	Architectural
Sensitivity	Medium
Photographs

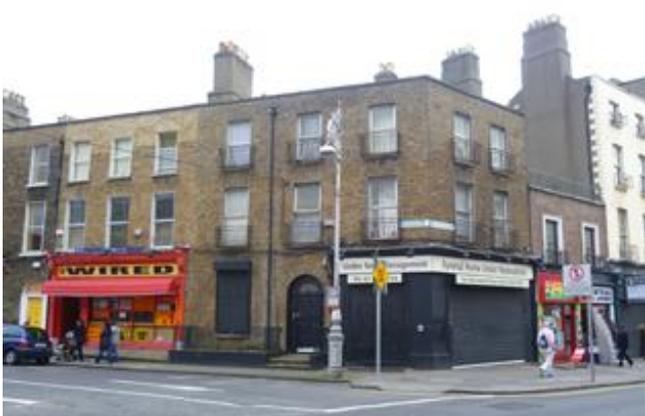
Identification No.	DCC RPS 2972
Additional Identifiers	NIAH 50010883
Legal Status	A Protected Structure
Location	15 Frederick Street North, Dublin 1
Date of Construction	c.1795
Original Use	House
Description	House: terraced two-bay four-storey house over basement, built c.1795 with associated steps and railings
Significance Rating	Regional (NIAH)
Categories of Special Interest	Architectural Artistic
Sensitivity	Medium
Photographs

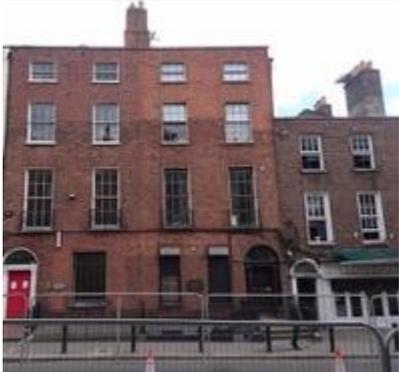
Identification No.	DCC RPS 2971
Additional Identifiers	NIAH 50010884
Legal Status	A Protected Structure
Location	14 Frederick Street North, Dublin 1
Date of Construction	c.1800
Original Use	House
Description	House: terraced four-storey house over basement, built c.1800 with associated steps and railings
Significance Rating	Regional (NIAH)
Categories of Special Interest	Architectural Artistic
Sensitivity	Medium
Photographs

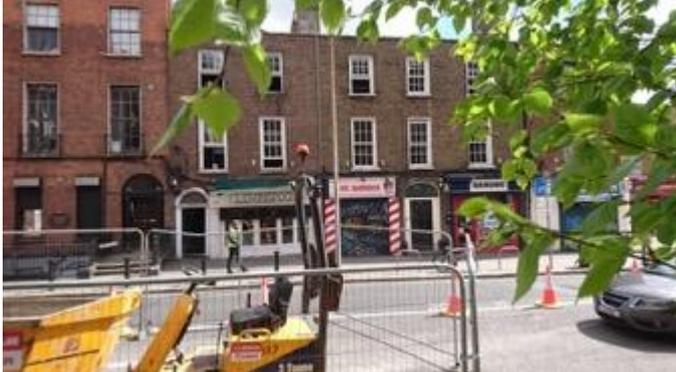
Identification No.	DCC RPS 2970
Additional Identifiers	n/a
Legal Status	A Protected Structure
Location	13 Frederick Street North, Dublin 1
Date of Construction	c.1820
Original Use	House
Description	House (restaurant): terraced two-bay three-storey house built c.1820
Significance Rating	Regional (NIAH)
Categories of Special Interest	Architectural
Sensitivity	Medium
Photographs

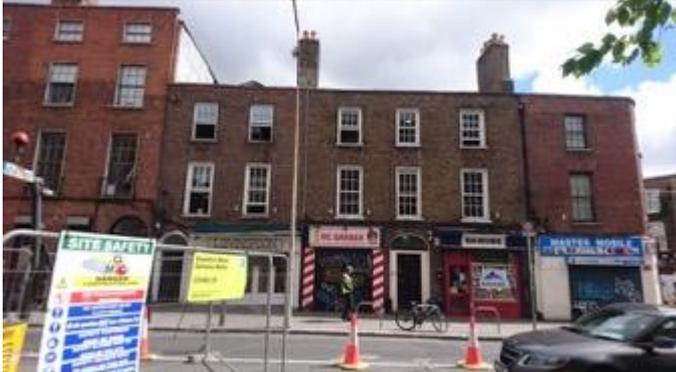
Identification No.	DCC RPS 1267 to 9
Additional Identifiers	NIAH 50010886 to 7
Legal Status	A Protected Structure
Location	12, 12a, 12b Frederick Street North, Dublin 1
Date of Construction	c.1820
Original Use	House
Description	House (shop): Terraced three-bay three-storey house, built c.1820, with modern shopfronts. Building: Corner-sited three-storey commercial building, built c.1820, on wedge plan, with curved corner bay
Significance Rating	Regional (NIAH)
Categories of Special Interest	Architectural
Sensitivity	Medium
Photographs

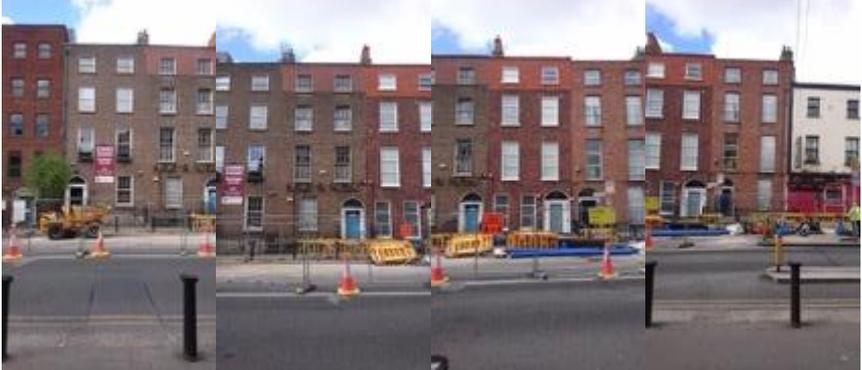
Identification No.	DCC RPS 2977 to 80
Additional Identifiers	NIAH 50010894 to 7
Legal Status	A Protected Structure
Location	28, 29, 30 and 31 Frederick St North
Date of Construction	c.1805
Original Use	House
Description	Terrace of four three-bay four-storey houses built in two pairs c.1805, over basement with associated steps and railings
Significance Rating	Regional (NIAH)
Categories of Special Interest	Architectural
Sensitivity	Medium
Photographs

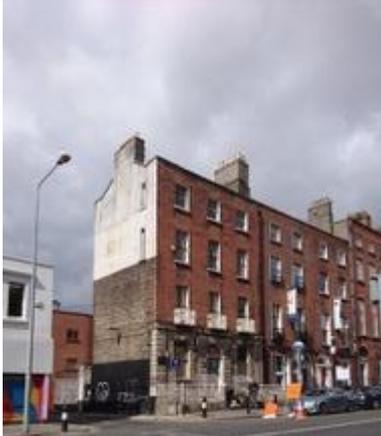
Identification No.	DCC RPS 2983
Additional Identifiers	NIAH 50010900
Legal Status	A Protected Structure
Location	34 Frederick Street North, Dublin 1
Date of Construction	c.1795
Original Use	House
Description	House (surgery): end-of-terrace corner-sited three-bay four-storey house over basement, built c.1795 with associated steps and railings
Significance Rating	Regional (NIAH)
Categories of Special Interest	Architectural Artistic Historical
Sensitivity	Medium
Photographs

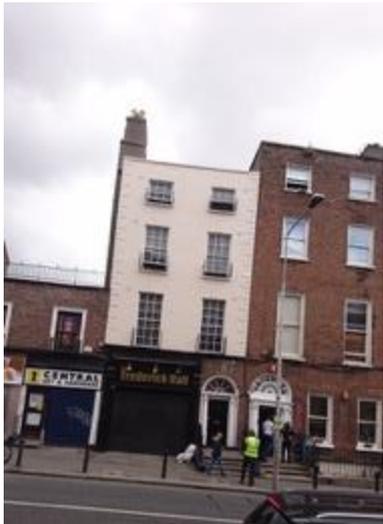
Identification No.	DCC RPS 2966
Additional Identifiers	NIAH 50010901
Legal Status	A Protected Structure
Location	10 Frederick Street North, Dublin 1
Date of Construction	c.1795
Original Use	House
Description	End-of-terrace two-bay four-storey house over concealed basement, built c.1805, with modern shopfront with associated steps and railings
Significance Rating	Regional (NIAH)
Categories of Special Interest	Architectural, Artistic
Sensitivity	Medium
Photographs

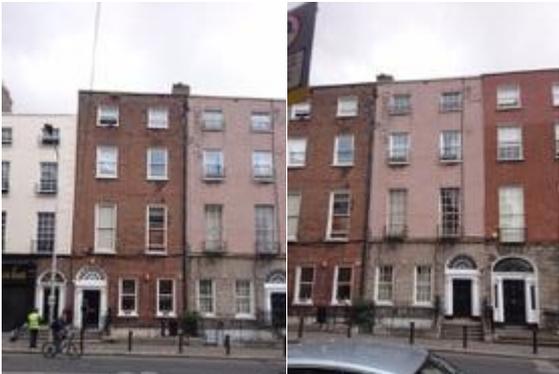
Identification No.	DCC RPS 2964 to 5
Additional Identifiers	NIAH 50010902 to 3
Legal Status	A Protected Structure
Location	8 and 9 Frederick Street North, Dublin 1
Date of Construction	c.1805
Original Use	House
Description	Pair of terraced four-storey houses over basement, built c.1805, with three-bay ground floor and two-bay upper floors with associated steps and railings
Significance Rating	Regional (NIAH)
Categories of Special Interest	Architectural Artistic
Sensitivity	Medium
Photographs

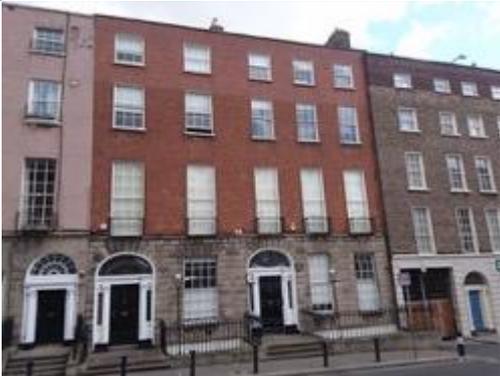
Identification No.	DCC RPS 2961
Additional Identifiers	NIAH 50010906 to 9
Legal Status	A Protected Structure
Location	Waltons, 2 to 5 Frederick Street North, Dublin 1
Date of Construction	c.1820
Original Use	House
Description	Hotel and shop: terrace of four five-storey houses with integrated carriage arch and modern shop windows to the ground floors, upper levels re-built and modern flat roof with associated railings (replacement) and steps.
Significance Rating	Regional (NIAH)
Categories of Special Interest	Architectural Artistic
Sensitivity	Medium
Photographs

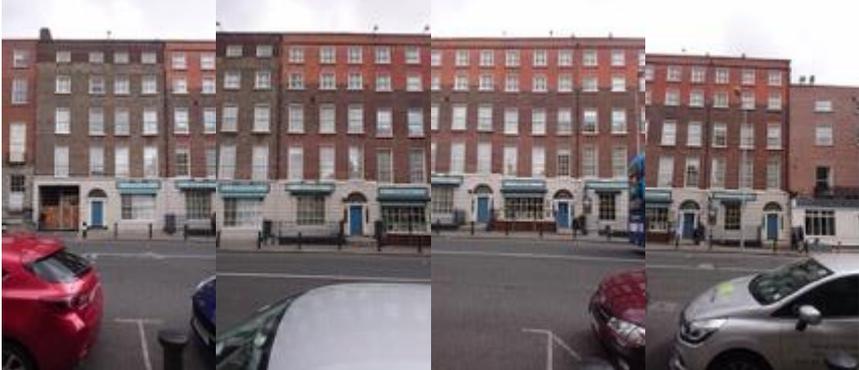
Identification No.	DCC RPS 2960
Additional Identifiers	NIAH 50010922
Legal Status	A Protected Structure
Location	Candy Café, 1 Frederick Street North, Dublin 1
Date of Construction	c.1765
Original Use	House
Description	House and shop (restaurant): Corner-sited end-of-terrace two-bay four-storey house over concealed basement, built c.1765 with associated railings
Significance Rating	Regional (NIAH)
Categories of Special Interest	Architectural Artistic
Sensitivity	Medium
Photographs

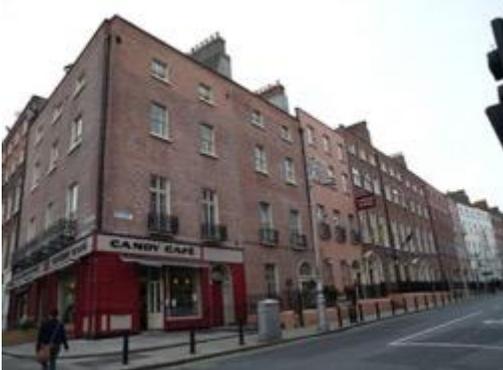
Identification No.	DCC RPS 3037 to 41
Additional Identifiers	NIAH 5001923 to 27
Legal Status	A Protected Structure
Location	1 to 6 Gardiner Row, Dublin 1
Date of Construction	c. 1765
Original Use	House
Description	Terraced two-bay four-storey houses over exposed basement, built c.1765
Significance Rating	Regional (NIAH)
Categories of Special Interest	Architectural
Sensitivity	Medium
Photographs

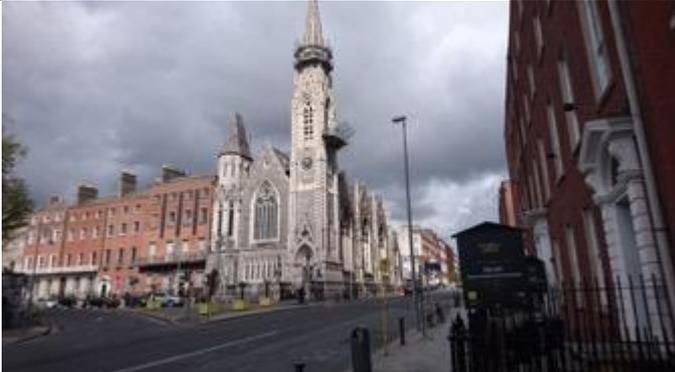
Identification No.	DCC RPS 6379
Additional Identifiers	NIAH 50010910
Legal Status	A Protected Structure
Location	Findlater's Church (Abbey Presbyterian), Parnell Square North, Dublin 1
Date of Construction	1862 to 4
Original Use	Church/Chapel
Description	Attached corner-sited freestanding gable-fronted stone-built Gothic Revival Presbyterian church, built 1862-4, to designs of Andrew Heiton.
Significance Rating	Regional (NIAH)
Categories of Special Interest	Architectural Artistic Historical Social
Sensitivity	Medium
Photographs

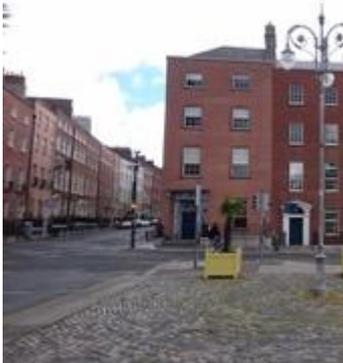
Identification No.	DCC RPS 6378
Additional Identifiers	n/a
Legal Status	A Protected Structure
Location	16 Parnell Square East, Dublin 1
Date of Construction	c.1800
Original Use	House
Description	House (office): end of terrace, two bay four storey over basement house, re-built c.2010 with sculpted limestone door-case and associated steps and railings
Significance Rating	Regional
Categories of Special Interest	Architectural Artistic
Sensitivity	Medium
Photographs

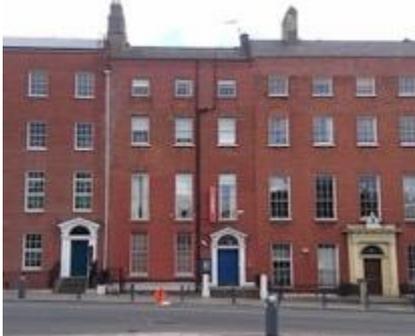
Identification No.	DCC RPS 6377
Additional Identifiers	NIAH 50011010
Legal Status	A Protected Structure
Location	Top of the Town, 12 Parnell Square East, Dublin 1
Date of Construction	c.1755
Original Use	House
Description	House: terraced House (theatre): terraced three-bay four-storey house over basement constructed c.1755 with associated steps and railings -bay four-storey house over basement, built c.1795 with associated steps and railings
Significance Rating	Regional (NIAH)
Categories of Special Interest	Architectural Artistic
Sensitivity	Medium
Photographs

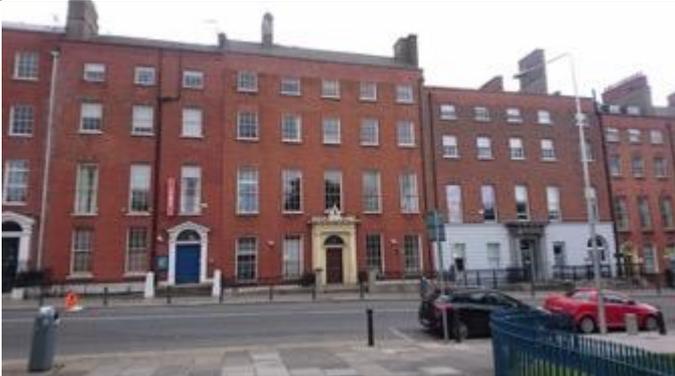
Identification No.	DCC RPS 6376
Additional Identifiers	NIAH 50011011
Legal Status	A Protected Structure
Location	11 Parnell Square East, Dublin 1
Date of Construction	c.1755
Original Use	House
Description	House (offices): terraced five-bay four-storey house over basement, built c.1755, with associated steps and railings
Significance Rating	National (NIAH)
Categories of Special Interest	Architectural Artistic Historical
Sensitivity	High
Photographs

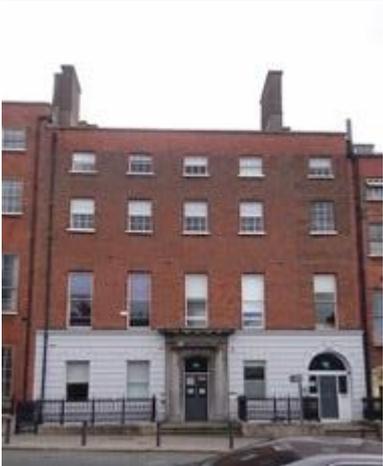
Identification No.	DCC RPS 6375
Additional Identifiers	NIAH 50011012
Legal Status	A Protected Structure
Location	15 Frederick Street North, Dublin 1
Date of Construction	c.1753
Original Use	House
Description	House (school): terraced five-bay four-storey house over basement, built c.1753 with associated steps and railings
Significance Rating	Regional (NIAH)
Categories of Special Interest	Architectural Artistic Historical
Sensitivity	Medium
Photographs

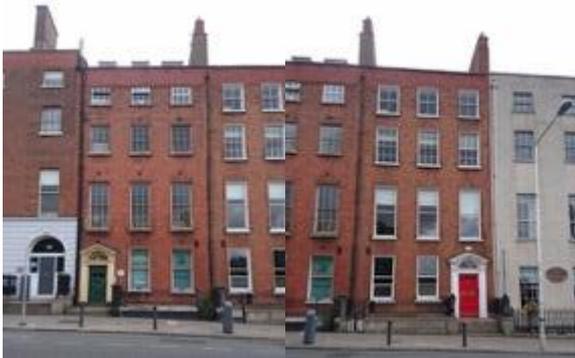
Identification No.	DCC RPS 6373 to 4
Additional Identifiers	NIAH 50011013 to 4
Legal Status	A Protected Structure
Location	8 to 9 Parnell Square East, Dublin 1
Date of Construction	c.1755
Original Use	House
Description	Pair of terraced three-bay four-storey-over-basement houses (surgery/offices) built c.1755 with associated steps and railings
Significance Rating	Regional (NIAH)
Categories of Special Interest	Architectural Artistic
Sensitivity	Medium
Photographs

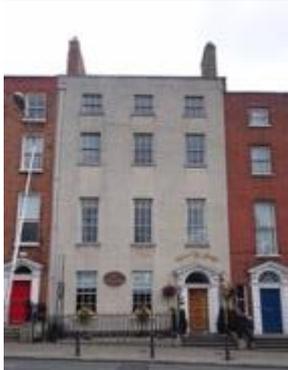
Identification No.	DCC RPS 6372
Additional Identifiers	NIAH 50011015
Legal Status	A Protected Structure
Location	Hotel St. George, 7 Parnell Square East, Dublin 1
Date of Construction	c.1755
Original Use	House
Description	House (hotel): terraced three-bay four-storey-over-basement house built c.1755 with associated steps and railings
Significance Rating	Regional (NIAH)
Categories of Special Interest	Architectural Artistic
Sensitivity	Medium
Photographs

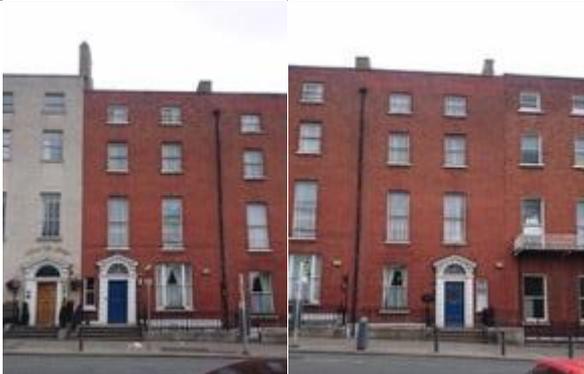
Identification No.	DCC RPS 6370 to 1
Additional Identifiers	NIAH 50011016 to 7
Legal Status	A Protected Structure
Location	The Charles Stewart Parnell, 5 to 6 Parnell Square East, Dublin 1
Date of Construction	c.1755
Original Use	House
Description	Pair of terraced two-bay four-storey-over-basement houses (guest house) built c.1755 with associated steps, railings, and lamps
Significance Rating	Regional (NIAH)
Categories of Special Interest	Architectural Artistic
Sensitivity	Medium
Photographs

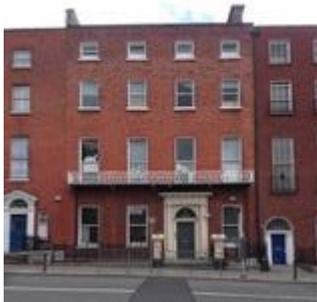
Identification No.	DCC RPS 6369
Additional Identifiers	NIAH 50011018
Legal Status	A Protected Structure
Location	4 Parnell Square East, Dublin 1
Date of Construction	c.1755
Original Use	House
Description	House (school): terraced four-bay four-storey-over-basement house built c.1755 with associated steps and railings
Significance Rating	Regional (NIAH)
Categories of Special Interest	Architectural Artistic Historical
Sensitivity	Medium
Photographs

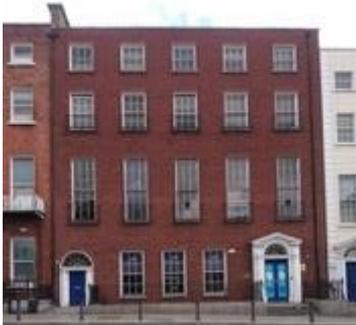
Identification No.	DCC RPS 6368
Additional Identifiers	n/a
Legal Status	A Protected Structure
Location	3 Parnell Square East, Dublin 1
Date of Construction	c.1755
Original Use	House
Description	House (school) terraced five-bay four-storey-over-basement house rebuilt c.1980, with associated steps and railings
Significance Rating	Regional (NIAH)
Categories of Special Interest	Architectural Artistic
Sensitivity	Medium
Photographs

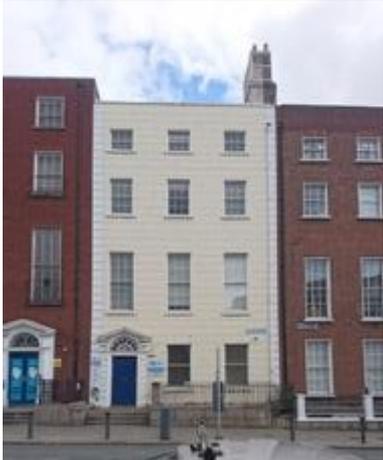
Identification No.	DCC RPS 6367
Additional Identifiers	NIAH 50011020
Legal Status	A Protected Structure
Location	2 Parnell Square East, Dublin 1
Date of Construction	c.1756
Original Use	House
Description	House (school): terraced three-bay four-storey house over basement, built 1756 with associated steps and railings
Significance Rating	Regional (NIAH)
Categories of Special Interest	Architectural Artistic
Sensitivity	Medium
Photographs

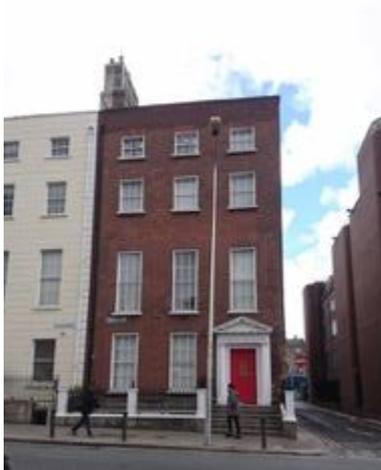
Identification No.	DCC RPS 6366, 1337
Additional Identifiers	NIAH 50011021
Legal Status	A Protected Structure
Location	Mandate, 1 Parnell Sq. East, 9 Cavendish Row
Date of Construction	c.1755
Original Use	House
Description	End-of-terrace three-bay four-storey house (offices) over basement, built 1756 associated steps, railings, and lamps
Significance Rating	Regional (NIAH)
Categories of Special Interest	Architectural Artistic
Sensitivity	Medium
Photographs

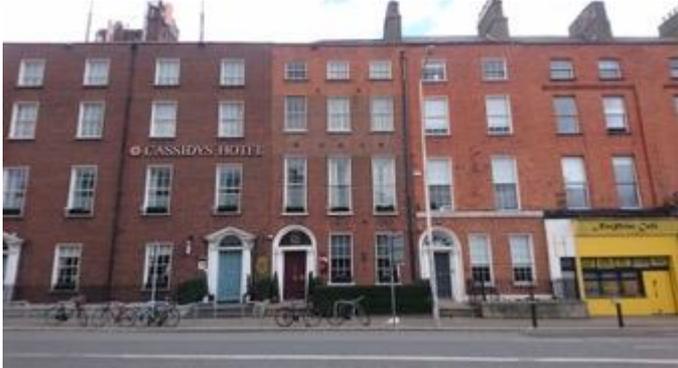
Identification No.	DCC RPS 1336
Additional Identifiers	NIAH 50011022
Legal Status	A Protected Structure
Location	6 Cavendish Row, Dublin 1
Date of Construction	c.1755
Original Use	House
Description	House (commercial): terraced three-bay four-storey-over-basement, built c.1756
Significance Rating	Regional (NIAH)
Categories of Special Interest	Architectural Artistic
Sensitivity	Medium
Photographs

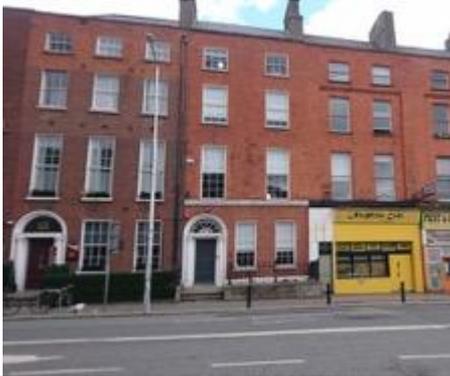
Identification No.	DCC RPS 1335
Additional Identifiers	NIAH 50011023
Legal Status	A Protected Structure
Location	5 Cavendish Row, Dublin 1
Date of Construction	c.1789
Original Use	House
Description	House (offices): terraced two-bay four-storey-over-basement built c.1789
Significance Rating	Regional (NIAH)
Categories of Special Interest	Architectural Artistic
Sensitivity	Medium
Photographs

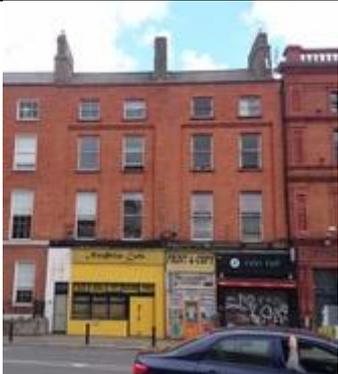
Identification No.	DCC RPS 1333 to 4
Additional Identifiers	NIAH 50011024 to 5
Legal Status	A Protected Structure
Location	3 to 4 Cavendish Row, Dublin 1
Date of Construction	c.1790
Original Use	House
Description	Pair of terraced two-bay four-storey-over-concealed-basement houses (retail) built c.1790 with associated lamps
Significance Rating	Regional (NIAH)
Categories of Special Interest	Architectural Artistic
Sensitivity	Medium
Photographs

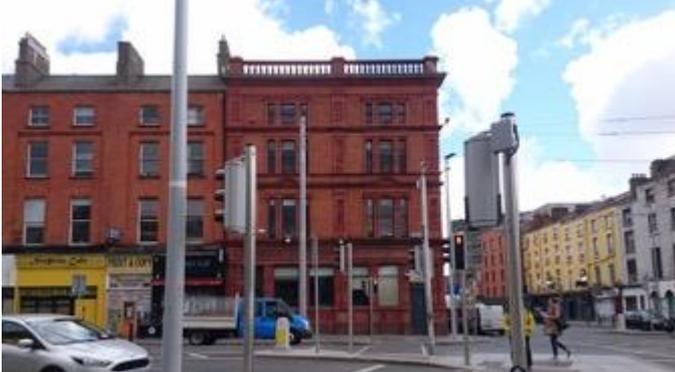
Identification No.	DCC RPS 1332
Additional Identifiers	NIAH 50011026
Legal Status	A Protected Structure
Location	1 to 2 Cavendish Row, Dublin 1
Date of Construction	1896
Original Use	Bank/financial institution
Description	Bank: corner-sited terraced two-bay four-storey bank, built 1896, incorporating later two-bay building of c.1913
Significance Rating	Regional (NIAH)
Categories of Special Interest	Architectural Artistic
Sensitivity	Medium
Photographs

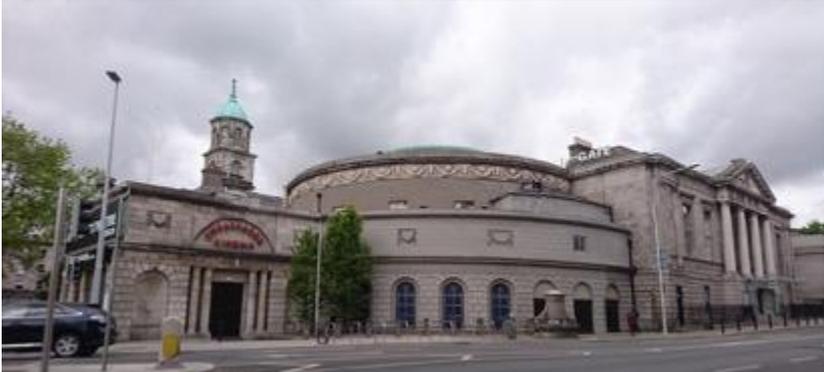
Identification No.	DCC RPS 1339
Additional Identifiers	NIAH 50011032
Legal Status	A Protected Structure
Location	Cavendish Row, Dublin 1
Date of Construction	c.1780
Original Use	Fountain
Description	Fountain: Freestanding granite public drinking fountain, installed c.1780
Significance Rating	Regional (NIAH)
Categories of Special Interest	Architectural Artistic Social
Sensitivity	Medium
Photographs

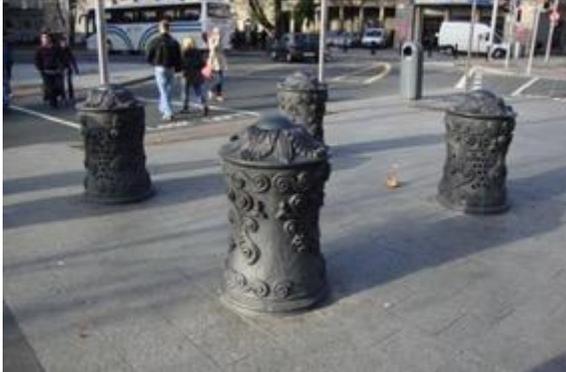
Identification No.	DCC RPS 6020
Additional Identifiers	NIAH 50010556
Legal Status	A Protected Structure
Location	Cavendish Row, O'Connell St Upper, Dublin 1
Date of Construction	c.1880
Original Use	Bollards
Description	Bollard / Monument: Four cast-iron bollards, erected c.1880, located at north end of O'Connell Street on central mall. They have been relocated further to the south as part of the Luas works
Significance Rating	Regional (NIAH)
Categories of Special Interest	Artistic Technical
Sensitivity	Medium
Photographs

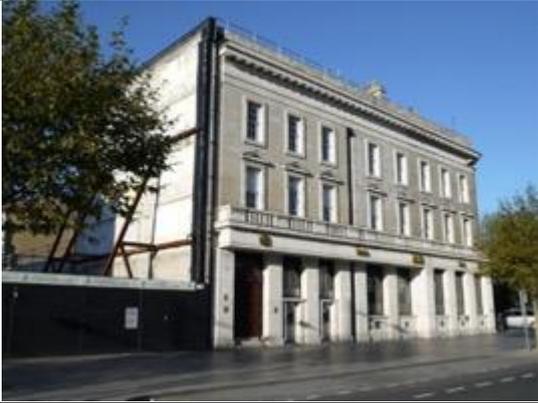
Identification No.	DCC RPS 6021
Additional Identifiers	NIAH 50010558
Legal Status	A Protected Structure
Location	AIB O'Connell St Upper, Parnell Street, Dublin 1
Date of Construction	1921 to 22
Original Use	Bank / Financial institution
Description	Corner-sited three-storey neo-Classical bank, built 1921 to 2 and extended 1936, eight-bays to O'Connell Street, chamfered corner entrance bay and four-bays to Parnell Street. Designed by Batchelor & Hicks.
Significance Rating	Regional (NIAH)
Categories of Special Interest	Architectural Artistic
Sensitivity	Medium
Photographs

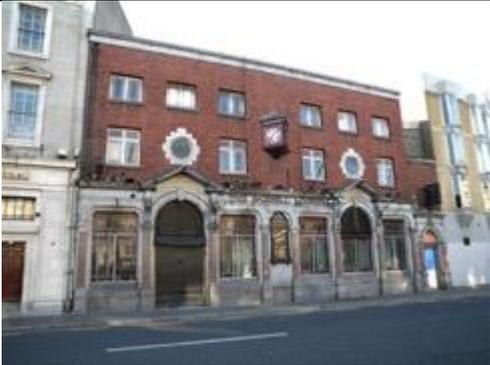
Identification No.	DCC RPS 6424
Additional Identifiers	NIAH 50010559
Legal Status	A Protected Structure
Location	The Parnell Mooney, 72 to 74 Parnell Street, Dublin 1
Date of Construction	c.1879
Original Use	Public House
Description	Terraced six-bay three-storey red brick and stone building, built 1879, designed as mirrored elevation with elaborate stone pub shopfront inserted to ground floor
Significance Rating	Regional (NIAH)
Categories of Special Interest	Architectural Artistic
Sensitivity	Medium
Photographs

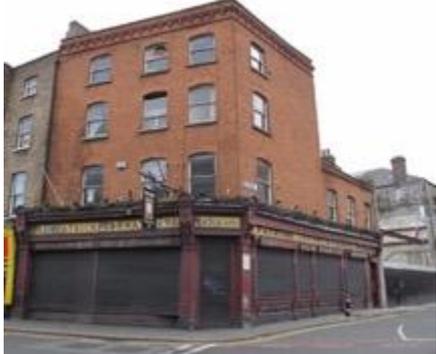
Identification No.	DCC RPS 6423
Additional Identifiers	NIAH 50010561
Legal Status	A Protected Structure
Location	Patrick Conway , Parnell Street, Dublin
Date of Construction	c. 1880
Original Use	Public house
Description	Corner-sited four-storey commercial building, built c.1880, having two-storey return and full-height square-profile return to rear (south) elevation, with continuous pub front to ground floor of both elevations and having angled corner-sited entrance bay
Significance Rating	Regional (NIAH)
Categories of Special Interest	Architectural, Artistic, Historical
Sensitivity	Medium
Photographs

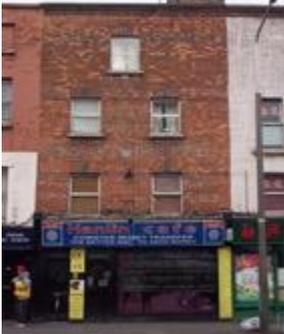
Identification No.	DCC RPS 6436
Additional Identifiers	NIAH 50011029
Legal Status	A Protected Structure
Location	158 Parnell Street, Dublin 1
Date of Construction	c. 1740
Original Use	House
Description	Terraced two-bay four-storey house, built c.1740, one-bay to top floor, with recent timber shopfront
Significance Rating	Regional (NIAH)
Categories of Special Interest	Architectural Technical
Sensitivity	Medium
Photographs

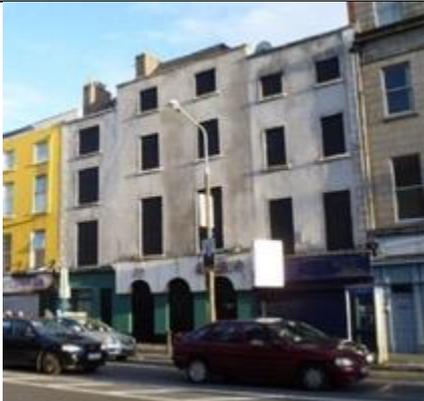
Identification No.	DCC RPS 6425 to 27
Additional Identifiers	NIAH 50010615 to 17
Legal Status	A Protected Structure
Location	76 to 78 Parnell Street, Dublin 1
Date of Construction	c. 1850
Original Use	House
Description	Group of three terraced two-bay four-storey houses, built c.1850
Significance Rating	Regional (NIAH)
Categories of Special Interest	Architectural
Sensitivity	Medium
Photographs
