Appendix A16.1-A16.3
Architectural Heritage
Appendices

16. Appendix 16.1 Historical Background

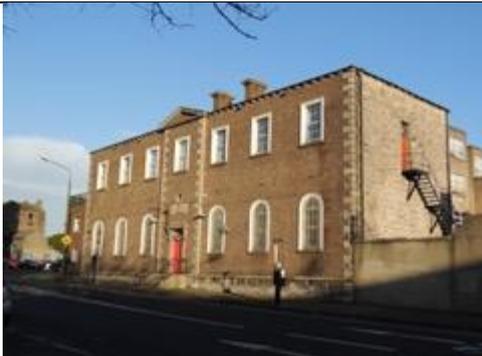
Identification No.	DCC RPS 8751
Additional Identifiers	NIAH 50070460
Legal Status	A Protected Structure
Location	2 St. Mary's Place North, Dublin 7
Date of Construction	c.1854
Original Use	School
Description	Detached seven-bay two-storey former school, dated 1854, having lower single-bay two-storey return to rear (north) elevation with pitched roof, and lower single-bay two-storey flat-roofed extension to west elevation
Significance Rating	Regional (NIAH)
Categories of Special Interest	Architectural
Sensitivity	Medium
Photographs

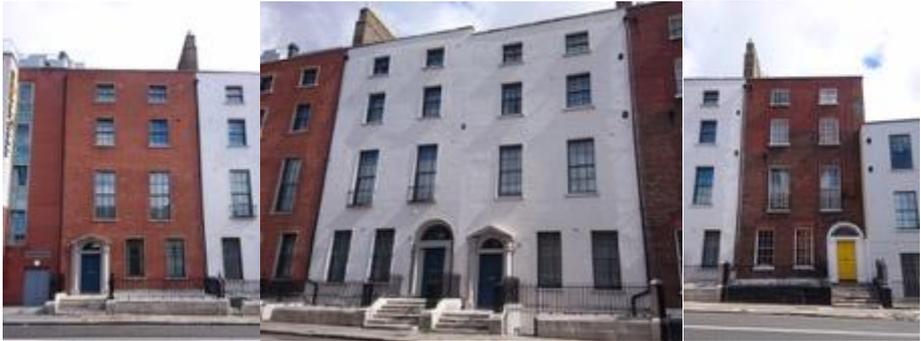
Identification No.	DCC RPS 3268
Additional Identifiers	NIAH 50010653
Legal Status	A Protected Structure
Location	1 Granby Row, Dublin 1
Date of Construction	c.1820
Original Use	House
Description	House (college): Attached former pair of two-bay three-storey houses over basement, built c.1820, with single-bay extension to south having integral carriage arch, and further polygonal-plan single-storey addition to south-east
Significance Rating	Regional (NIAH)
Categories of Special Interest	Architectural Artistic
Sensitivity	Medium
Photographs

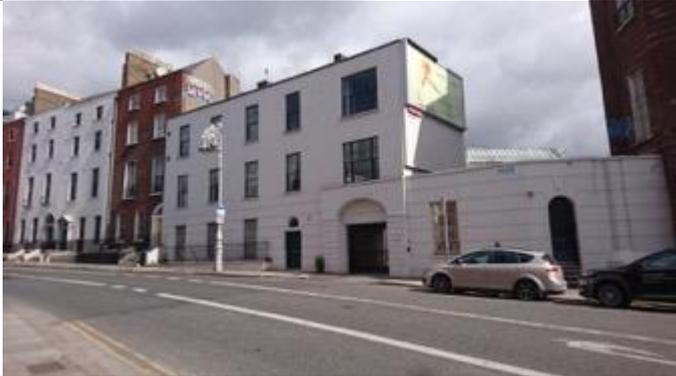
Identification No.	DCC RPS 3273
Additional Identifiers	NIAH 50010651
Legal Status	A Protected Structure
Location	15 Granby Row, Dublin 1
Date of Construction	c.1755
Original Use	House
Description	House (apartments): Terraced two-bay four-storey house over basement, built c.1760 with associated steps and railings
Significance Rating	Regional (NIAH)
Categories of Special Interest	Architectural Artistic
Sensitivity	Medium
Photographs

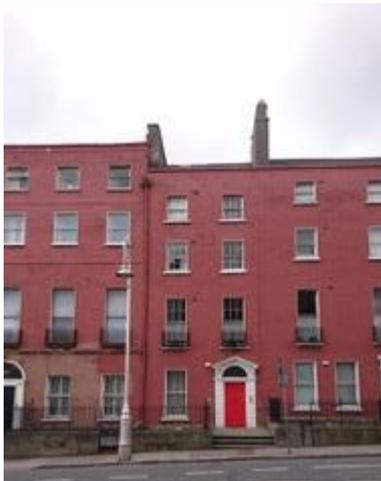
Identification No.	DCC RPS 3274
Additional Identifiers	NIAH 50010652
Legal Status	A Protected Structure
Location	16 Granby Row, Dublin 1
Date of Construction	c.1760
Original Use	House
Description	House (apartments): Terraced two-bay four-storey house over basement, built c.1760 with associated steps and railings
Significance Rating	Regional (NIAH)
Categories of Special Interest	Architectural Artistic
Sensitivity	Medium
Photographs

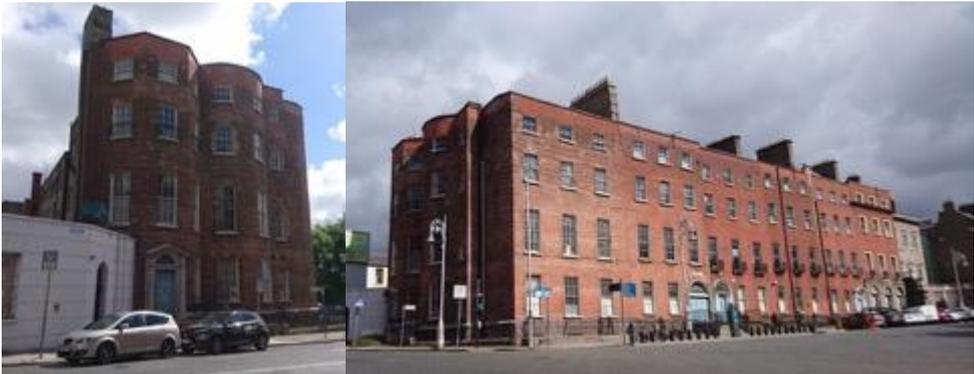
Identification No.	DCC RPS 6391
Additional Identifiers	NIAH 50010650
Legal Status	A Protected Structure
Location	Vaughan's Hotel, 29 Parnell Square West, Dublin 1
Date of Construction	1770
Original Use	House
Description	House: terraced three-bay four-storey-over-basement, completed 1770 with associated steps and railings
Significance Rating	National (NIAH)
Categories of Special Interest	Architectural Artistic Historical
Sensitivity	High
Photographs

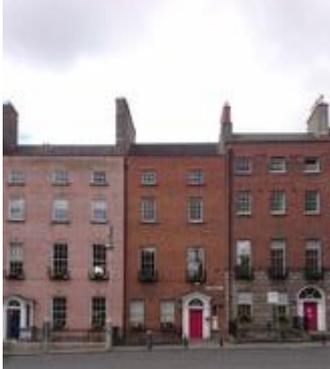
Identification No.	DCC RPS 6374
Additional Identifiers	NIAH 50010647
Legal Status	A Protected Structure
Location	ICTU, 32 Parnell Square West, Dublin 1
Date of Construction	c.1755
Original Use	House
Description	House (offices): terraced four-storey-over-basement, built c.1758 with three-bay ground floor and two-bay upper floors and associated steps and railings
Significance Rating	Regional (NIAH)
Categories of Special Interest	Architectural Artistic
Sensitivity	Medium
Photographs

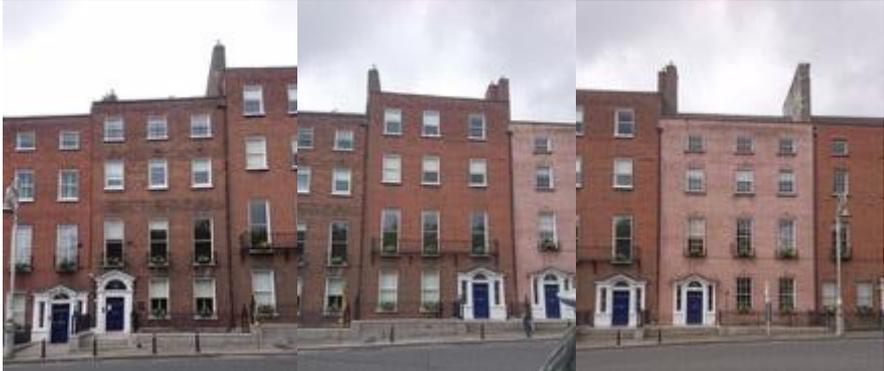
Identification No.	DCC RPS 6398 to 9
Additional Identifiers	NIAH 50010642 to 3
Legal Status	A Protected Structure
Location	Club na Múinteoirí, Daybreak School, 36 to 37 Parnell Square West, Dublin 1
Date of Construction	c.1765
Original Use	House
Description	House (theatre): terraced four-storey-over-basement, built c.1765 with two-bay ground floor and three-bay upper floors with associated steps and railings
Significance Rating	Regional (NIAH)
Categories of Special Interest	Architectural Artistic
Sensitivity	Medium
Photographs

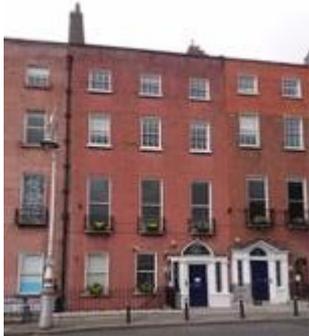
Identification No.	DCC RPS 6401
Additional Identifiers	NIAH 50010638 to 9
Legal Status	A Protected Structure
Location	39 Parnell Square West, Dublin 1
Date of Construction	c.1755
Original Use	House
Description	House (misc.): pair of terraced three-bay four-storey-over-basement houses, built by 1760 with associated steps and railings
Significance Rating	Regional (NIAH)
Categories of Special Interest	Architectural Artistic Historical
Sensitivity	Medium
Photographs

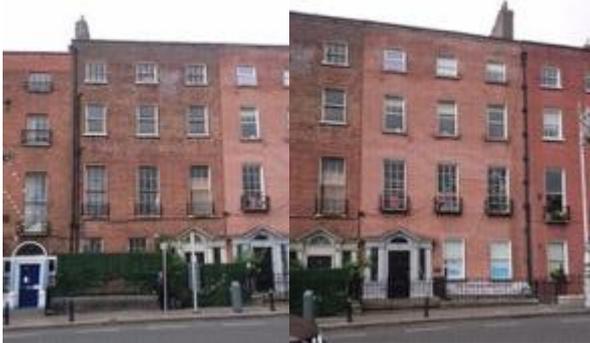
Identification No.	DCC RPS 6402 to 3
Additional Identifiers	NIAH 50010638 to 9
Legal Status	A Protected Structure
Location	40 to 41 Parnell Square West
Date of Construction	c.1755
Original Use	House
Description	House (misc.): pair of terraced three-bay four-storey-over-basement houses, built by 1760 with associated steps and railings
Significance Rating	Regional (NIAH)
Categories of Special Interest	Architectural Artistic Historical
Sensitivity	Medium
Photographs

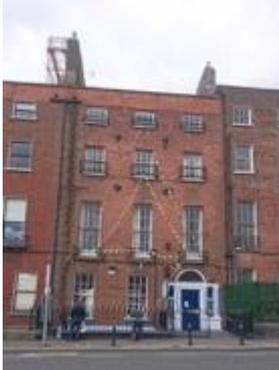
Identification No.	DCC RPS 6404
Additional Identifiers	NIAH 50010637
Legal Status	A Protected Structure
Location	St Martin's Apostolate, 42 Parnell Square West
Date of Construction	c.1760
Original Use	House
Description	House (chapel): terraced three-bay four-storey-over-basement, built c.1760 with associated steps, railings, and coal holes
Significance Rating	Regional (NIAH)
Categories of Special Interest	Architectural Artistic Social
Sensitivity	Medium
Photographs

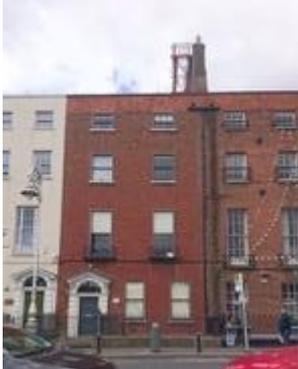
Identification No.	DCC RPS 6406
Additional Identifiers	NIAH 50010635
Legal Status	A Protected Structure
Location	Kevin Barry Memorial Hall, 44 Parnell Square West, Dublin 1
Date of Construction	c.1755
Original Use	House
Description	House (offices): Terraced three-bay four-storey-over-basement, built c.1765, with altered, two-bay, first floor and associated steps and railings (replacements)
Significance Rating	Regional (NIAH)
Categories of Special Interest	Architectural Artistic Cultural
Sensitivity	Medium
Photographs

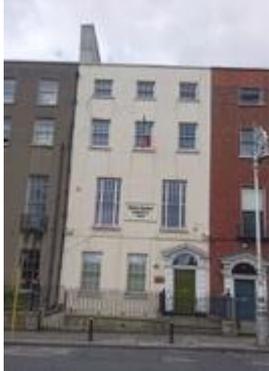
Identification No.	DCC RPS 6407
Additional Identifiers	NIAH 50010634
Legal Status	A Protected Structure
Location	45 Parnell Square West, Dublin 1
Date of Construction	c.1765
Original Use	House
Description	House: terraced three-bay four-storey house over exposed basement, built c.1765 with associated steps and railings
Significance Rating	Regional (NIAH)
Categories of Special Interest	Architectural Artistic
Sensitivity	Medium
Photographs

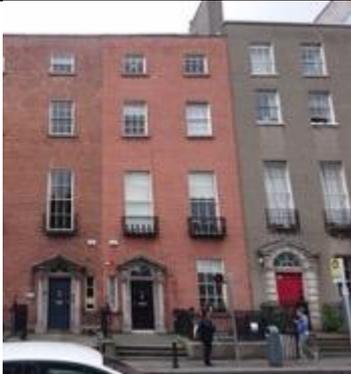
Identification No.	DCC RPS 6408
Additional Identifiers	NIAH 50010633
Legal Status	A Protected Structure
Location	46 Parnell Square West, Dublin 1
Date of Construction	c.1755
Original Use	House
Description	House (offices): terraced two-bay four-storey house over exposed basement, built c.1765 with associated steps and railings
Significance Rating	Regional (NIAH)
Categories of Special Interest	Architectural Artistic
Sensitivity	Medium
Photographs

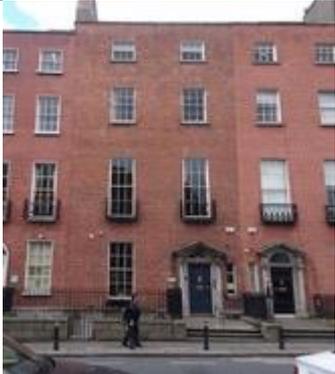
Identification No.	DCC RPS 6409
Additional Identifiers	NIAH 50010632
Legal Status	A Protected Structure
Location	Kent Carthy Solicitors, 47 Parnell Square West, Dublin 1
Date of Construction	c.1755
Original Use	House
Description	House (offices): terraced two-bay four-storey house over exposed basement, built c.1765 with associated steps and railings
Significance Rating	Regional (NIAH)
Categories of Special Interest	Architectural Artistic
Sensitivity	Medium
Photographs

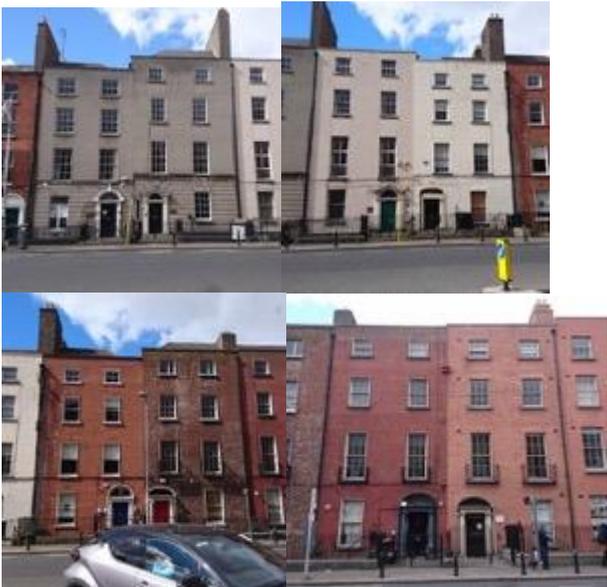
Identification No.	DCC RPS 6418
Additional Identifiers	NIAH 50010623
Legal Status	A Protected Structure
Location	The Kingfisher Restaurant, 59 Parnell Square West, Dublin 1
Date of Construction	1895
Original Use	House
Description	Hospital, west wing: Corner-sited attached four-storey-over-basement, built 1895 to designs by Albert E. Murray, having five-bay facade to south and grouped four-bay facade to west
Significance Rating	Regional (NIAH)
Categories of Special Interest	Architectural Artistic
Sensitivity	Medium
Photographs

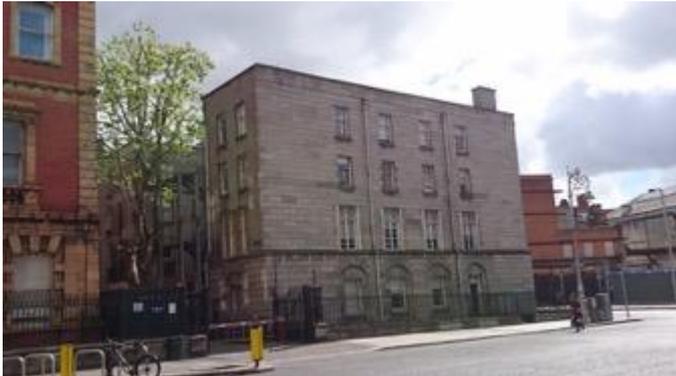
Identification No.	DCC RPS 6420
Additional Identifiers	NIAH 50010619
Legal Status	A Protected Structure
Location	Rotunda Hospital, Parnell Street, Dublin 1
Date of Construction	1751 to 7
Original Use	Hospital/infirmary
Description	Hospital main hospital: attached eleven-bay three-storey hospital, built 1751 to 7, having applied Doric portico with pediment to three-bay central pedimented breakfront. Built by John Ensor to designs of Richard Castle. Attached buildings to west forming quadrant colonnade wing, having attached rotunda theatre to east and central three-stage stone cupola with copper dome with associated gates and railings
Significance Rating	National (NIAH)
Categories of Special Interest	Architectural Artistic Social
Sensitivity	High
Photographs

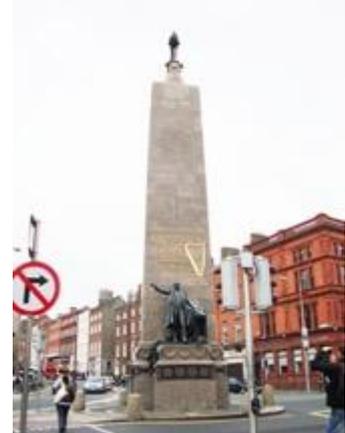
Identification No.	DU018-425
Additional Identifiers	DCC RPS 6020 NIAH 50010557
Legal Status	A recorded monument, a Protected Structure
Location	Parnell Monument, O'Connell St Upper, Dublin 1
Date of Construction	1906
Original Use	Monument
Description	Freestanding granite obelisk and bronze statue of Charles Stewart Parnell, made 1899 to 1911, dated 1906, unveiled 1911, designed in neo-Classical Revival style by sculptor Augustus Saint-Gaudens with assistance of architects Henry Bacon and George Sheridan.
Significance Rating	National (NIAH)
Categories of Special Interest	Architectural Artistic Historical
Sensitivity	High
Photographs

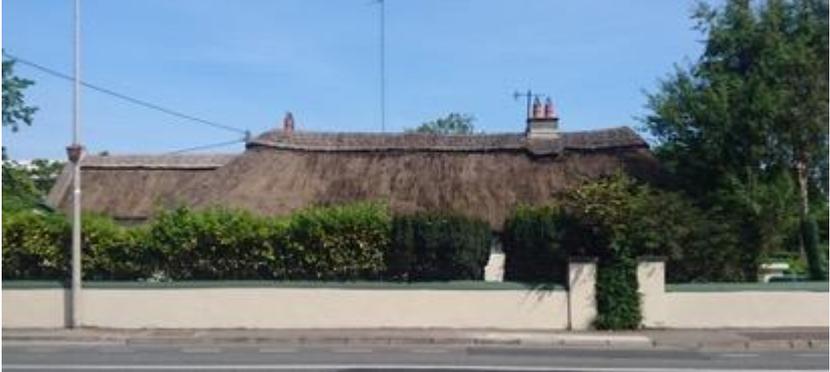
Identification No.	NIAH 11349004
Additional Identifiers	n/a
Location	Swords Road, Dardistown
Date of Construction	1750 to 1850
Original Use	House
Description	Detached three-bay single-storey thatched house, c.1800, on a L-shaped plan with gable-fronted projecting entrance porch. ROOF: Double pitched thatch roof; decorative thatched ridging with two nap rendered chimney stacks; timber barge boards to porch. WALLS: Nap rendered. OPENINGS: Square headed windows with nap rendered reveals; stone cills and uPVC casements; round headed door opening.
Significance Rating	Regional (NIAH)
Categories of Special Interest	Architectural Social Technical
Sensitivity	Medium
Photographs

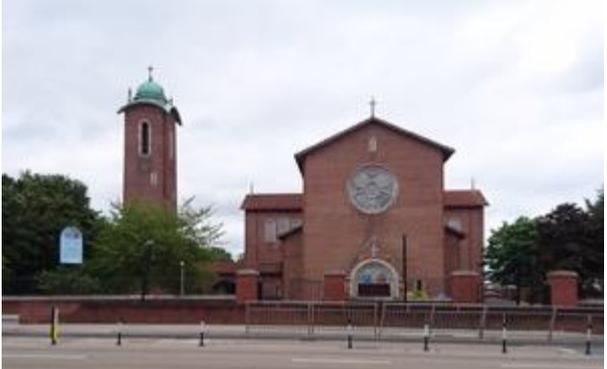
Identification No.	NIAH 50130240
Legal Status	n/a
Location	Church of the Holy Child, Whitehall
Date of Construction	c.1955
Original Use	Church
Description	Freestanding gable-fronted cruciform-plan Catholic Church, built 1955-7, facing west and having projecting porch, three-bay nave with side aisles, secondary entrances in quadrant flat-roofed porches to re-entrant corners to north and south and to arcade to north; freestanding campanile to north connected to main volume by arcaded walkway, and recent two-storey flat-roofed extension to east end
Significance Rating	Regional (NIAH)
Categories of Special Interest	Architectural Artistic Social
Sensitivity	Medium
Photographs

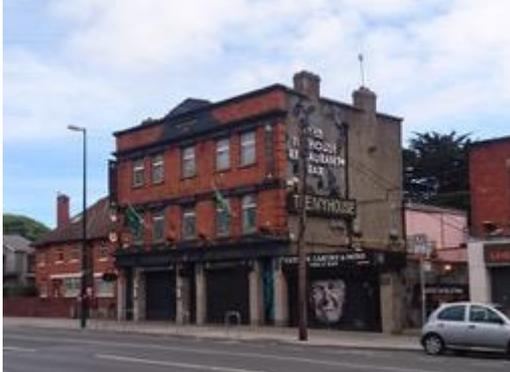
Identification No.	NIAH 50120001
Legal Status	n/a
Location	Ivy House/Patrick Carthy & Sons Public Bar, 114 Drumcondra Road Upper, Dublin 9
Date of Construction	c.1910
Original Use	Public house
Description	Detached five-bay three-storey public house, built c. 1910, with pub front to front (west) elevation, return to rear and single-storey accretion to side (south) elevation
Significance Rating	Regional (NIAH)
Categories of Special Interest	Architectural, Social
Sensitivity	Medium
Photographs

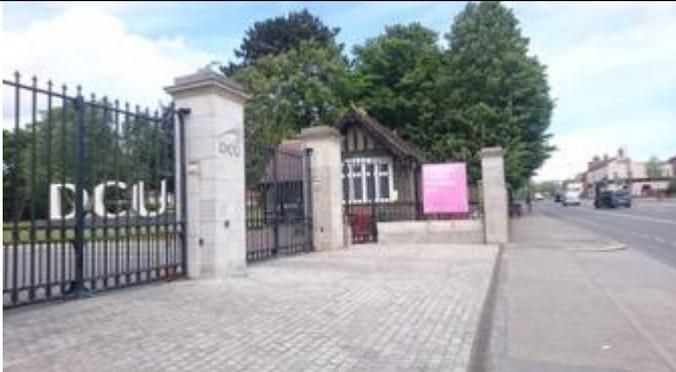
Identification No.	NIAH 50130255 to 56
Additional Identifiers	n/a
Location	Gate lodge, St. Patrick's College, Drumcondra Road Upper, Dublin 9
Date of Construction	c.1910
Original Use	Gate lodge, gates
Description	Gate lodge: Detached single-storey L-plan gate lodge, built 1911 to 12, with two-bay front and west elevations, lean-to porch to re-entrant angle and flat-roofed abutment to north. Gates: Ashlar granite gate screen, built 1910 to 12, located at entrance to Dublin City University St. Patrick's Campus
Significance Rating	Regional (NIAH)
Categories of Special Interest	Architectural, Historical, Social
Sensitivity	Medium
Photographs

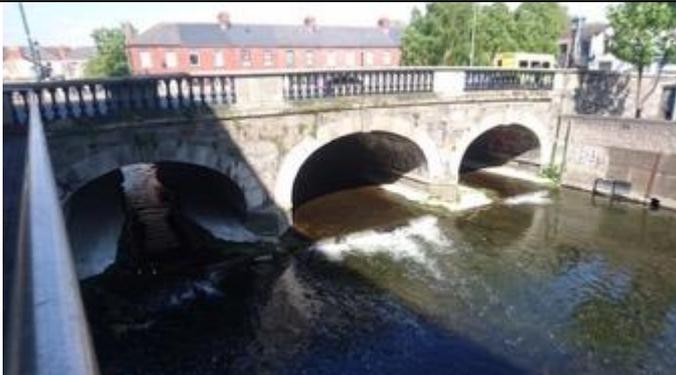
Identification No.	NIAH 50120266
Legal Status	n/a
Location	Drumcondra Bridge (known as Frank Flood Bridge), Drumcondra Road Lower, Drumcondra Road Upper
Date of Construction	c.1817
Original Use	Bridge
Description	Bridge road/river: Three arch granite and limestone bridge over the Tolka River c.1817 with cast iron and granite balustrades and cast-iron lamp stands
Significance Rating	Regional (NIAH)
Categories of Special Interest	Architectural, Artistic, Historical, Technical
Sensitivity	Medium
Photographs

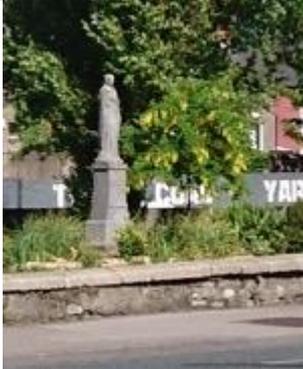
Identification No.	NIAH 50130158, CBC0002BTH103
Legal Status	Not protected or included in any existing inventories
Location	Statue of Our Lady, Our Lady's Park, Drumcondra Bridge, Dublin 9
Date of Construction	1953
Description	Free standing statue of Our Lady on granite plinth
Significance Rating	Local
Categories of Special Interest	Historical, Social
Sensitivity	Low
Photographs

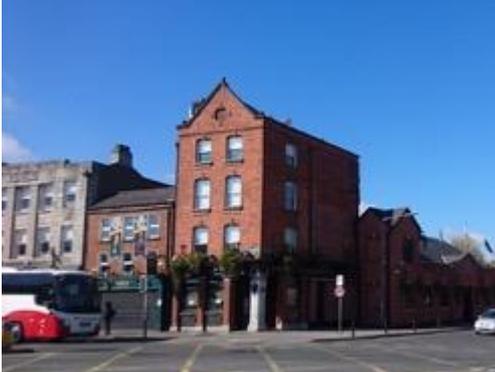
Identification No.	NIAH 50130171
Legal Status	n/a
Location	Fagan's Bar and Restaurant, 146 Drumcondra Road Lower, Dublin 9
Date of Construction	c. 1907
Original Use	Public house

Description	Corner-sited attached two-bay four-storey gable-fronted public house with accommodation above, dated 1907, having open porch entrance at northeast corner
Significance Rating	Regional (NIAH)
Categories of Special Interest	Architectural, Artistic, Social
Sensitivity	Medium
Photographs

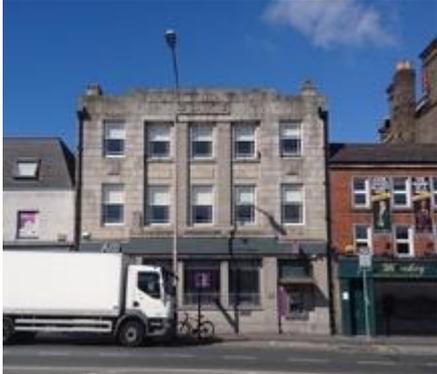
Identification No.	NIAH 50130172	
Legal Status	n/a	
Location	140 Drumcondra Road Lower, Dublin 9	
Date of Construction	c.1900	
Original Use	Bank/Financial institution	
Description	Allied Irish Bank, five-bay three storey cut limestone façade built c. 1900	
Significance Rating	Regional (NIAH)	
Categories of Special Interest	Architectural	
Sensitivity	Medium	
Photographs

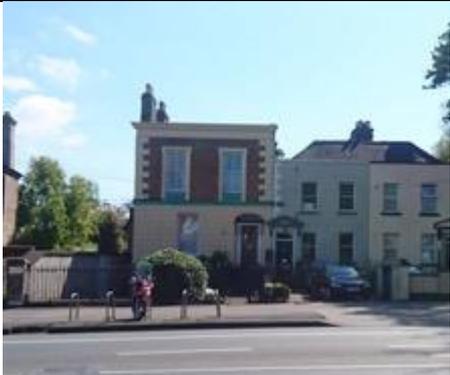
Identification No.	NIAH 50120170	
Legal Status	n/a	
Location	137 Drumcondra Road Lower, Dublin 9	
Date of Construction	c.1820	
Original Use	House	
Description	House: end-of-terrace 2-storey-over-basement c.1820 with associated gates and railings	
Significance Rating	Regional (NIAH)	
Categories of Special Interest	Architectural, Artistic	
Sensitivity	Medium	
Photographs

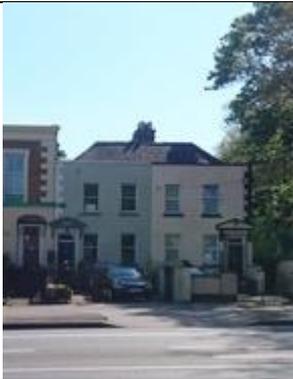
Identification No.	NIAH 50120171 to 72	
Legal Status	n/a	
Location	135, 133 Drumcondra Road Lower, Dublin 9	
Date of Construction	c.1740	
Original Use	Houses	
Description	Pair of two-storey-over-basement two-bay houses behind front gardens, (railings to no. 135)	
Significance Rating	Regional (NIAH)	
Categories of Special Interest	Architectural, Artistic, Historical	
Sensitivity	Medium	
Photographs

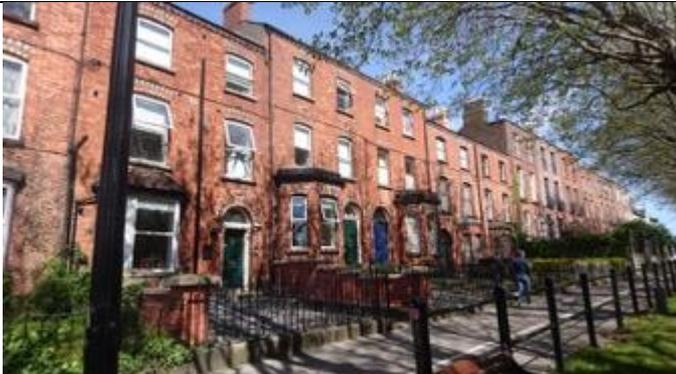
Identification No.	NIAH 50130182 to 89	
Legal Status	n/a	
Location	80, 78, 76, 74, 72, 70, 68, 66 Drumcondra Road Lower, Dublin 9	
Date of Construction	c.1890	
Original Use	Houses	
Description	Terrace of eight three-storey two-bay houses with single-storey canted bays built c.1890 with associated gates and railings	
Significance Rating	Regional (NIAH)	
Categories of Special Interest	Architectural Artistic	
Sensitivity	Medium	
Photographs

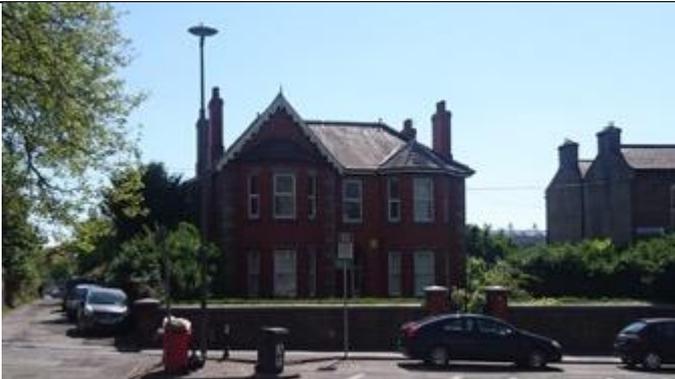
Identification No.	NIAH 50120187
Legal Status	n/a
Location	Blessington Cottage, 57 Drumcondra Road Lower, Dublin 9
Date of Construction	c.1900
Original Use	House
Description	Detached three-bay two-storey former house, built c. 1900, having canted end bays, that to north being gable-fronted and slightly forward of house facade proper, and with recent two-storey addition to rear at north end.
Significance Rating	Regional (NIAH)
Categories of Special Interest	Architectural Artistic
Sensitivity	Medium
Photographs

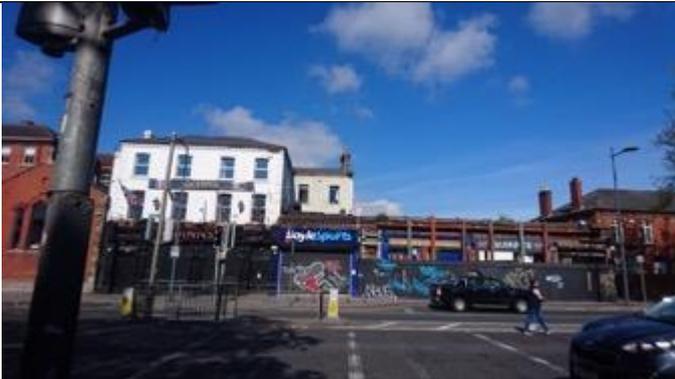
Identification No.	NIAH 50130207
Legal Status	n/a
Location	Saint Vincent's Centre, 40 Drumcondra Road Lower, Dublin 9
Date of Construction	c.1895
Original Use	School
Description	Former Sacred Heart Home (industrial School) built c.1895. Five bay three storey over basement set back from the street flanked by gabled chapel building – redbrick with granite dressings.
Significance Rating	Regional
Categories of Special Interest	Architectural, Social
Sensitivity	Medium
Photographs

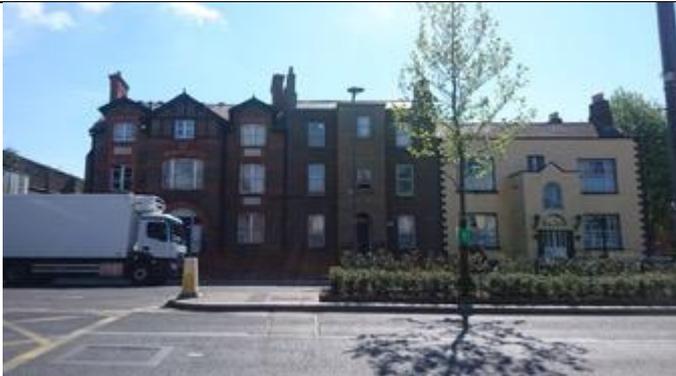
Identification No.	NIAH 50130210
Legal Status	n/a
Location	22 Drumcondra Road Lower, Dublin 9
Date of Construction	c.1880
Original Use	House
Description	Attached corner-sited four-bay two-storey former house (or houses), built c. 1880, having four-bay side (south) elevation with single-storey extension. pub front to front (east) and side elevations
Significance Rating	Regional (NIAH)
Categories of Special Interest	Architectural, Artistic, Social
Sensitivity	Medium
Photographs

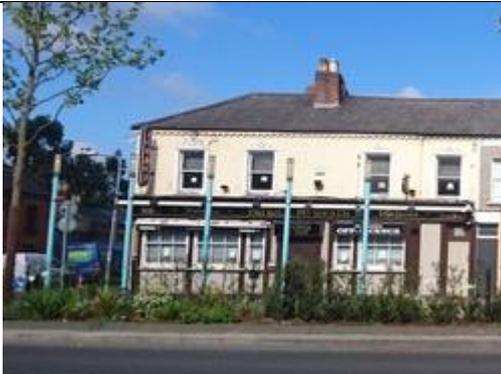
Identification No.	CBC0002BTH084
Legal Status	n/a
Location	1,3 Drumcondra Road Lower, Dublin 9
Date of Construction	c.1930
Original Use	Houses
Description	Two three bay three storey with associated railings built c. 1830
Significance Rating	Regional (NIAH)
Categories of Special Interest	Architectural, Artistic
Sensitivity	Medium
Photographs

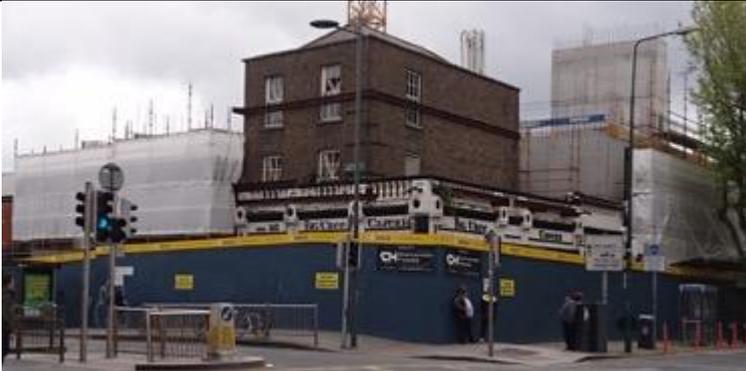
Identification No.	NIAH 50010710
Legal Status	n/a
Location	Chartbusters, 38 Dorset Street Lower, North Circular Road, Dublin 1
Date of Construction	c.1900
Original Use	Retail
Description	Corner-sited commercial building, built c.1900, having two-bay elevation to Dorset Street Lower and three-bay to North Circular Road, with decorative limestone shopfront spanning both elevations and having main entrance to corner and accessed from both elevations
Significance Rating	Regional (NIAH)
Categories of Special Interest	Architectural, Artistic
Sensitivity	Medium
Photographs

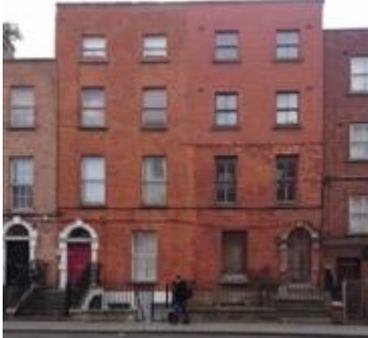
Identification No.	NIAH 50010706
Legal Status	n/a
Location	T & J. Hogan, 68 Dorset Street Upper, Dublin 1
Date of Construction	c.1780
Original Use	Shop
Description	Terraced two-bay four-storey house, built c.1790, with decorative granite shopfront inserted to ground floor c.1890
Significance Rating	Regional (NIAH)
Categories of Special Interest	Architectural, Artistic, Social
Sensitivity	Medium
Photographs

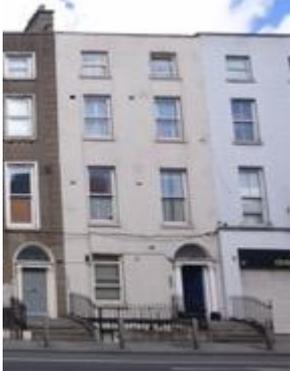
Identification No.	NIAH 50060602 to 4
Legal Status	n/a
Location	95 to 97 Dorset Street Upper, Dublin 1
Date of Construction	c.1800
Original Use	Public house
Description	Terraced two-bay four-storey former houses, built c.1800, with replacement shopfronts to ground floor
Significance Rating	Regional (NIAH)
Categories of Special Interest	Architectural
Sensitivity	Medium
Photographs

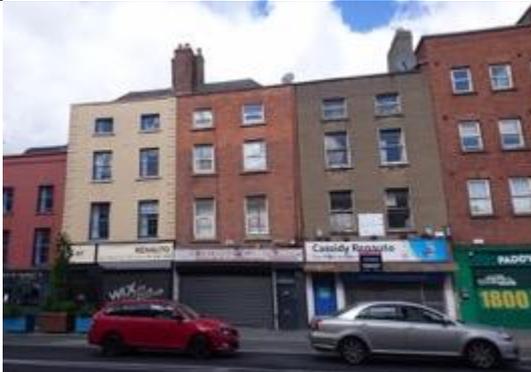
Identification No.	NIAH 50060594
Legal Status	n/a
Location	Glynn's, The Wellington House, Dorset Street Upper, Wellington Street Lower, Dublin 1
Date of Construction	c.1790
Original Use	House
Description	End-of-terrace two-bay four-storey Georgian townhouse over basement, built c.1790, with pub-front inserted to ground floor c.1850. Flat-roof two-storey return abuts to rear.
Significance Rating	Regional (NIAH)
Categories of Special Interest	Architectural
Sensitivity	Medium
Photographs

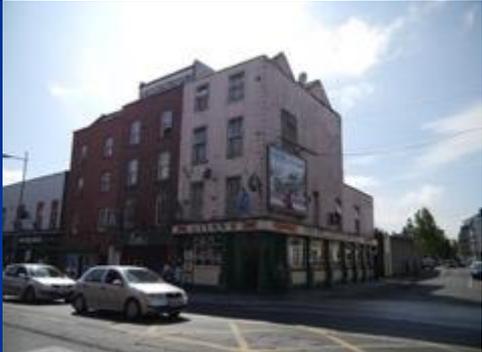
Identification No.	NIAH 50010692
Legal Status	n/a
Location	Joxer Daly's, Dorset Street Upper, Dublin 1
Date of Construction	c.1810
Original Use	House
Description	End-of-terrace four-bay two-storey over basement house, built c.1810, with pub-front and integral carriage arch inserted to ground floor c.1880.
Significance Rating	Regional (NIAH)
Categories of Special Interest	Architectural, Artistic
Sensitivity	Medium
Photographs

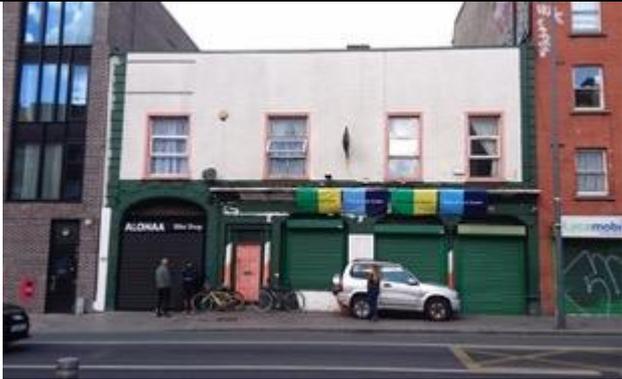
Identification No.	NIAH 50010614	
Legal Status	n/a	
Location	Centra, O'Connell Street Upper, Parnell Street, Dublin 1	
Date of Construction	c.1830	
Original Use	Public house	
Description	Corner-sited four-storey commercial building having five bays to Parnell Street and two to O'Connell Street, with further chamfered corner entrance bay, built c.1925.	
Significance Rating	Regional (NIAH)	
Categories of Special Interest	Architectural, Artistic, Historical	
Sensitivity	Medium	
Photographs

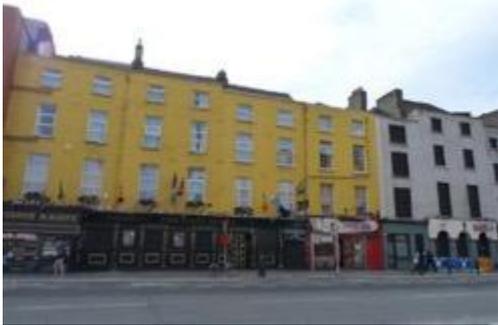
Identification No.	NIAH 50011028
Legal Status	n/a
Location	Hop-House, 160 Parnell Street, Dublin 1
Date of Construction	c.1730
Original Use	Public house
Description	Terraced two-bay four-storey commercial building over concealed basement, built c.1730, refaced c.1890. Now in use as public house with later granite shopfront, c.1900. Roof concealed behind machicolated parapet with ashlar granite finials and coping. Rendered chimneystack with clay pots, shared with No. 159. Flemish bond red brick walls with lime pointing having polychromatic brick quoins to front elevation surmounted by moulded granite eaves course. Granite sill courses with moulded brick cornices to second and third floors. Slightly projecting brickwork to first storey framing windows and having brick piers supporting moulded brick cornice. Segmental- arch window openings having gauged polychrome brick voussoirs; red brick reveals and granite sills. One-over-one pane timber sliding sash windows throughout. Shopfront comprising granite pilasters with inset medallions, plinth and panelled stall riser, square-headed display windows with granite sills and ornate multiple-pane stained-glass windows with lead tracery. Gilt and mirror nameboard to timber fascia, surmounted by timber cornice and flanked by decorative timber brackets. Square-headed door opening to shopfront with timber panelled double-leaf doors having Tudor-style decorative cast-iron door furniture and studs within granite surrounds. Delivery grate in footpath serving basement. Draught lobby to interior having tiled floor, flanked by coffered timber panelled walls with stained-glass over lights. Square-headed door openings to interior of lobby having double-leaf glazed timber door. Interior having original timber floors, panelled walls, painted exposed beams to ceiling. Elevated seating areas with timber balustrades.

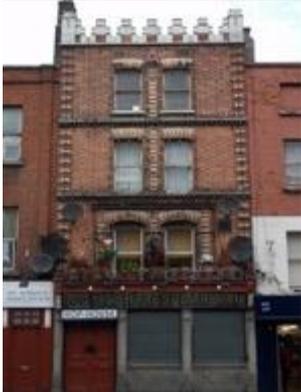
Significance Rating	Regional (NIAH)
Categories of Special Interest	Architectural, Artistic
Sensitivity	Medium
Photographs

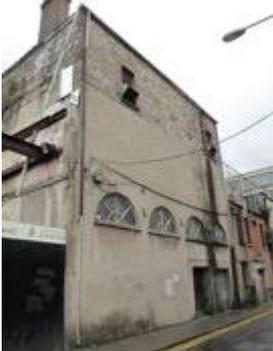
Identification No.	NIAH 50010560	
Legal Status	n/a	
Location	Catholic Commercial Club, Moore Lane	
Date of Construction	c.1897	
Original Use	Public house	
Description	Detached regular plan double-height building, built 1897, as part of Catholic Commercial Club on 42 O'Connell Street. Not currently in use. Hipped slate roof with glazed roof light and red brick chimneystacks to north elevation. Replacement rainwater goods. Coursed rubble masonry walls having red brick block-and-start quoins, rendered lower part of front (west) elevation and north elevation, yellow brick wall laid in English garden wall bond to rear (east) elevation. Gauged brick square-headed window openings to upper wall to front with red brick block-and-start surrounds, masonry sills and timber louvered vents. Semi-circular window openings to front and rear elevations, formed in gauged brick to rear, having masonry sills and timber spoked fanlights. Square-headed door openings to front with steel doors.

Significance Rating	Regional (NIAH)	
Categories of Special Interest	Architectural, Social	
Sensitivity	Medium	
Photographs

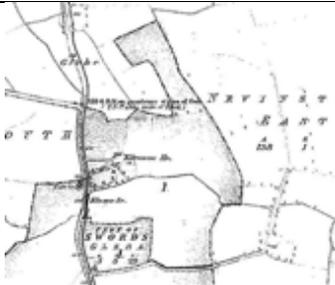
Identification No.	CBC0002BTH003
Additional Identifiers	n/a
Legal Status	Not protected or included in any existing inventories
Location	Kilronan House
Date of Construction	c.1820
Description	House built c.1820 with outbuildings, lodge, and drive.
Change and movement within the site	The main house is demolished but some outbuildings appear to survive with historic boundary treatments and planting.
Surviving Features within the study area	Main features unrecognizable – peripheral features visible
Significance Rating	Local
Categories of Special Interest	Historical
Sensitivity	Low
Historic Maps

<p>Extract from Griffith's Valuation Map, 1848. highlighting the former designed landscape associated with Kilronan House</p>

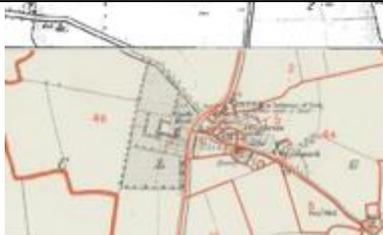
Identification No.	FCC RPS 611
Additional Identifiers	n/a
Legal Status	A protected structure
Location	Castlemoate House, Swords Road
Date of Construction	early 19 th century
Description	Five-bay two-storey early 19 th century house, outbuilding, walled garden, and entrance gates
Surviving Features within the study area	Main features substantially present – some loss of integrity
Significance Rating	Regional
Categories of Special Interest	Historic
Sensitivity	Medium
Historic Maps

<p>Extract from Griffith's Valuation Map, 1848. highlighting the former designed landscape associated with Castlemoate House</p>

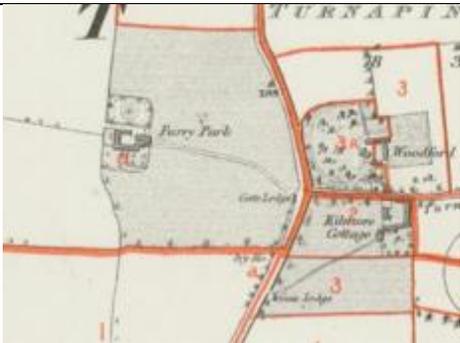
Identification No.	NIAH 2395 (Garden Survey)
Additional Identifiers	n/a
Legal Status	A protected structure
Location	Furry Park
Date of Construction	c.1820
Description	House c.1820 with parkland, drive, lodge, and walled gardens
Change and movement within the site	Buildings corresponding to the location of the original house, parkland covered by industrial development and playing pitches
Surviving Features within the study area	Main features substantially present – peripheral features unrecognisable
Significance Rating	Local (NIAH)
Categories of Special Interest	historic
Sensitivity	Low
Historic Maps

<p>Extract from Griffith's Valuation Map, 1848. highlighting the former designed landscape associated with Furry Park</p>

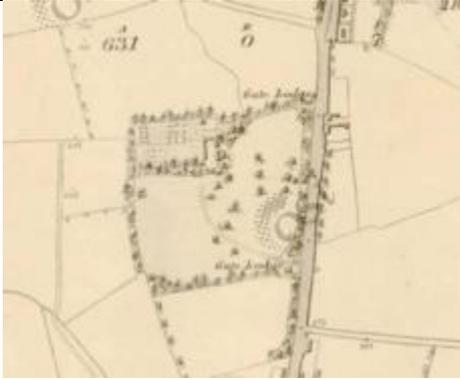
<p>Extract from OS map of 1843.</p>

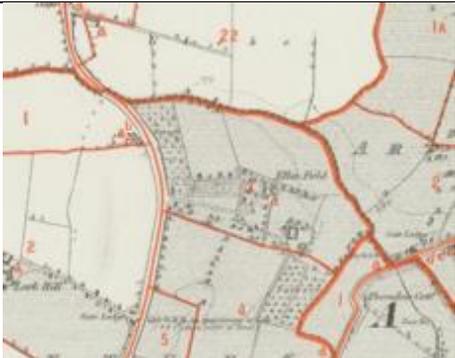
Identification No.	CBC0002BTH019
Additional Identifiers	n/a
Location	Ellen Field Park
Date of Construction	c.1860
Description	House, with formal gardens, parkland, nursery, drive, and lodge now covered by playing fields and parkland. Ellen Field and lodge now demolished.
Surviving Features within the study area	Main features unrecognizable – peripheral features visible
Significance Rating	Local
Categories of Special Interest	Historic,
Sensitivity	Low
Historic Maps

<p>Extract from Griffith's Valuation Map, 1848. highlighting the former designed landscape associated with Ellen Field Park</p>

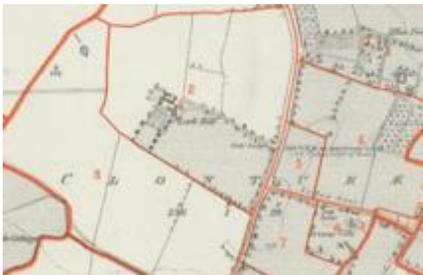
Identification No.	NIAH 2390 (Garden Survey)
Additional Identifiers	n/a
Legal Status	A protected structure
Location	Maryville, Lark Hill
Date of Construction	c. 1830
Description	House (site of) with associated parkland and gate lodge now demolished and covered by residential developments
Surviving Features within the study area	Virtually no recognizable features
Significance Rating	Record-only
Categories of Special Interest	Historic, architectural artistic
Sensitivity	Negligible
Historic Maps

<p>Extract from Griffith's Valuation Map, 1848. highlighting the former designed landscape associated with Maryville/Lark Hill</p>

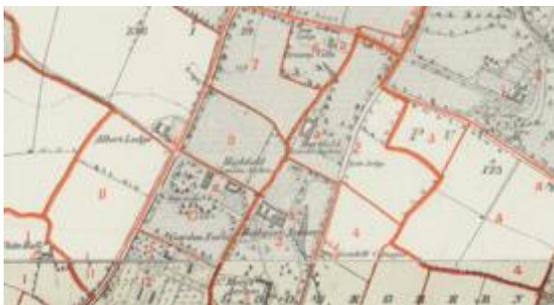
Identification No.	NIAH 2392 and 2394 (Garden Survey)
Additional Identifiers	n/a
Legal Status	A protected structure
Location	St Mary's Asylum / Highfield, Highpark and Hartfield
Date of Construction	Early 19th century
Description	Institutional buildings with formally laid out gardens and parklands. Some historic parkland and institutional buildings survive. The convent and chapel on Grace Park Road are protected (DCC RPS 3238).
Features associated with the designed landscape in the study area	House (Highfield Hospital) with associated gardens including gate lodge, walls, gates, and piers - Granite capped, rendered side walls with piers and gates (replacement) set into rubble walling with single storey gate lodge behind
Surviving Features within the study area	Main features substantially present – some loss of integrity
Significance Rating	Regional
Categories of Special Interest	Historic, architectural artistic social

<p>Extract from Griffith's Valuation Map, 1848. highlighting the former designed landscape associated with St Mary's Asylum / Highfield, Highpark and Hartfield</p>

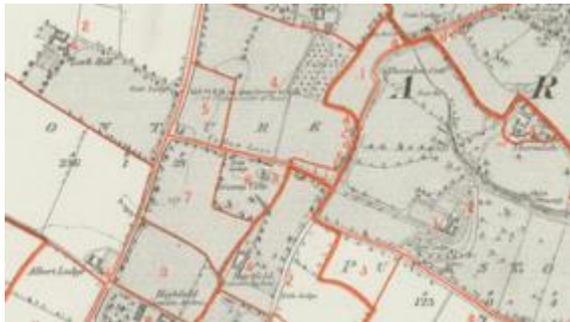
Identification No.	CBC0002BTH027
Additional Identifiers	n/a
Legal Status	A protected structure
Location	Broomhill
Date of Construction	c.1890
Description	House (hotel) with lodge, drive and formally laid out gardens now developed as a hotel complex with residential developments to the south and east. Main features substantially present – peripheral features unrecognizable
Surviving Features within the study area	House (hotel): six-bay two-storey house built c.1890 with plaster detailing, extended above and to the rear, now in use as a hotel.
Significance Rating	Local (designed landscape), Regional (original house)
Categories of Special Interest	Historic, architectural artistic Social
Sensitivity	Low
Historic Maps

<p>Extract from Griffith's Valuation Map, 1848. highlighting the former designed landscape associated with Broomhill.</p>

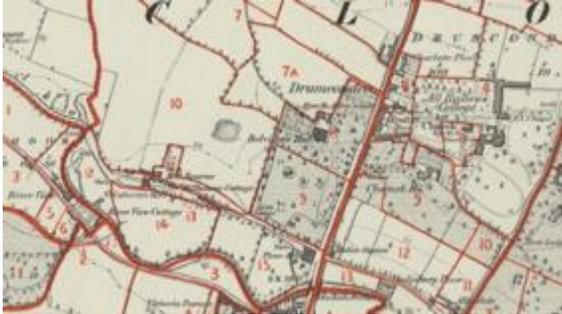
Identification No.	DU018-012001
Additional Identifiers	DCC 2369
Legal Status	A recorder monument, a protected structure
Location	Belvedere House, 7 to 19 Drumcondra Rd Upper
Date of Construction	c. 1750
Description	St Patrick's College: original house, tower, fountain, quadrangle and former church, stone boundary walls, main entrance, and gate lodge
Surviving Features within the study area	Main features substantially present – some loss of integrity
Significance Rating	Regional
Categories of Special Interest	Historic, architectural artistic social,
Sensitivity	Medium
Historic Maps

<p>Extract from Griffith's Valuation Map, 1848. highlighting the former designed landscape associated with Belvedere House</p>

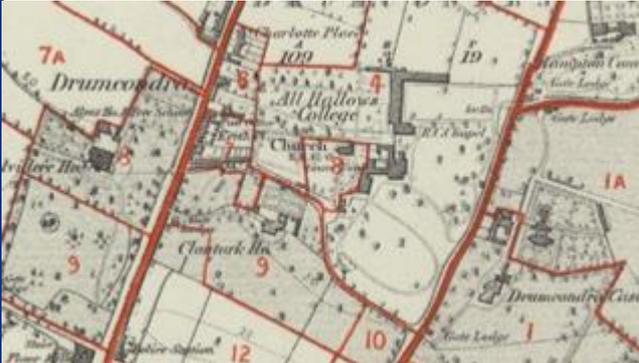
Identification No.	DCC RPS 6084
Additional Identifiers	n/a
Legal Status	A protected structure
Location	Rosminian House for the Blind, Clonturk House, Ormond Rd, Dublin 9
Date of Construction	built 1830
Description	House with associated formal gardens and park landscape. The original lodge and drive are built over with residential developments
Surviving Features within the study area	Main features substantially present – peripheral features unrecognisable
Significance Rating	Regional
Categories of Special Interest	Historic, architectural artistic
Sensitivity	Medium
Historic Maps

<p>Extract from Griffith's Valuation Map, 1848. highlighting the former designed landscape associated with Clonturk House.</p>

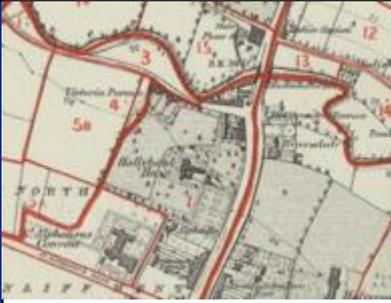
Identification No.	CBC0002BTH061
Additional Identifiers	n/a
Legal Status	Not protected
Location	Hollybank House, Hollybank Road, Dublin 9
Date of Construction	c. 1830
Description	House c. 1830 (site of) with associated parkland now demolished and covered by residential developments Virtually no recognizable features
Significance Rating	Record-only
Categories of Special Interest	Historic
Sensitivity	Negligible
Historic Maps

<p>Extract from Griffith's Valuation Map, 1848. highlighting the former designed landscape associated with Hollybank House</p>

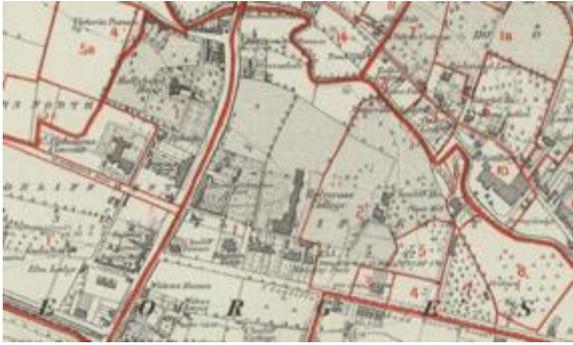
Identification No.	DCC RPS 2361
Additional Identifiers	n/a
Legal Status	A protected structure
Location	81 Drumcondra Rd Lower
Date of Construction	1890
Description	Holy Cross College, Archbishop's House and associated gardens including stone boundary walls, gates, piers, railings, plinths, lodge, and walled garden. Main features substantially present – some loss of integrity
Significance Rating	Regional
Categories of Special Interest	Historic, architectural artistic
Sensitivity	Medium
Historic Maps

<p>Extract from Griffith's Valuation Map. highlighting the former designed landscape associated with Drumcondra Terrace East</p>

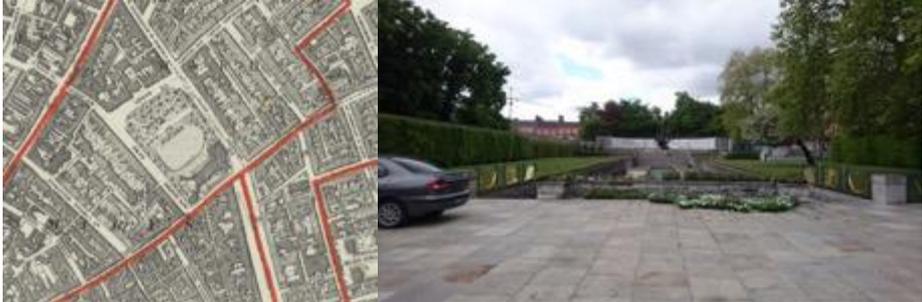
Identification No.	DCC RPS 6437
Additional Identifiers	NIAH 2370 (Garden Survey)
Legal Status	A protected structure
Location	Parnell Square
Date of Construction	1750
Description	Rutland Square Dublin Developed to fund the construction of the maternity hospital, the formal gardens were laid out in 1750 and were the centre of Dublin's first Georgian Square. The gardens have been built on in recent times with the expansion of the Rotunda, and the establishment of the Garden of Remembrance c.1966. Main features substantially present – some loss of integrity
Significance Rating	National
Categories of Special Interest	Architectural, artistic, historic, social
Sensitivity	High
Historic Maps

<p>Extract from Griffith's Valuation Map, 1848. highlighting the former designed landscape associated with Parnell Square.</p>

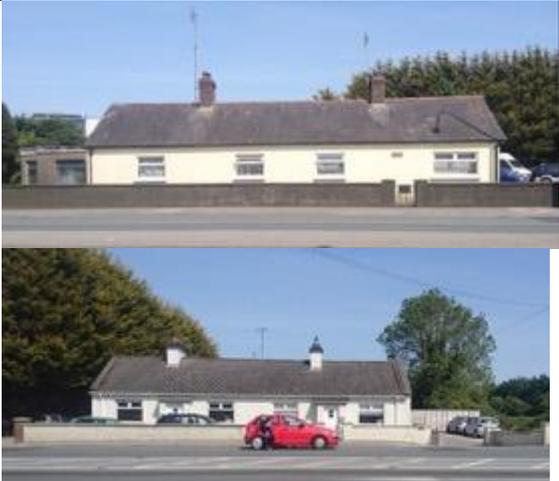
Identification No.	CBC0002BTH002
Legal Status	n/a
Location	Cottages, Swords Road, Nevinstown, Co. Fingal
Date of Construction	c.1920
Original Use	Houses
Description	Houses, two semi-detached four-bay cottages behind rendered garden walls built c.1920
Significance Rating	Local
Categories of Special Interest	Architectural
Sensitivity	Low

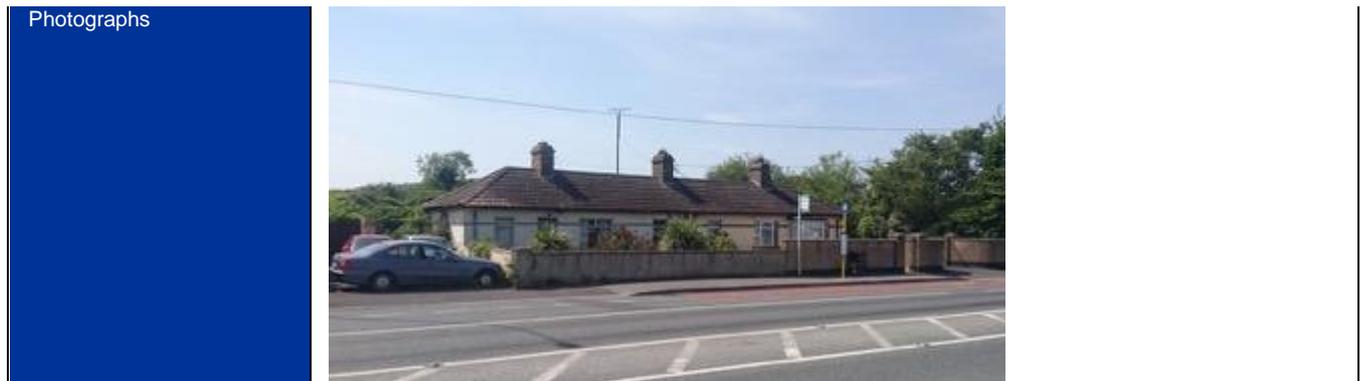
Identification No.	CBC0002BTH004
Legal Status	n/a
Location	Kettles Lane, Glebe
Date of Construction	c.1820
Original Use	House
Description	House (offices): three bay cottage with projecting porch built c.1820, much altered
Significance Rating	Local
Categories of Special Interest	Architectural
Sensitivity	Low

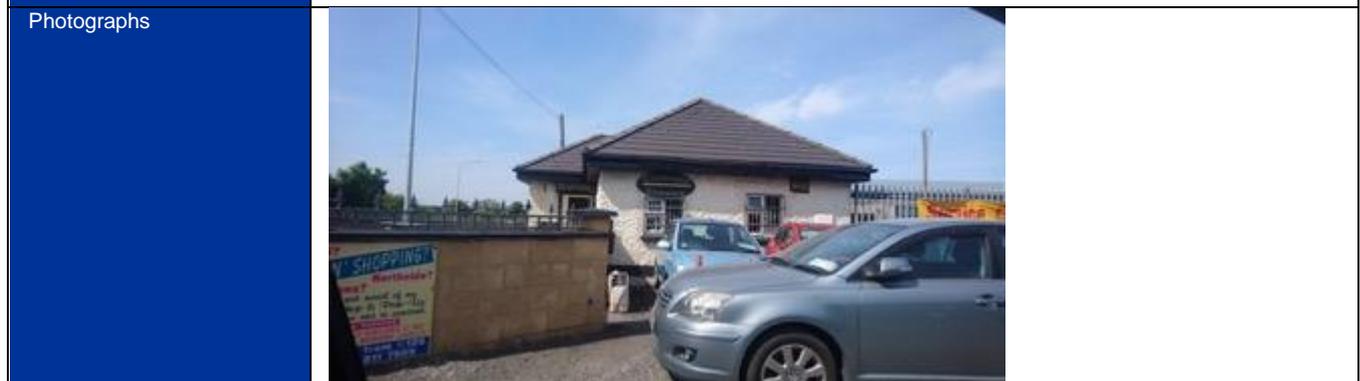
Identification No.	CBC0002BTH005
Legal Status	n/a
Location	Flexlease Ltd. Cloughran
Date of Construction	c.1890
Original Use	School
Description	Schoolhouse (offices), built c.1890 much altered
Significance Rating	Local
Categories of Special Interest	Architectural Social
Sensitivity	Low

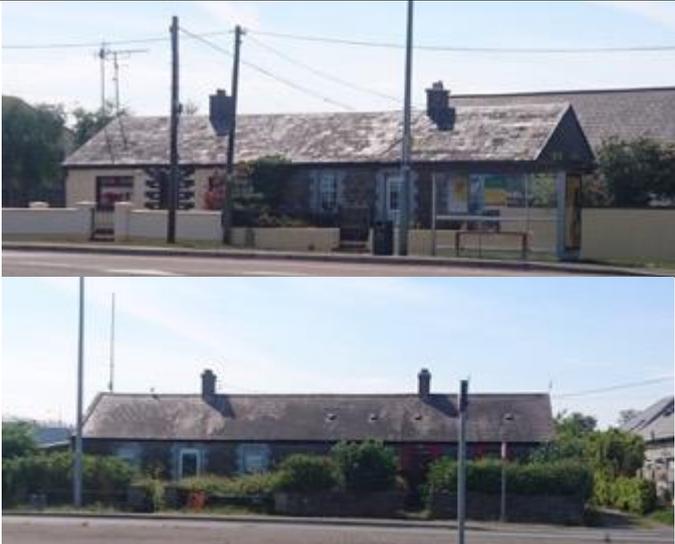
Identification No.	CBC0002BTH008
Legal Status	n/a
Location	Toberbunny Lodge
Date of Construction	c.1920
Original Use	House
Description	House (vacant): Lodge built c.1920, in derelict condition
Significance Rating	Local
Categories of Special Interest	Architectural
Sensitivity	Low
Photographs

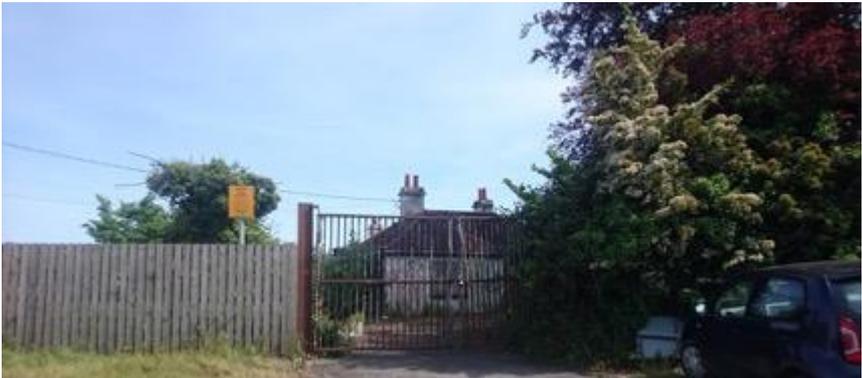
Identification No.	CBC0002BTH009
Legal Status	n/a
Location	Cottages, Dardistown
Date of Construction	c.1900
Original Use	House
Description	Pair of semi-detached three bay cottages built c.1900, in derelict condition behind rendered garden walls
Significance Rating	Local
Categories of Special Interest	Architectural
Sensitivity	Low
Photographs

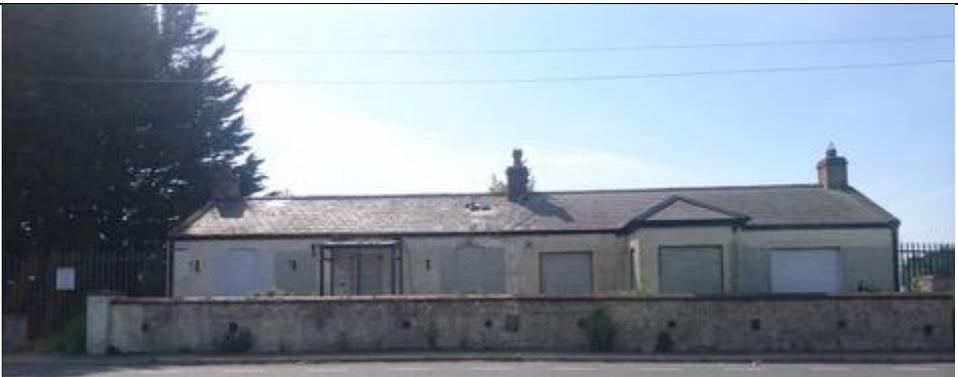
Identification No.	CBC0002BTH012
Legal Status	n/a
Location	Ivy House, Santry
Date of Construction	c.1820
Original Use	House
Description	Detached three bay cottage, rendered with brick trims and stacks c.1820 (possibly re-built c.1920)
Significance Rating	Local
Categories of Special Interest	Architectural
Sensitivity	Low
Photographs

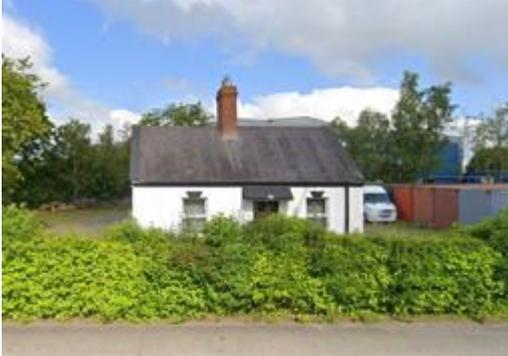
Identification No.	CBC0002BTH013
Legal Status	n/a
Location	Cottage, Swords Road, Santry
Date of Construction	c.1920
Original Use	House
Description	Detached three bay cottage built, rendered with brick trims and stacks c.1920
Significance Rating	Local
Categories of Special Interest	Architectural
Sensitivity	Low
Photographs

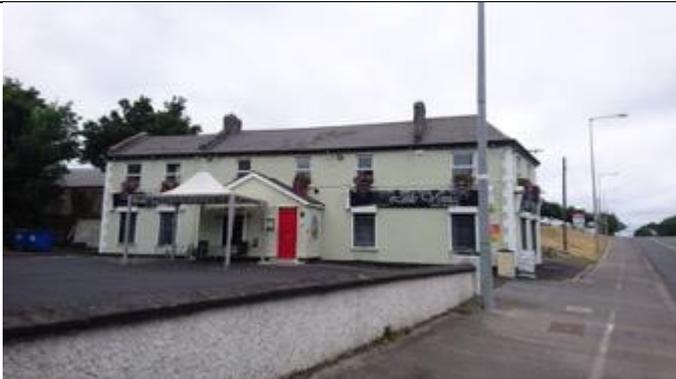
Identification No.	CBC0002BTH014
Legal Status	n/a
Location	Little Venice, Swords Road, Santry
Date of Construction	c.1800
Original Use	House
Description	Barracks (restaurant): two storey six-bay former police station constructed c. 1800 - much altered
Significance Rating	Regional
Categories of Special Interest	Architectural
Sensitivity	Medium
Photographs
