Appendix A16.1-A16.3
Architectural Heritage
Appendices

16. Appendix 16.1 Historical Background

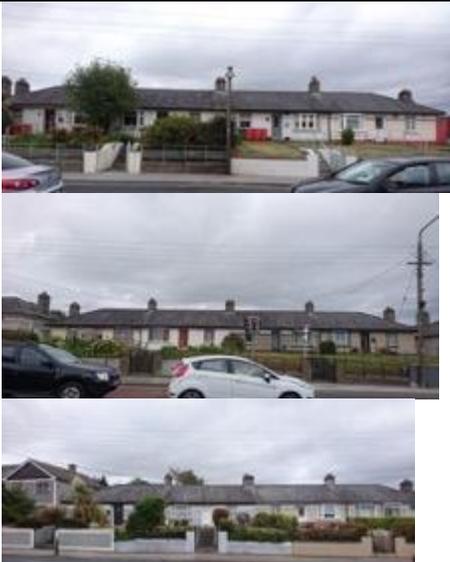
Identification No.	CBC0002BTH018
Legal Status	n/a
Location	St Canice's Terrace, Whitehall, Dublin 9
Date of Construction	c.1920
Original Use	Houses
Description	Three terraces of four three-bay cottages built c.1920 with associated steps, walls, gates, and railings
Significance Rating	Local
Categories of Special Interest	Architectural Social
Sensitivity	Low
Photographs

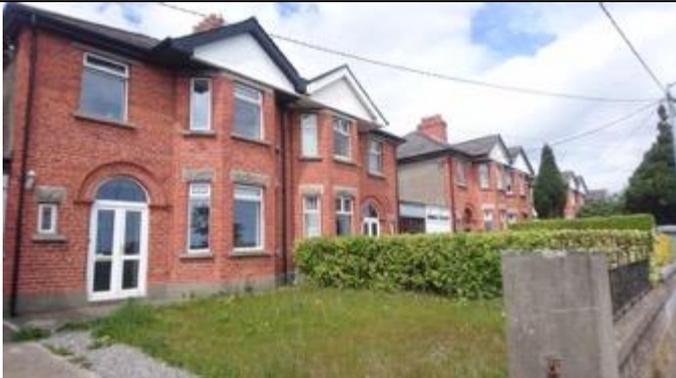
Identification No.	CBC0002BTH023
Legal Status	n/a
Location	77 to 81 Swords Road
Date of Construction	c.1920
Original Use	Houses
Description	Two-storey two-bay semi-detached houses constructed c.1920, with mature gardens site walls, piers and railings
Significance Rating	Local
Categories of Special Interest	Architectural
Sensitivity	Low
Photographs

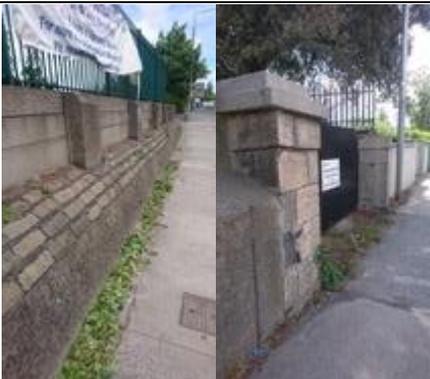
Identification No.	CBC0002BTH024
Legal Status	n/a
Location	Entrance, former gate lodge High park / Hartfield, Swords Road
Date of Construction	
Original Use	Gate
Description	Cut limestone piers mark the site of the former gate lodge – hoarded up as the lands behind are under construction.
Significance Rating	Local
Categories of Special Interest	Architectural Historical
Sensitivity	Low
Photographs

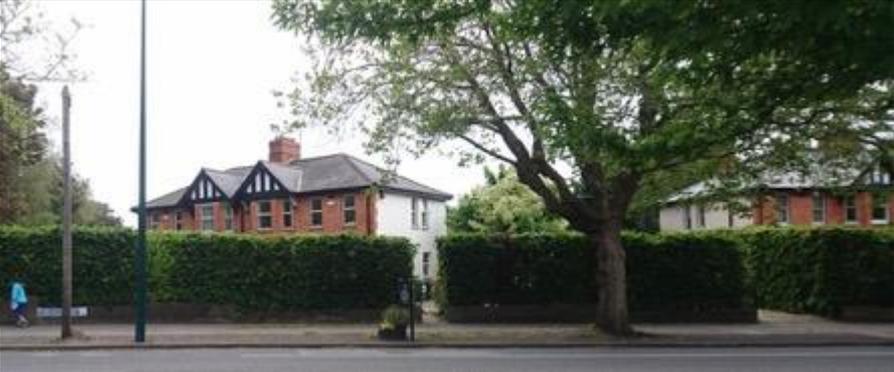
Identification No.	CBC0002BTH029
Legal Status	n/a
Location	53, 55, 57, 59, 61, 63, 65 and 67 Drumcondra Road Upper, Dublin 9
Date of Construction	c.1890
Original Use	Houses
Description	Terrace of eight two-storey late-Victorian houses built c.1890 with canted bay behind mature gardens with steps, railings and gates.
Significance Rating	Local
Categories of Special Interest	Architectural Artistic
Sensitivity	Low
Photographs

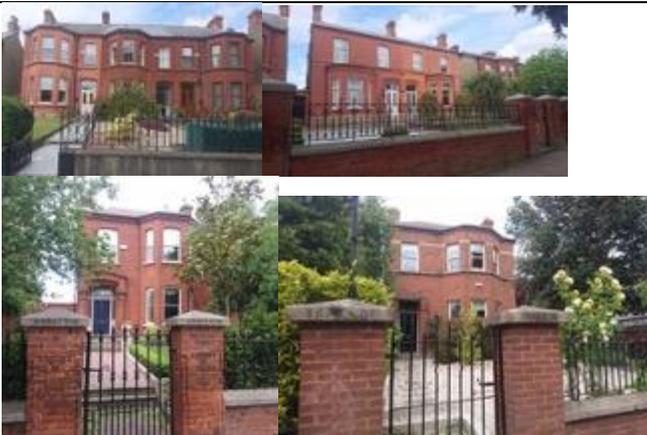
Identification No.	CBC0002BTH033
Legal Status	n/a
Location	31 / 31A Drumcondra Road Upper, Dublin 9
Date of Construction	c.1870
Original Use	Houses
Description	Pair of two-storey two-bay houses built c.1870 with associated walls, gates and railings
Significance Rating	Local
Categories of Special Interest	Architectural
Sensitivity	Low
Photographs

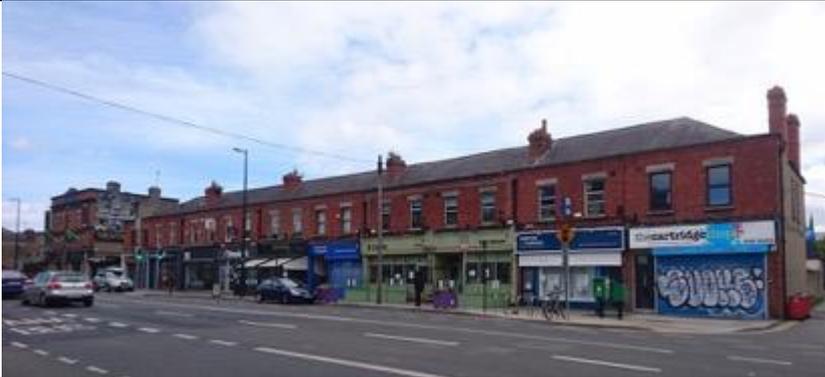
Identification No.	CBC0002BTH035
Legal Status	n/a
Location	94 and 92 Drumcondra Road Upper, Dublin 9
Date of Construction	c.1890
Original Use	Houses
Description	Pair of two-bay two-storey shops built .1890
Significance Rating	Local
Categories of Special Interest	Architectural
Sensitivity	Low
Photographs

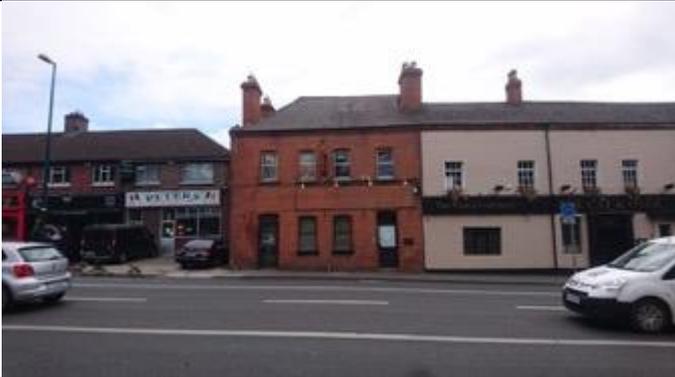
Identification No.	CBC0002BTH037
Legal Status	n/a
Location	The Cat and Cage, 74, 76, 78 Drumcondra Road Upper, Dublin 9
Date of Construction	c.1830
Original Use	Houses
Description	Public house: two-storey six-bay corner building with ground floor shop front constructed c.1830 - heavily altered
Significance Rating	Local
Categories of Special Interest	Architectural
Sensitivity	Low
Photographs

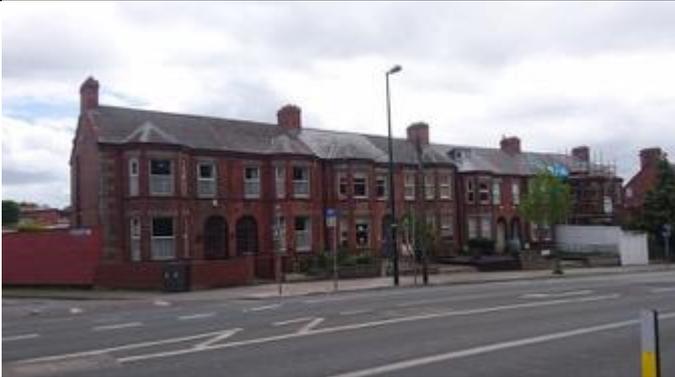
Identification No.	CBC0002BTH041
Legal Status	n/a
Location	56, 54, 52, 50, 48, 46, 44, 42, 40, 38 Drumcondra Rd Upper
Date of Construction	c.1890
Original Use	Houses
Description	Terrace of 10no two-bay two-storey with attic houses constructed c.1890 with associated walls, railings and gates
Significance Rating	Local
Categories of Special Interest	Architectural
Sensitivity	Low
Photographs

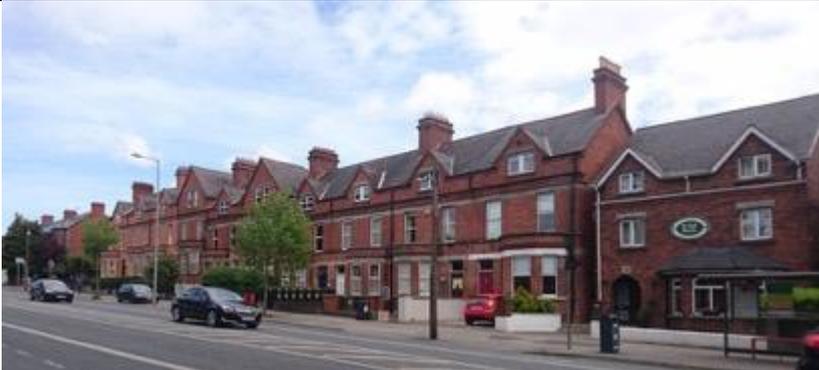
Identification No.	CBC0002BTH042
Legal Status	n/a
Location	18, 16, 14, 12, 10, 8, 6 Drumcondra Road Upper, Dublin 9
Date of Construction	c.1920
Original Use	Houses
Description	7no. two-bay two-storey buildings with retail at the ground floor
Significance Rating	Local
Categories of Special Interest	Architectural
Sensitivity	Low
Photographs

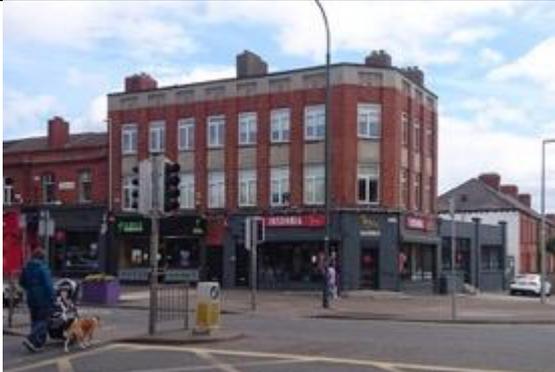
Identification No.	CBC0002BTH043
Legal Status	n/a
Location	2 to 4 Drumcondra Road Upper, Dublin 9
Date of Construction	c.1910
Original Use	Commercial
Description	eight-bay three-storey corner commercial building constructed c.1910
Significance Rating	Local
Categories of Special Interest	Architectural
Sensitivity	Low
Photographs

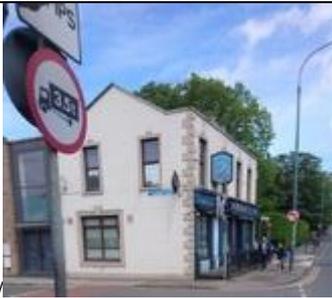
Identification No.	CBC0002BTH045
Legal Status	n/a
Location	Millmount House, 18 Drumcondra Road Upper, Dublin 9
Date of Construction	c.1890
Original Use	House
Description	Three by two storey detached public house, built c.1890 on the site of a flour mill, with associated railings – much altered.
Significance Rating	Local
Categories of Special Interest	Architectural
Sensitivity	Low
Photographs

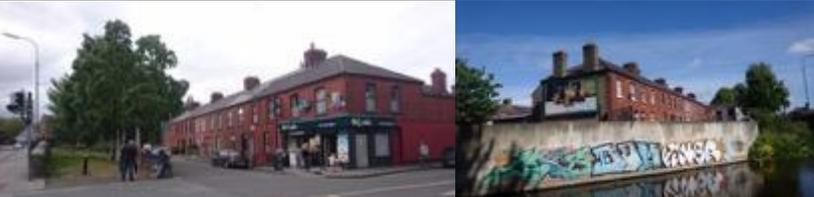
Identification No.	CBC0002BTH047
Legal Status	n/a
Location	Millmount Terrace, Drumcondra, Dublin 9
Date of Construction	c.1890
Original Use	Houses
Description	Terrace of 9 two-storey two-bay red-brick houses
Significance Rating	Local
Categories of Special Interest	Architectural
Sensitivity	Low
Photographs

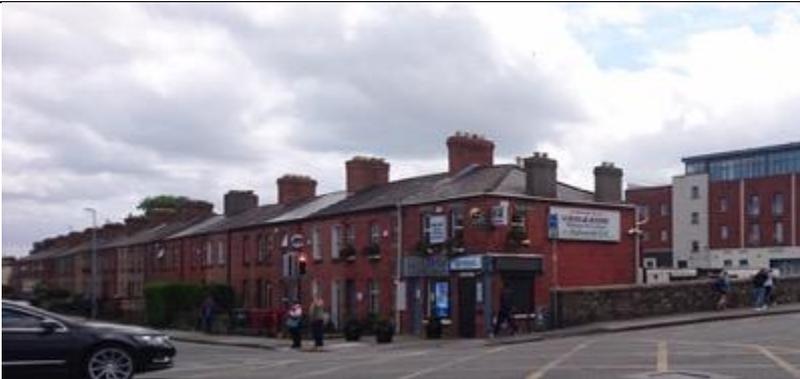
Identification No.	CBC0002BTH048
Legal Status	n/a
Location	4, 6, 8, 10, 12, 14, 16, 18, 20, 22 Richmond Road, Dublin 3
Date of Construction	c.1920
Original Use	Houses
Description	Terrace of two bay two storey red brick houses built c.1890 (No 4 at the corner of Drumcondra Rd was an infill built c. 1920
Significance Rating	Local
Categories of Special Interest	Architectural
Sensitivity	Low
Photographs

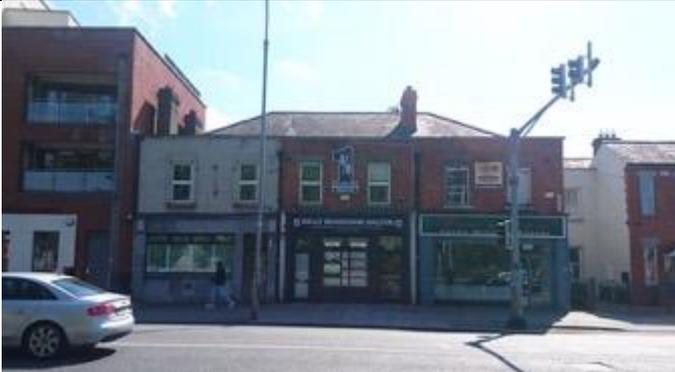
Identification No.	CBC0002BTH050
Legal Status	n/a
Location	163, 165, 167 Drumcondra Road Lower, Dublin 9
Date of Construction	c.1920
Original Use	
Description	Two-bay two-storey terraced shops built c. 1920
Significance Rating	Regional
Categories of Special Interest	
Sensitivity	Medium
Photographs

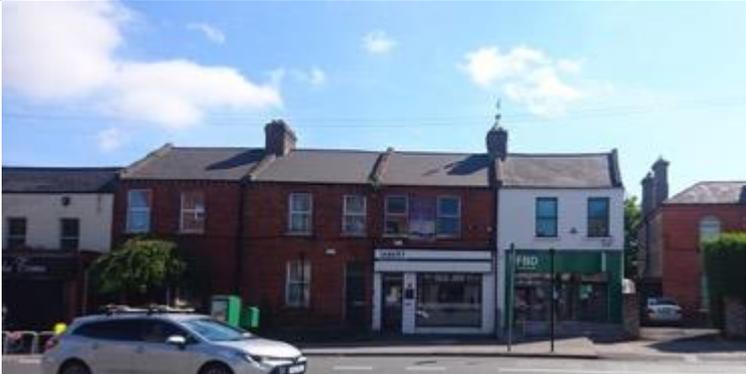
Identification No.	CBC0002BTH053
Legal Status	n/a
Location	141, 143, 145, 147 Drumcondra Road Lower, Dublin 9
Date of Construction	c.1890
Original Use	Houses
Description	Terrace of two story two bay houses built c.1890 with associated gates and railings (141 and 143 only)
Significance Rating	Regional
Categories of Special Interest	Architectural
Sensitivity	Medium
Photographs

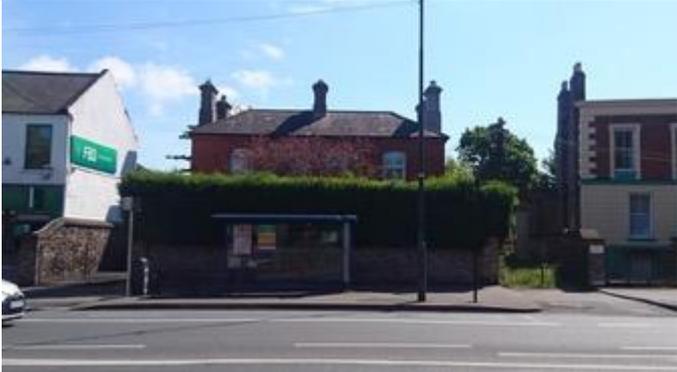
Identification No.	CBC0002BTH055
Legal Status	n/a
Location	Riversdale, 139 Drumcondra Road Lower, Dublin 9
Date of Construction	c.1820
Original Use	Houses
Description	Pair of semi-detached two-storey two-bay brick built houses, built c.1820 – modern front boundary walls
Significance Rating	Regional
Categories of Special Interest	Architectural
Sensitivity	Medium
Photographs

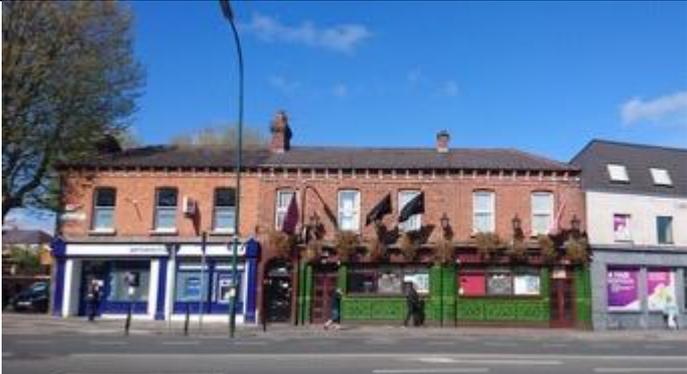
Identification No.	CBC0002BTH056
Legal Status	n/a
Location	130, 132, 134 Drumcondra Road Lower, Dublin 9
Date of Construction	c.1900
Original Use	Houses
Description	Terrace of three 2-storey 2/3-bay shops built c.1900
Significance Rating	Local
Categories of Special Interest	Architectural Artistic
Sensitivity	Low
Photographs

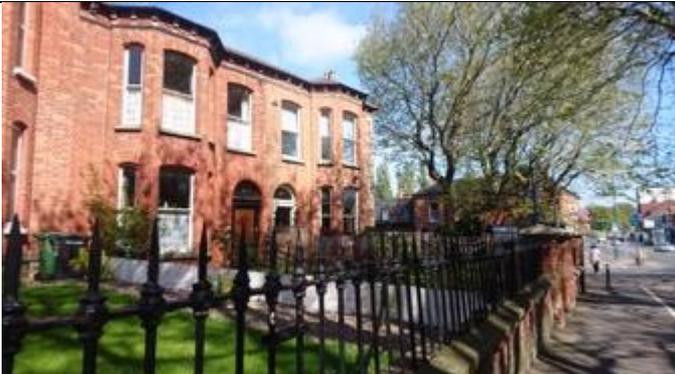
Identification No.	CBC0002BTH061
Legal Status	n/a
Location	128, 126, 124, 122, 120, 118 Drumcondra Road Lower, Dublin 9
Date of Construction	c.1890
Original Use	Houses
Description	Terrace of six two-storey two-bay houses with two-storey canted bays built c.1890 with associated brick walls, piers, railings, gates and steps
Significance Rating	Regional
Categories of Special Interest	Architectural Artistic
Sensitivity	Medium
Photographs

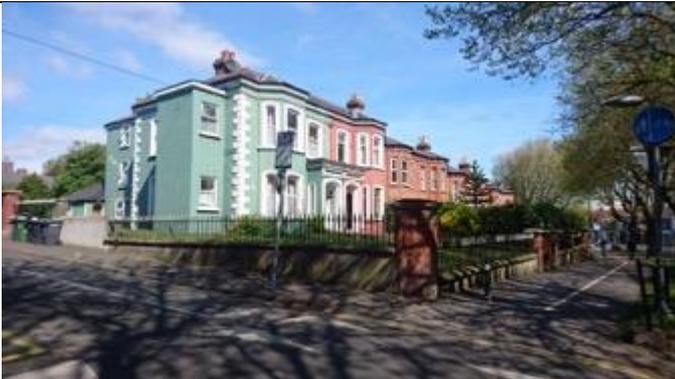
Identification No.	CBC0002BTH063
Legal Status	n/a
Location	116, 114 Drumcondra Road Lower, Dublin 9
Date of Construction	c.1890
Original Use	Houses
Description	Pair of attached two-storey two-bay houses with two-storey canted bays built c.1890, decorative plaster detailing, with associated walls, piers, railings, gates and steps
Significance Rating	Regional
Categories of Special Interest	Architectural Artistic
Sensitivity	Medium
Photographs

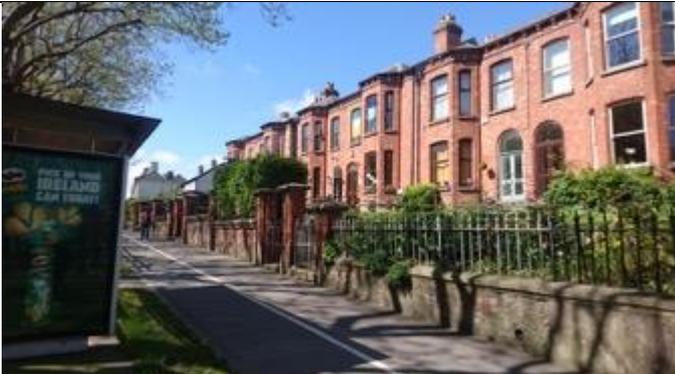
Identification No.	CBC0002BTH064
Legal Status	n/a
Location	110, 108, 106, 104, 102 Drumcondra Road Lower, Dublin 9
Date of Construction	c.1890
Original Use	Houses
Description	Terrace of five two-storey two-bay houses with two-storey canted bays built c.1890 with associated brick walls, piers, railings, gates and steps
Significance Rating	Regional
Categories of Special Interest	Architectural Artistic
Sensitivity	Medium
Photographs

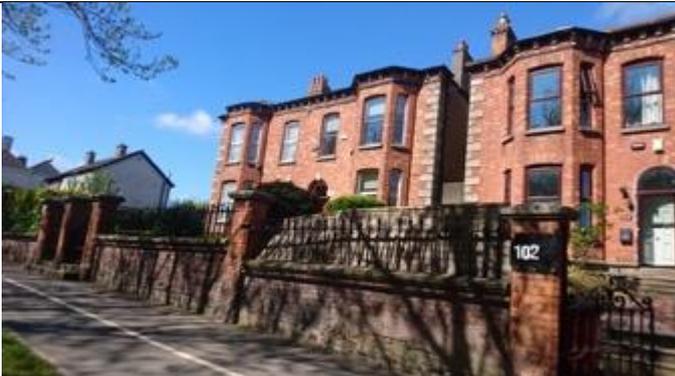
Identification No.	CBC0002BTH065
Legal Status	n/a
Location	98, 100 Drumcondra Road Lower, Dublin 9
Date of Construction	c.1890
Original Use	Houses
Description	Pair of semi-detached two-storey two-bay houses with two-storey canted bays built c.1890, decorative plaster detailing, with associated walls, piers, railings, gates and steps
Significance Rating	Regional
Categories of Special Interest	Architectural Artistic
Sensitivity	Medium
Photographs

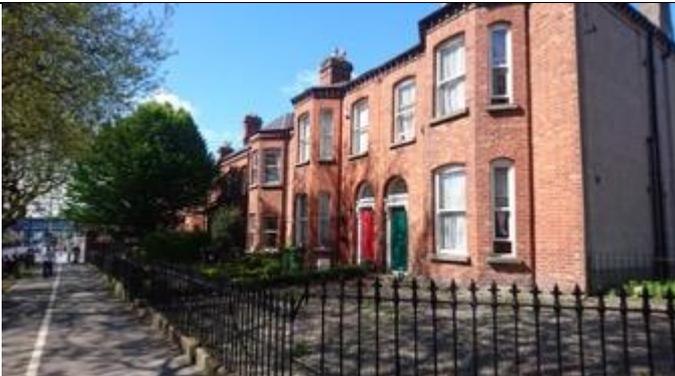
Identification No.	CBC0002BTH070
Legal Status	n/a
Location	64, 62, 60, 58, 56, Drumcondra Road Lower, Dublin 9
Date of Construction	c.1890
Original Use	House
Description	Terrace of five two-storey two-bay houses with two-storey canted bays built c.1890 with associated gates and railings
Significance Rating	Regional
Categories of Special Interest	Architectural
Sensitivity	Medium
Photographs

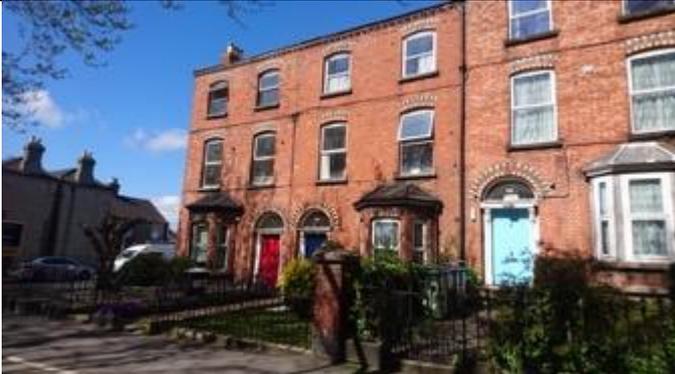
Identification No.	CBC0002BTH071
Legal Status	n/a
Location	54, 52 Drumcondra Road Lower, Dublin 9
Date of Construction	c.1890
Original Use	House
Description	Pair of two bay two-storey houses with canted single storey bays built c.1890
Significance Rating	Regional
Categories of Special Interest	Architectural
Sensitivity	Medium
Photographs

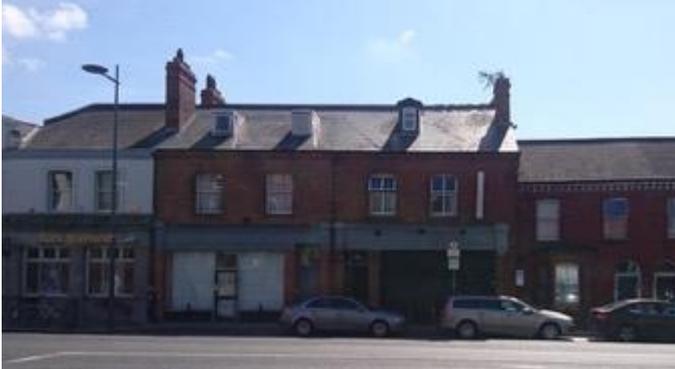
Identification No.	CBC0002BTH076
Legal Status	n/a
Location	39, 41 Drumcondra Road Lower, Dublin 9
Date of Construction	c.1890
Original Use	Houses
Description	Pair of terraced two-storey two-bay shops built c.1890
Significance Rating	Local
Categories of Special Interest	Architectural
Sensitivity	Low
Photographs

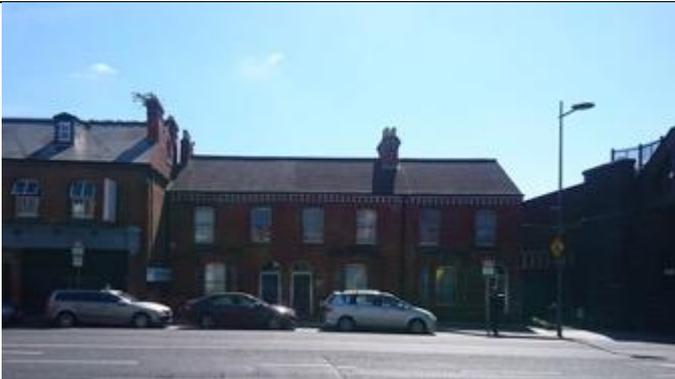
Identification No.	CBC0002BTH077
Legal Status	n/a
Location	37, 35, 33 Drumcondra Road Lower, Dublin 9
Date of Construction	c.1920
Original Use	Houses
Description	Three terraced two-bay two-storey houses with canted bay to the ground floor, with associated gates and railings
Significance Rating	Local
Categories of Special Interest	Architectural
Sensitivity	Low
Photographs

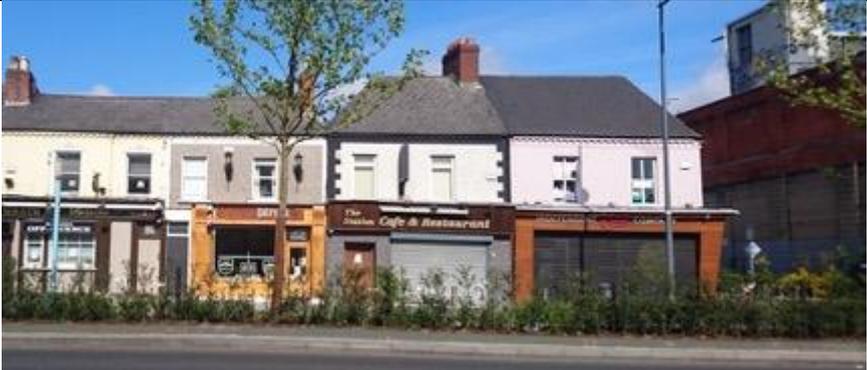
Identification No.	CBC0002BTH079
Legal Status	n/a
Location	28, 26, 24 Drumcondra Road Lower, Dublin 9
Date of Construction	c.1890
Original Use	Houses
Description	Terrace of two-storey two-bay shops built c.1890
Significance Rating	Local
Categories of Special Interest	Architectural
Sensitivity	Low
Photographs

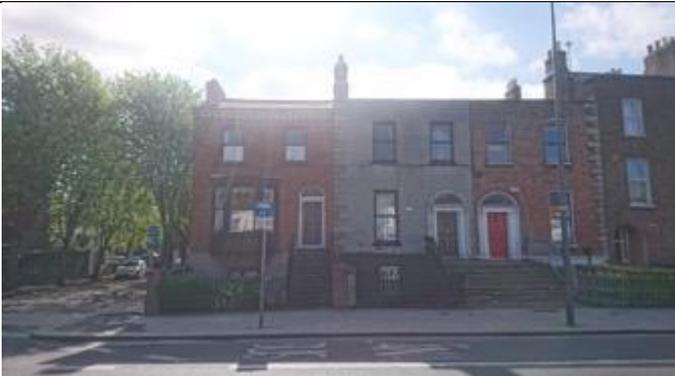
Identification No.	CBC0002BTH080
Legal Status	n/a
Location	21, 23 Drumcondra Road Lower, Dublin 9
Date of Construction	c.1840
Original Use	Houses
Description	Pair of two-bay two-storey-over-raised-basement terraced houses with associated steps, gates and railings built c.1840
Significance Rating	Regional
Categories of Special Interest	Architectural
Sensitivity	Medium
Photographs

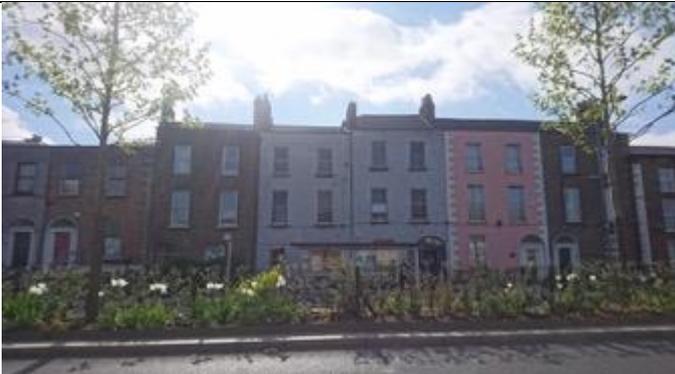
Identification No.	CBC0002BTH081
Legal Status	n/a
Location	11,13,15,17, 19 Drumcondra Road Lower, Dublin 9
Date of Construction	c.1820
Original Use	Houses
Description	Terrace of five three-storey-over-basement two-bay houses, some now in use as offices with associated railings built c. 1820
Significance Rating	Local
Categories of Special Interest	Architectural
Sensitivity	Low
Photographs

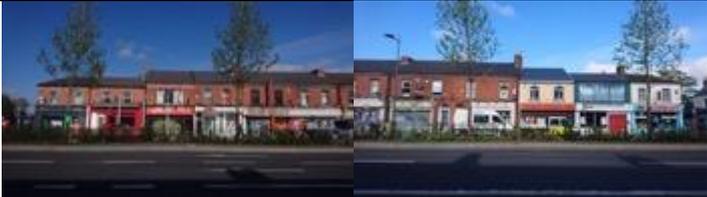
Identification No.	CBC0002BTH082
Legal Status	n/a
Location	1A, 2, 4, 6, 8, 10, 12, 14, 20 Drumcondra Road Lower, Dublin 9
Date of Construction	c.1870
Original Use	Houses
Description	Terrace of two-storey two-bay shops built c.1870
Significance Rating	Local
Categories of Special Interest	Architectural
Sensitivity	Low
Photographs

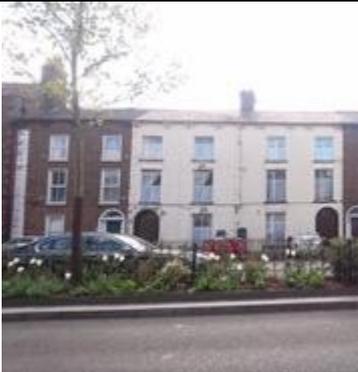
Identification No.	CBC0002BTH083
Legal Status	n/a
Location	5,7,9 Drumcondra Road Lower, Dublin 9
Date of Construction	c.1820
Original Use	House
Description	Terrace of four three-storey two-bay-houses, some now in use as offices with associated railings built c. 1820
Significance Rating	Local
Categories of Special Interest	Architectural
Sensitivity	Low
Photographs

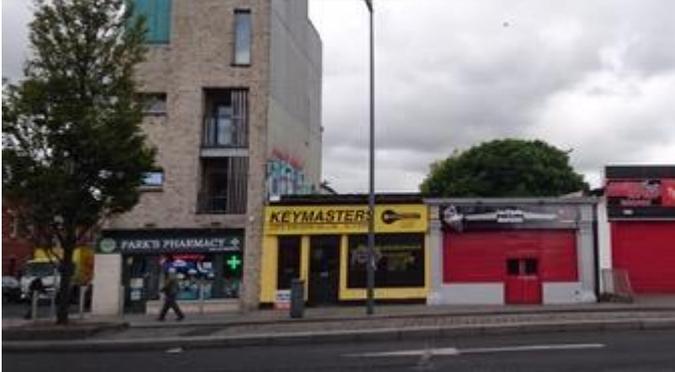
Identification No.	CBC0002BTH087
Legal Status	Not protected or included on any existing inventories
Location	60 Dorset Street Lower, Dublin 1
Date of Construction	c.1890
Original Use	Commercial
Description	Single storey retail building with decorative shopfront c.1890
Significance Rating	Local
Categories of Special Interest	Architectural
Sensitivity	Low
Photographs

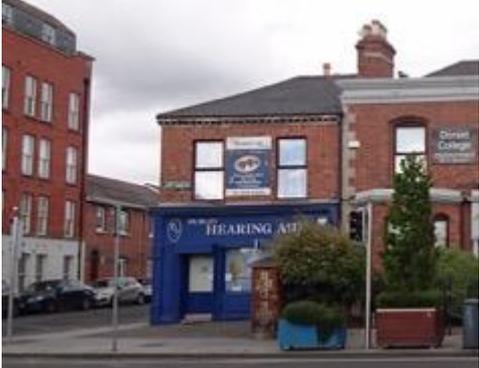
Identification No.	CBC0002BTH088
Legal Status	Not protected or included on any existing inventories
Location	67 Dorset Street Lower, Dublin 1
Date of Construction	c.1890
Original Use	House
Description	Shop: corner sited two-bay-two storey built c.1890
Significance Rating	Local
Categories of Special Interest	Architectural
Sensitivity	Low
Photographs

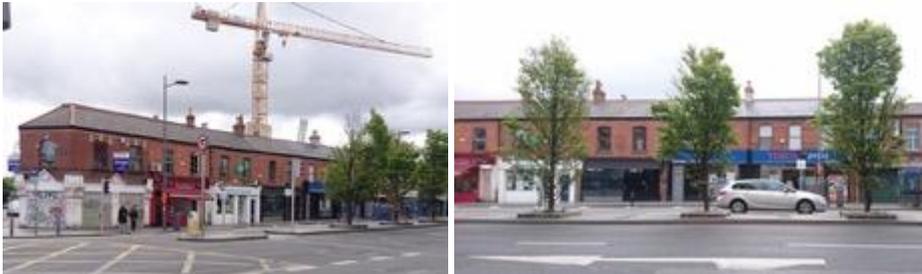
Identification No.	CBC0002BTH089
Legal Status	Not protected or included on any existing inventories
Location	44 to 52 Dorset Street Lower, Dublin 1
Date of Construction	c.1870
Original Use	Houses
Description	Terrace of two-storey two-bay shops built c.1870
Significance Rating	Local
Categories of Special Interest	Architectural, Artistic, Social
Sensitivity	Low
Photographs

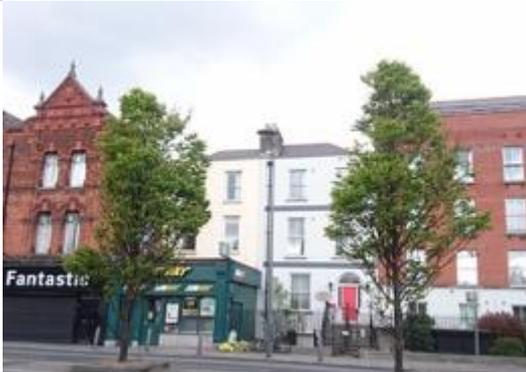
Identification No.	CBC0002BTH090
Legal Status	Not protected or included on any existing inventories
Location	77, 78 Dorset Street Lower, Dublin 1
Date of Construction	c.1890
Original Use	Houses
Description	Terraced three-storey two-bay houses built c.1820 incl. railings in front of No. 77
Significance Rating	Local
Categories of Special Interest	Architectural
Sensitivity	Low
Photographs

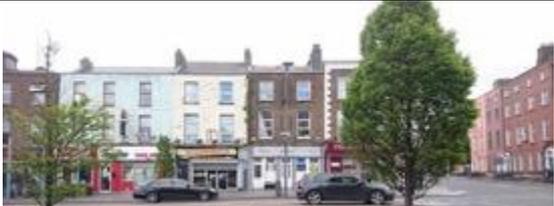
Identification No.	CBC0002BTH091
Legal Status	Not protected or included on any existing inventories
Location	28 to 33 Dorset Street Lower, Dublin 1
Date of Construction	c.1800
Original Use	Houses
Description	Terrace of six three storey two bay shops built c.1800
Significance Rating	Local
Categories of Special Interest	Architectural
Sensitivity	Low
Photographs

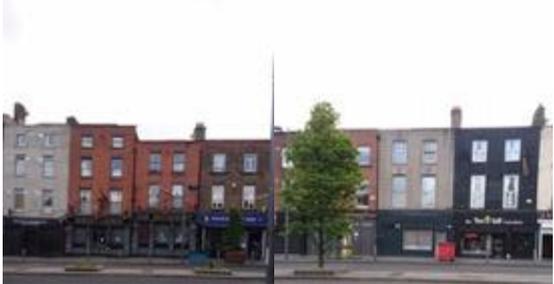
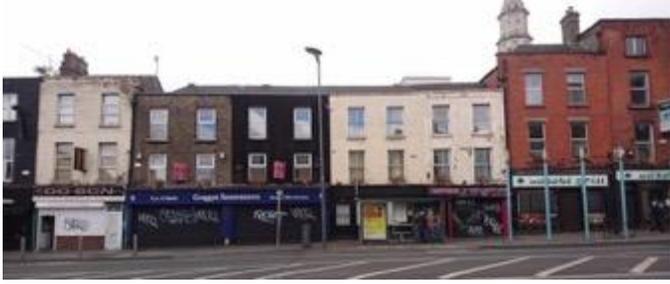
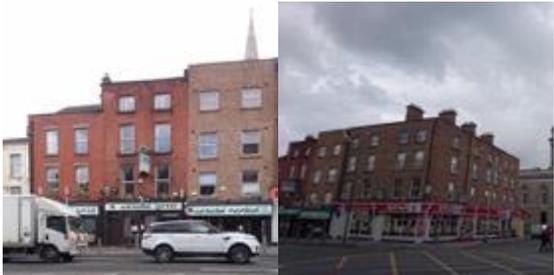
Identification No.	CBC0002BTH093
Legal Status	Not protected or included on any existing inventories
Location	6 to 20 Dorset Street Lower, Dublin 1
Date of Construction	c.1800
Original Use	Houses
Description	Terrace of three-storey two-bay shops built c.1800, much altered
Significance Rating	Local
Categories of Special Interest	Architectural
Sensitivity	Low
Photographs

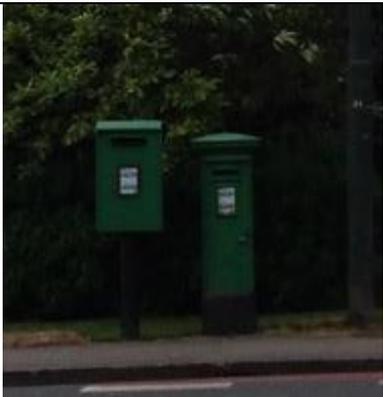
Identification No.	CBC0002PB001
Additional Identifiers	n/a
Legal Status	Not protected or included on any existing inventories
Location	Post box, At Swords Road R132(south of Santry Close),
Date of Construction	c.1930
Description	Freestanding cast-iron pillar box, manufactured c.1930, with round plan, domed top and moulded corona, raised and framed notice slot beneath moulded frame of letter slot. Integrated handle to hinged opening with 'P & T' in traditional raised lettering
Significance Rating	Regional
Categories of Special Interest	Artistic, Social, Technical
Sensitivity	Medium
Photographs

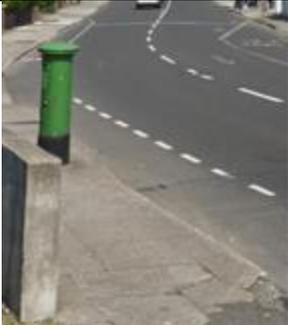
Identification No.	CBC0002PB002
Additional Identifiers	n/a
Legal Status	Not protected or included on any existing inventories
Location	post-box, At 246 Swords Road, Santry, Dublin 9
Date of Construction	c. 1930
Description	Freestanding cast-iron pillar box, manufactured c.1930, with round plan, domed top and moulded corona, raised and framed notice slot beneath moulded frame of letter slot. Integrated handle to hinged opening with 'P & T' in traditional raised lettering
Significance Rating	Regional
Categories of Special Interest	Artistic, Social, Technical
Sensitivity	Medium
Photographs

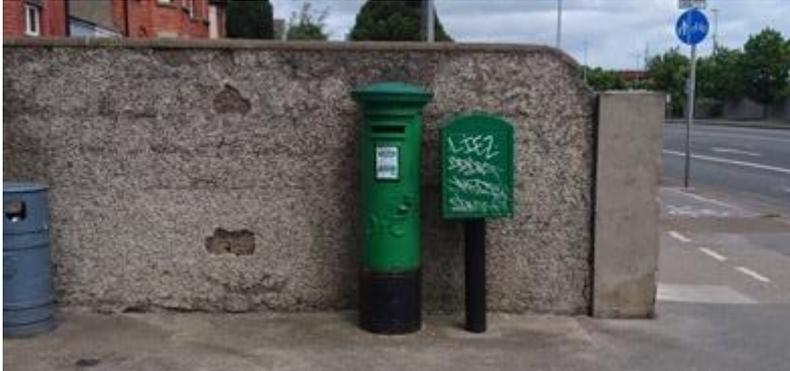
Identification No.	CBC0002PB003
Additional Identifiers	NIAH 50130139
Legal Status	Not protected but recognised by the NIAH
Location	post box, At 97 Swords Road, Whitehall, Dublin 9
Date of Construction	c. 1930
Description	Freestanding cast-iron pillar box, manufactured c.1930, with round plan, domed top and moulded corona, raised and framed notice slot beneath moulded frame of letter slot. Integrated handle to hinged opening with 'P & T' in traditional raised lettering
Significance Rating	Regional
Categories of Special Interest	Artistic, Social, Technical
Sensitivity	Medium
Photographs

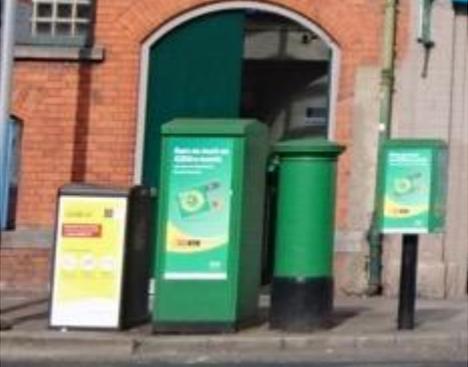
Identification No.	CBC0002PB005
Additional Identifiers	NIAH 50130209
Legal Status	Not protected but recognised by the NIAH
Location	post-box, At Drumcondra Station, Drumcondra Road, Dublin 9
Date of Construction	c. 1930
Description	Freestanding cast-iron pillar box, manufactured c.1930, with round plan, domed top and moulded corona, raised and framed notice slot beneath moulded frame of letter slot. Integrated handle to hinged opening with 'P & T' in traditional raised lettering
Significance Rating	Regional
Categories of Special Interest	Artistic, Social, Technical
Sensitivity	Medium
Photographs

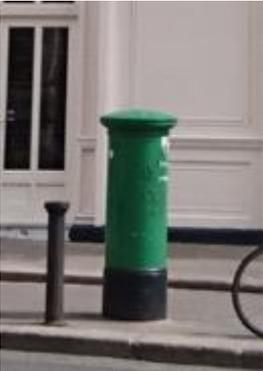
Identification No.	CBC0002PB007
Additional Identifiers	n/a
Legal Status	Not protected or included on any existing inventories
Location	post box, At Candy Café, 1 Frederick Street North, Dublin 1
Date of Construction	c. 1930
Description	Freestanding cast-iron pillar box, manufactured c.1930, with round plan, domed top and moulded corona, raised and framed notice slot beneath moulded frame of letter slot. Integrated handle to hinged opening with 'P & T' in traditional raised lettering
Significance Rating	Regional
Categories of Special Interest	Artistic, Social, Technical
Sensitivity	Medium
Photographs

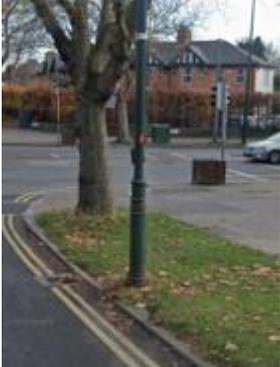
Identification No.	CBC0002LP001
Legal Status	Not protected or included in any existing inventories
Location	Junction Griffith Avenue, Whitehall, Dublin
Date of Construction	c.1930
Description	Cast iron moulded bases to the lamp posts Griffith's Avenue – replacement modern heads
Significance Rating	Local
Categories of Special Interest	Artistic, Technical
Sensitivity	Low
Photographs

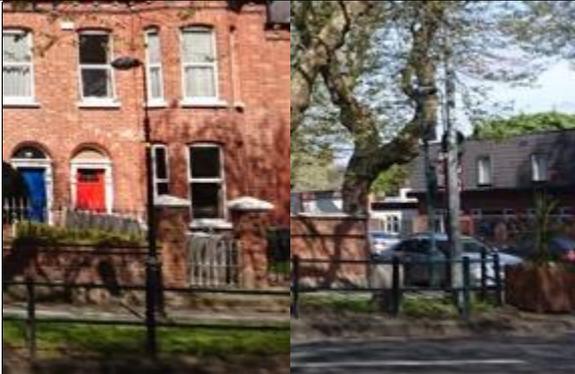
Identification No.	CBC0002LP003
Legal Status	Not protected or included in any existing inventories
Location	Drumcondra Road Lower, Dublin 9
Date of Construction	c.1930
Description	A number of historic bases with Dublin City Crest, lining the footpaths either side of Drumcondra Rd between Hollybank Road and St. Alphonsus Avenue. Double lanterns rounded, L-shape with replacement heads
Significance Rating	Regional
Categories of Special Interest	Artistic, Technical
Sensitivity	Medium
Photographs

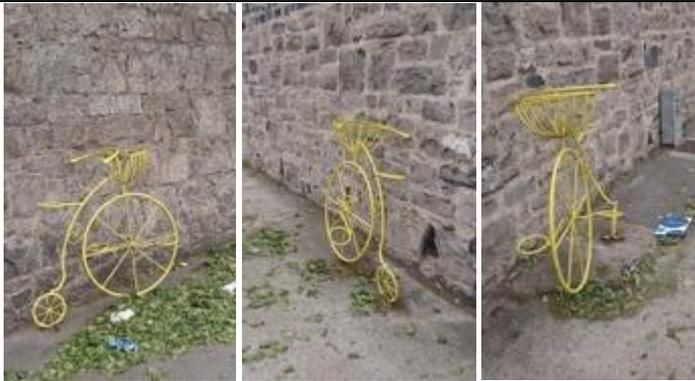
Identification No.	CBC0002BTH102
Legal Status	Not protected or included in any existing inventories
Location	At Saint Patrick's Campus, DCU, Drumcondra Road Upper, Dublin 9
Date of Construction	Unknown
Description	Free standing painted steel sculptures of bicycles.
Significance Rating	Local
Categories of Special Interest	Historical, Social
Sensitivity	Low
Photographs

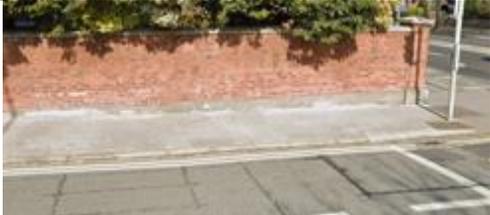
Identification No.	CBC0002BTH031
Legal Status	Not protected or included in any existing inventories
Location	Home Farm Road, Dublin 9
Description	Cut granite kerb stones (north footpath only)
Significance Rating	Local
Categories of Special Interest	Architectural
Sensitivity	Low
Photographs

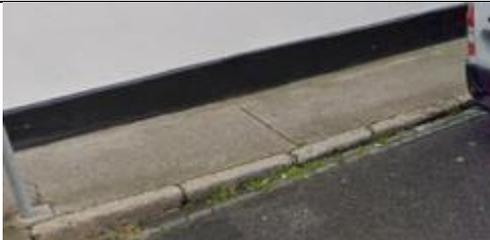
Identification No.	CBC0002BTH038
Legal Status	Not protected or included in any existing inventories
Location	Church Avenue, Dublin 9
Description	Triple row of setts to the edge of the carriageway with granite kerbs (footpath along the Drumcondra Road is modern but there are potentially historic stones under the path / road)
Significance Rating	Local
Categories of Special Interest	Architectural
Sensitivity	Low
Photographs

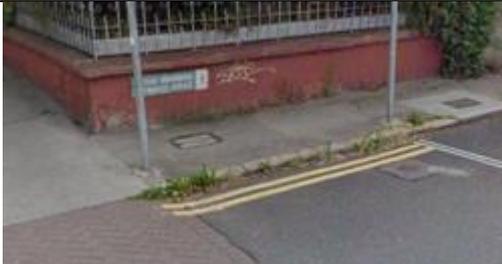
Identification No.	CBC0002BTH040
Legal Status	Not protected or included in any existing inventories
Location	Ormond Road, Dublin 9
Description	Cut granite kerb stones – footpath along the Drumcondra Road is modern but there are potentially historic stones under the path / road
Significance Rating	Local
Categories of Special Interest	Architectural
Sensitivity	Low
Photographs

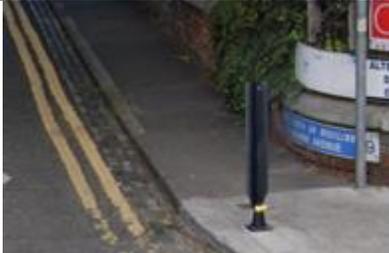
Identification No.	CBC0002BTH044
Legal Status	Not protected or included in any existing inventories
Location	Milbourne Avenue, Dublin 9
Description	Triple row of setts to the edge of the carriageway with granite kerbs (north side only)
Significance Rating	Local
Categories of Special Interest	Architectural
Sensitivity	Low
Photographs

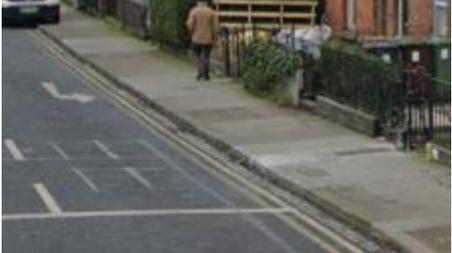
Identification No.	CBC0002BTH046
Legal Status	Not protected or included in any existing inventories
Location	Richmond Road, Dublin 9
Description	Triple row of setts to the edge of the carriageway with granite kerbs (south side only)
Significance Rating	Local
Categories of Special Interest	Architectural
Sensitivity	Low
Photographs

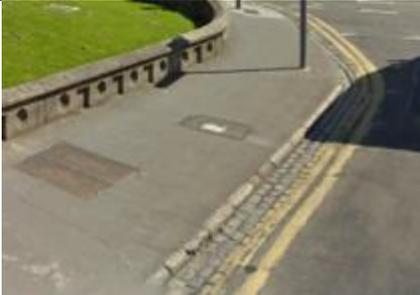
Identification No.	CBC0002BTH051
Legal Status	Not protected or included in any existing inventories
Location	Botanic Avenue, Drumcondra Road Upper, Dublin 9
Description	Triple row of setts to the edge of the carriageway with granite kerbs to the north side
Significance Rating	Local
Categories of Special Interest	Architectural
Sensitivity	Low
Photographs

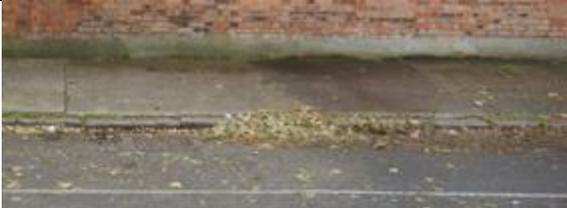
Identification No.	CBC0002BTH059
Legal Status	Not protected or included in any existing inventories
Location	Hollybank Road, Dublin 9
Description	Cut granite kerb stones
Significance Rating	Local
Categories of Special Interest	Architectural
Sensitivity	Low
Photographs

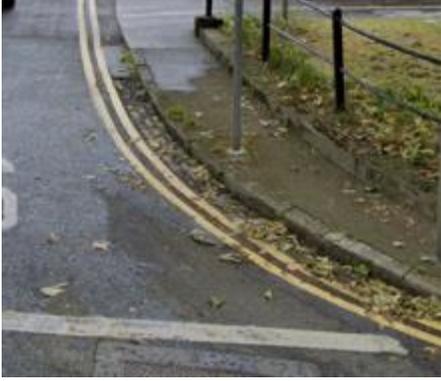
Identification No.	CBC0002BTH066
Legal Status	Not protected or included in any existing inventories
Location	Dargle Rd, Dublin 9
Description	Cut granite kerb stones
Significance Rating	Local
Categories of Special Interest	Architectural
Sensitivity	Low
Photographs

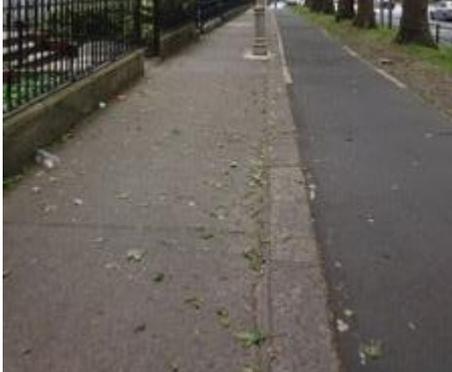
Identification No.	CBC0002BTH067
Legal Status	Not protected or included in any existing inventories
Location	Drumcondra Road Lower, Dublin 9
Description	Cut granite kerb stones between the entrance to the Archbishops House and 59 Drumcondra Road Lower
Significance Rating	Local
Categories of Special Interest	Architectural
Sensitivity	Low
Photographs

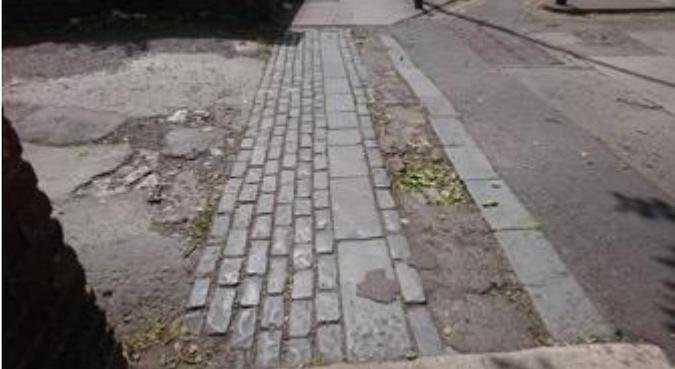
Identification No.	DCC RPS 2349
Legal Status	A protected structure
Location	Lane to the south of 45 Drumcondra Road Lower, Dublin 9
Description	Limestone kerbs and sets at the entrance to the mews lane
Significance Rating	Regional
Categories of Special Interest	Architectural
Sensitivity	Medium
Photographs

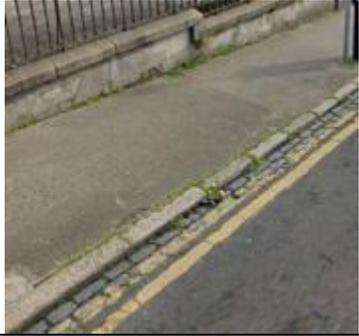
Identification No.	CBC0002BTH085
Legal Status	Not protected or included in any existing inventories
Location	Whitworth Place, Dublin 9
Description	Triple row of setts to the edge of the carriageway with granite kerbs (north side only)
Significance Rating	Local
Categories of Special Interest	Architectural
Sensitivity	Low
Photographs

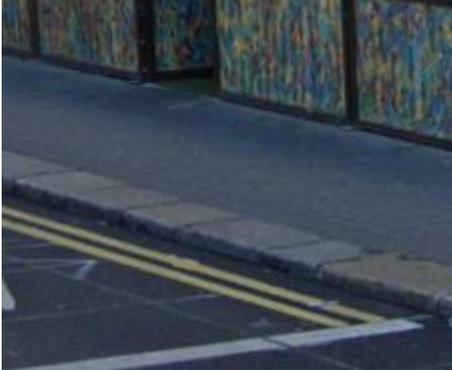
Identification No.	CBC0002BTH096
Legal Status	Not protected or included in any existing inventories
Location	Frederick Steet North, Dublin 1
Description	Wide granite kerbs lining both sides of the road with some modern replacements
Significance Rating	Regional
Categories of Special Interest	Architectural
Sensitivity	Medium
Photographs

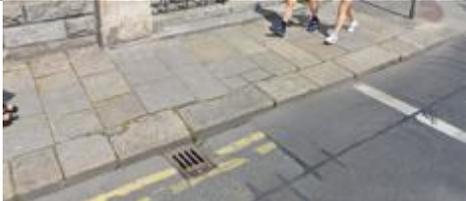
Identification No.	CBC0002BTH097
Legal Status	Not protected or included in any existing inventories
Location	Parnell Square North, Dublin 1
Description	Wide granite kerbs and granite paving on the footpath
Significance Rating	Regional
Categories of Special Interest	Architectural
Sensitivity	Medium
Photographs

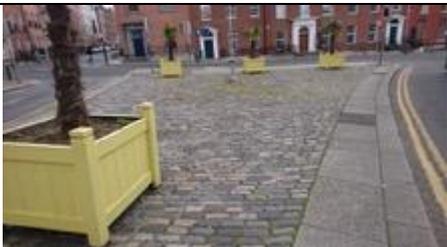
Identification No.	CBC0002BTH098
Legal Status	Not protected or included in any existing inventories
Location	Junction Frederick St North, Parnell Square North, Dublin 1
Description	Setts on traffic island
Significance Rating	Regional
Categories of Special Interest	Architectural
Sensitivity	Medium
Photographs

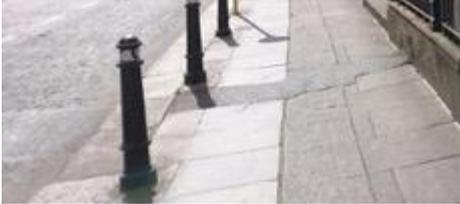
Identification No.	CBC0002BTH101
Legal Status	Not protected or included in any existing inventories
Location	Parnell Square West, Dublin 1
Description	Wide granite kerbs lining both sides of the road with some modern replacements at entrances to the Rotunda Hospital
Significance Rating	Regional
Categories of Special Interest	Architectural
Sensitivity	Medium
Photographs
