Appendix I1

Accessibility Audit Report

Jacobs Engineering Ireland Limited

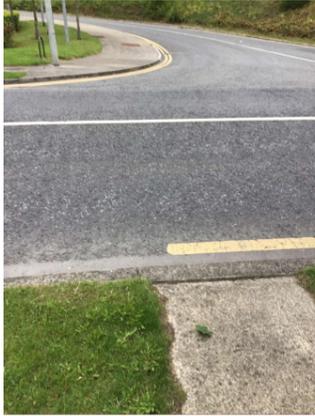
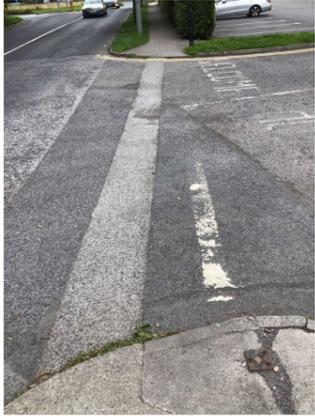
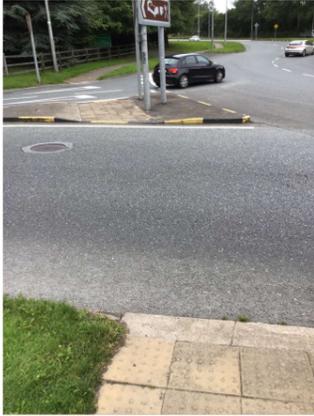
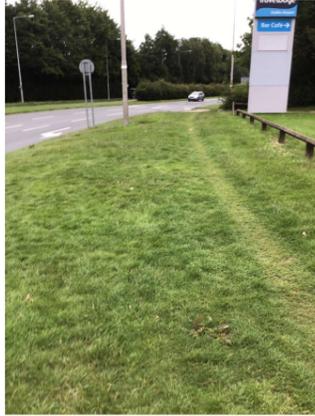
979 - No crossing facilities provided	981 - No crossing facilities provided	982 - No crossing facilities provided	983 - Footpath not provided
<p>This is located along the R125 at Airside Retail Park. It is considered high severity as a lack of a crossing at this point requires unreasonable diversion and makes crossing inaccessible.</p>	<p>This is located along the R125, at the Travelodge entrance. It is considered high severity as there are no alternatives to crossing at this point, making it inaccessible. Whilst the kerb is flush with the road, there is no tactile paving indicate the direction to cross.</p>	<p>This is located on the R125 at the Pinnockhill Roundabout. This is considered high severity as there is no alternative to crossing at this point, making it inaccessible. Whilst tactile paving is provided, there are no signals to indicate when it is safe to cross.</p>	<p>This is located along the R125 at Pinnockhill Roundabout. It is considered high severity as it makes the area inaccessible to those with visual impairments as there is no indication of direction to follow. It is also inaccessible for those in a wheelchair due to the surface.</p>

717989, 745775	717945, 745828	717931, 745883	717931, 745889
Solution: Provide crossing facilities.	Solution: Provide crossing facilities.	Solution: Provide crossing facilities.	Solution: Extend/ Provide footway.
984 - No crossing facilities provided	986 - No crossing facilities provided	987 - No crossing facilities provided	
<p>This is located along the R132 at the Pinnockhill Roundabout. It is high severity as there are no alternative crossings at this point, making it inaccessible.</p>	<p>This is located at the R836 at Pinnockhill Roundabout. It is high severity as there are no alternative crossings at this point, making it inaccessible.</p>	<p>This is located along the R132 at Pinnockhill Roundabout. It is high severity as there are no alternatives to crossing at this point, making it inaccessible.</p>

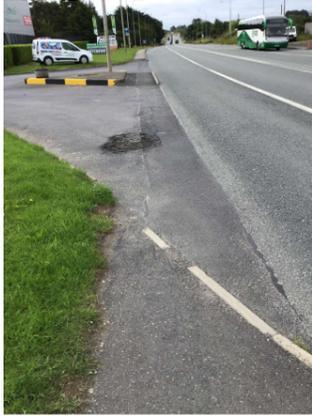
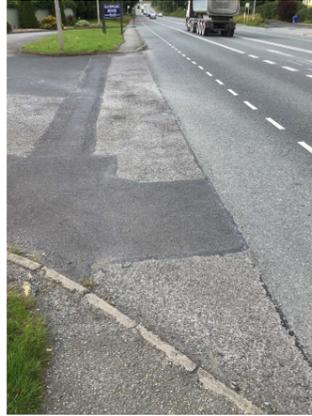
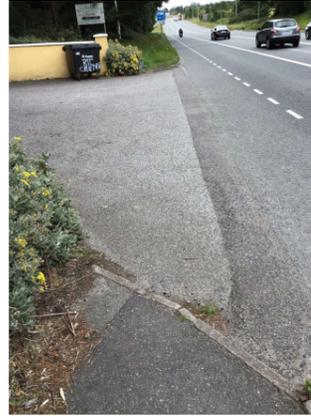
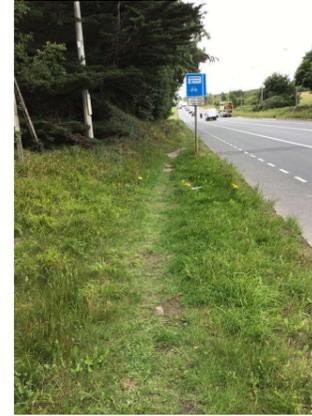
<p>717697, 745305</p>	<p>717677, 745280</p>	<p>717680, 745248</p>	<p>717686, 745204</p>
<p>Solution: Provide crossing facilities.</p>	<p>Solution: Raise the driveway to meet the required standard height.</p>	<p>Solution: Implement more suitable paving which is even.</p>	<p>Solution: Raise the entryway to meet the required standard height.</p>
1012 - No crossing facilities provided	1013 - No crossing facilities provided	1020 - No crossing facilities provided	1021 - Footpath not provided
<p>This is located along the R132 located at the entrance to a number of retail units. This is high severity as it is not clear where the end of the footpath is, which may cause visually impaired pedestrians to veer into the carriageway.</p>	<p>This is located along the R132, at the entrance to Glenmore House B&B. This is considered high severity as there is no distinction between the entrance and the carriageway, causing visually impaired pedestrians to veer into the carriageway.</p>	<p>This is located along the R132, at a private entrance. This is high severity as there is no distinctions between the entryway and the road, which could cause visually impaired pedestrians to veer into the carriageway. There is no alternative to crossing at this point, making it inaccessible.</p>	<p>This is located along the R132, at a private entrance, at the same crossing as 1020. This is high severity as there is no footpath provided on this side of the entryway, making it inaccessible for those with reduced mobility, or visually impaired pedestrians with no indication of direction.</p>

<p>717738, 745064</p>	<p>717748, 744974</p>	<p>717756, 744801</p>	<p>717755, 744801</p>
<p>Solution: Provide crossing facilities or continue footpath and provide a dropped kerb access to private development.</p>	<p>Solution: Provide crossing facilities or continue footpath and provide a dropped kerb access to private development.</p>	<p>Solution: Provide crossing facilities or continue footpath and provide a dropped kerb access to private development</p>	<p>Solution: Provide footpath.</p>

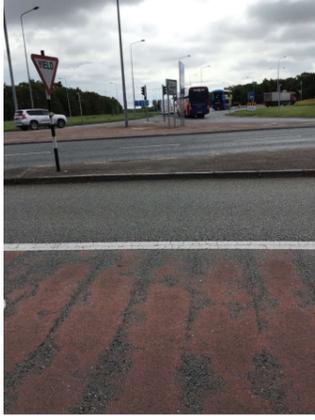
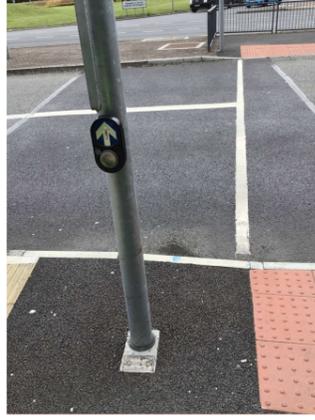
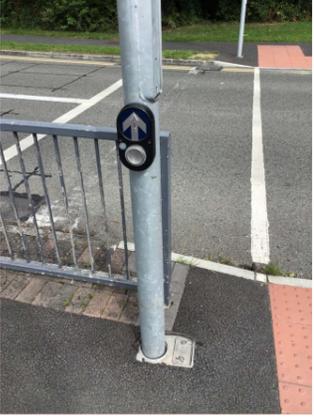
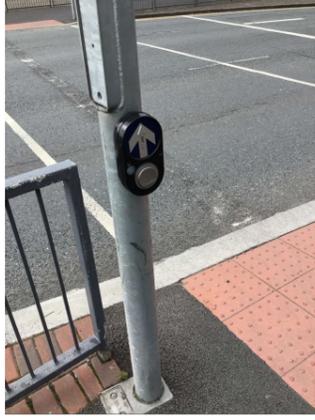
<p>717661, 744148</p>	<p>717652, 743987</p>	<p>717608, 743904</p>	<p>717602, 743859</p>
<p>Solution: Provide footpath.</p>	<p>Solution: Provide crossing facilities.</p>	<p>Solution: Provide crossing facilities.</p>	<p>Solution: Provide footpath.</p>
<p>1053 - No crossing facilities provided</p>	<p>1054 - Unsuitable access for disabled users</p>	<p>1055 - Unsuitable access for disabled users</p>	<p>1056 - Unsuitable access for disabled users</p>
<p>This is located on the R132, on approach to Airport Roundabout. This is considered high severity as crossing requires unreasonable diversion, making it inaccessible.</p>	<p>This is located at the R132 exit of Airport Roundabout. It is considered high severity as the push button is not working, with no sound or pulse for disabled users, making it inaccessible.</p>	<p>This is located at the R132 exit of Airport Roundabout. It is considered high severity as the push button is not working, with no sound or pulse for disabled users, making it inaccessible.</p>	<p>This is located at the exit lanes from Dublin Airport towards Airport Roundabout. It is considered high severity as the push button is not working, with no sound or pulse for disabled users, making it inaccessible.</p>

<p>717611, 743533</p>	<p>717594, 743509</p>	<p>717597, 743495</p>	<p>717596, 743494</p>
<p>Solution: Provide crossing facilities.</p>	<p>Solution: Fix push button.</p>	<p>Solution: Fix push button.</p>	<p>Solution: Fix push button.</p>

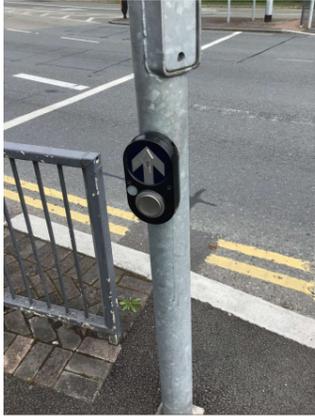
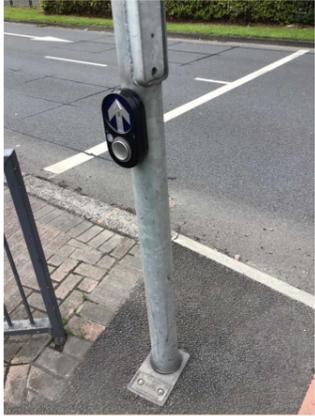
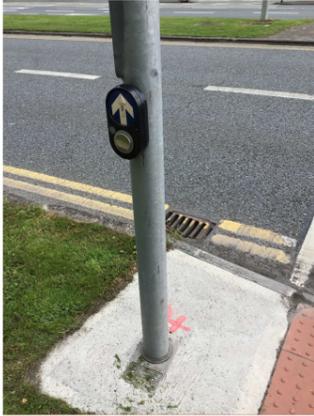
1057 - Unsuitable access for disabled users	1058 - Unsuitable access for disabled users	1059 - Unsuitable access for disabled users
<p>This is located at the exit lanes from Dublin Airport towards Airport Roundabout. It is considered high severity as the push button is not working, with no sound or pulse for disabled users, making it inaccessible.</p>	<p>This is located at the entrance lanes from Airport Roundabout towards Dublin Airport. It is considered high severity as the push button is not working, with no sound or pulse for disabled users, making it inaccessible.</p>	<p>This is located at the entrance lanes from Airport Roundabout towards Dublin Airport. It is considered high severity as the push button is not working, with no sound or pulse for disabled users, making it inaccessible.</p>

<p>717594, 743477</p>	<p>717585, 743472</p>	<p>717581, 743461</p>
<p>Solution: Fix push button.</p>	<p>Solution: Fix push button.</p>	<p>Solution: Fix push button.</p>

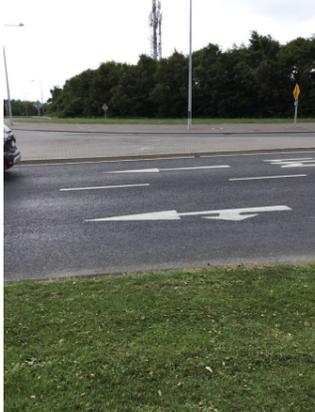
<p>1061 - No crossing facilities provided</p>
<p>This is located on the R132, south of Airport Roundabout. This is high severity as crossing requires unreasonable diversion, making it inaccessible.</p>

<p>717640, 743411</p>
<p>Solution: Provide crossing facilities.</p>

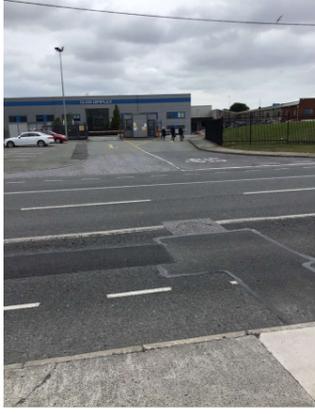
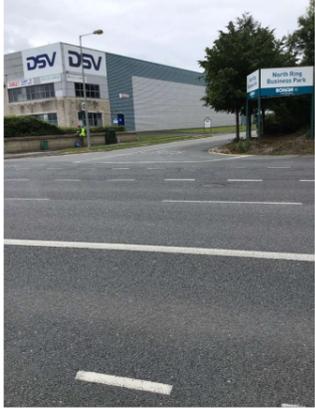
<p>717037, 742008</p>	<p>717038, 741992</p>	<p>717081, 741855</p>	<p>717082, 741814</p>
<p>Solution: Reposition dropped kerb to align crossings.</p>	<p>Solution: Lower kerb to be flush with crossing.</p>	<p>Solution: Provide crossing facilities.</p>	<p>Solution: Relocate signpost to more appropriate location, or completely remove as no sign present.</p>
1092 - No crossing facilities provided	1102 - No crossing facilities provided		
<p>This is located along the R132, at the entrance to Glen Dimplex. This is high severity as there is no alternative to crossing at this point, making it inaccessible.</p>	<p>This is located along the R132, at the entrance of North Ring Business Park. This is high severity as there is no alternative to crossing at this point, making it inaccessible.</p>

<p>717076, 741673</p>	<p>717103, 741412</p>		
<p>Solution: Provide crossing facilities.</p>	<p>Solution: Provide crossing facilities.</p>

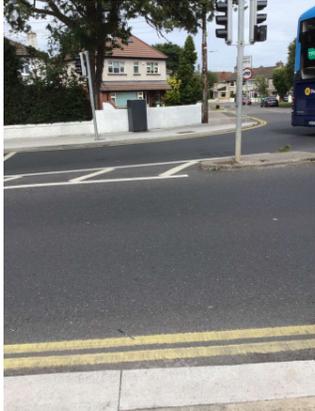
<p>1177 - No crossing facilities provided</p>
<p>This is located at the Swords Road/Shanrath Road junction. This is high severity as crossing requires unreasonable diversion, making it inaccessible for those with reduced mobility.</p>

<p>716770, 738943</p>
<p>Solution: Provide crossing facilities.</p>

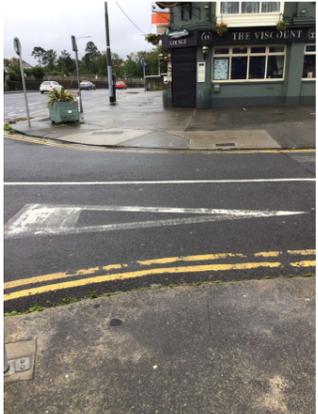
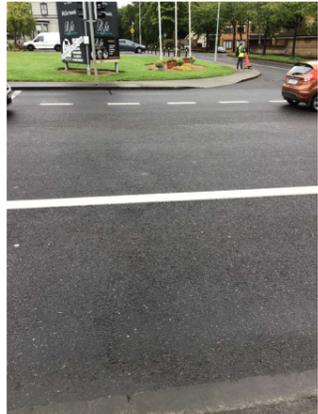
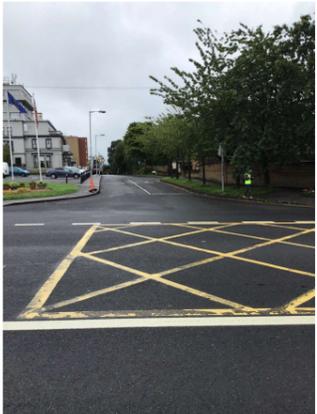
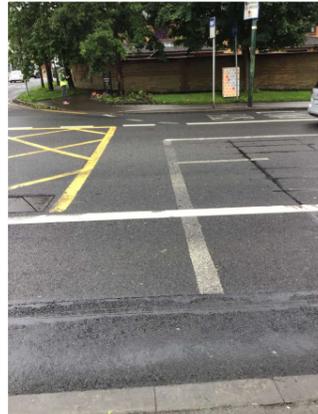
Table 11.1: High Severity Issues in Zone 10

1209 - No crossing facilities provided	1226 - No crossing facilities provided	1227 - No crossing facilities provided	1228 - No crossing facilities provided
<p>This is located along the R132, at the junction with Iveragh Road. This is considered high severity as crossing requires unreasonable diversion, making it inaccessible.</p>	<p>This is located along the R132 at the entrance to the Bonnington Dublin Hotel. This is high severity as there is no alternative to crossing at this point, making it inaccessible.</p>	<p>This is located along the R132, at the junction with Seven Oaks. This is considered high severity as there is no alternative to crossing at this point, making it inaccessible.</p>	<p>This is located on the R132, south of the junction with Seven Oaks. This is high severity as there is no alternative to crossing at this point, making it inaccessible.</p>

<p>716722, 738211</p>	<p>716557, 737838</p>	<p>716562, 737812</p>	<p>716548, 737816</p>

<p>Solution: Provide crossing facilities.</p>	<p>Solution: Provide crossing facilities.</p>	<p>Solution: Provide crossing facilities.</p>	<p>Solution: Provide crossing facilities.</p>

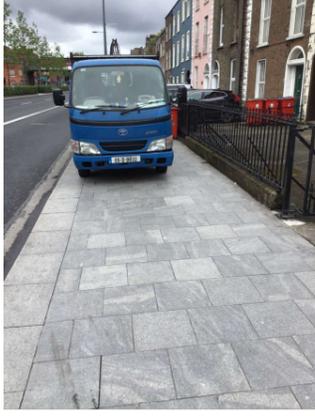
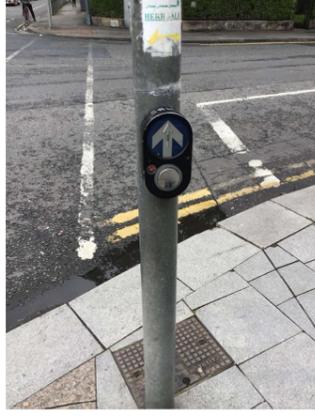
<p>716019, 736311</p>	<p>716077, 736545</p>	<p>715868, 736034</p>	<p>715864, 736026</p>
<p>Solution: Fix road surface and provide crossing facilities.</p>	<p>Solution: Relocate street furniture.</p>	<p>Solution: Provide correct tactile paving.</p>	<p>Solution: Provide correct tactile paving at crossing.</p>
<p>1363 - Vehicles parked in footway</p>	<p>1368 - Unsuitable access for disabled users</p>		
<p>This is located along Drumcondra Road Lower, north of Whitworth Place. This is high severity as it makes the path inaccessible for people using wheelchairs or walking aids.</p>	<p>This is located along Drumcondra Road Lower, at the junction with R131. This is high severity as the push button does not pulse for visually impaired or deaf pedestrians, making it inaccessible.</p>

<p>715872, 736036</p>	<p>715949, 736207</p>		
<p>Solution: Enforce no parking on footpaths in this area.</p>	<p>Solution: Fix push button.</p>

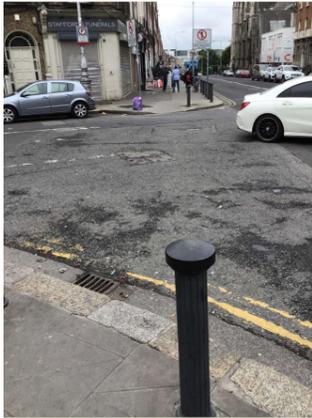
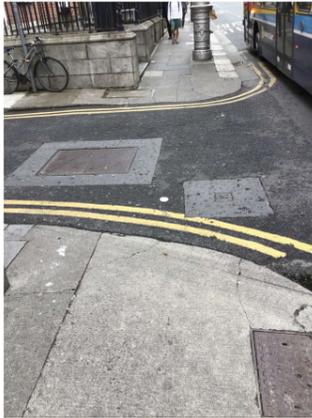
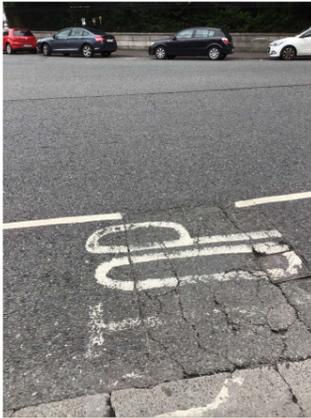
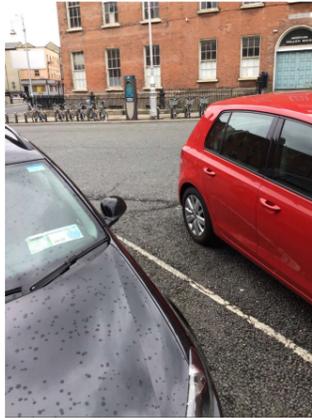
Table 15.1: High Severity Issues in Zone SR 1

1414 - No crossing facilities provided	1439 - No crossing facilities provided	1441 - No crossing facilities provided	1443 - No crossing facilities provided
<p>This is located on Frederick Street North. This is high severity as there is no alternative to crossing at this point, making it inaccessible.</p>	<p>This is located on Parnell Square West, opposite Rotunda Hospital. This is high severity as there is no alternative to crossing at this point, making it inaccessible.</p>	<p>This is located on Parnell Square West, at the junction with Parnell Square North. This is high severity as crossing requires unreasonable diversion, making it inaccessible.</p>	<p>This is located on Parnell Square North. This is high severity as there is no alternative to crossing at this point, making it inaccessible.</p>

<p>715516, 735312</p>	<p>715581, 734989</p>	<p>715481, 735092</p>	<p>715493, 735122</p>

<p>Solution: Provide crossing facilities. Tighten Junction</p>			
<p>Solution: Provide crossing facilities.</p>		<p>Solution: Provide crossing facilities.</p>	
1446 - No crossing facilities provided			
<p>This is located on Granby Row, at Granby Lane. This is high severity as there is no alternative to crossing at this point, making it inaccessible.</p>
